PROGRESS OF OYSTER RESTORATION PROJECT ON CORMORANT KEY/CHARLOTTE HARBOR

Office of Resilience and Coastal Protection / Aquatic Preserves

Florida Department of Environmental Protection

Charlotte Harbor National Estuary Partnership (CHNEP) Watershed Summit | Jun. 22nd, 2023

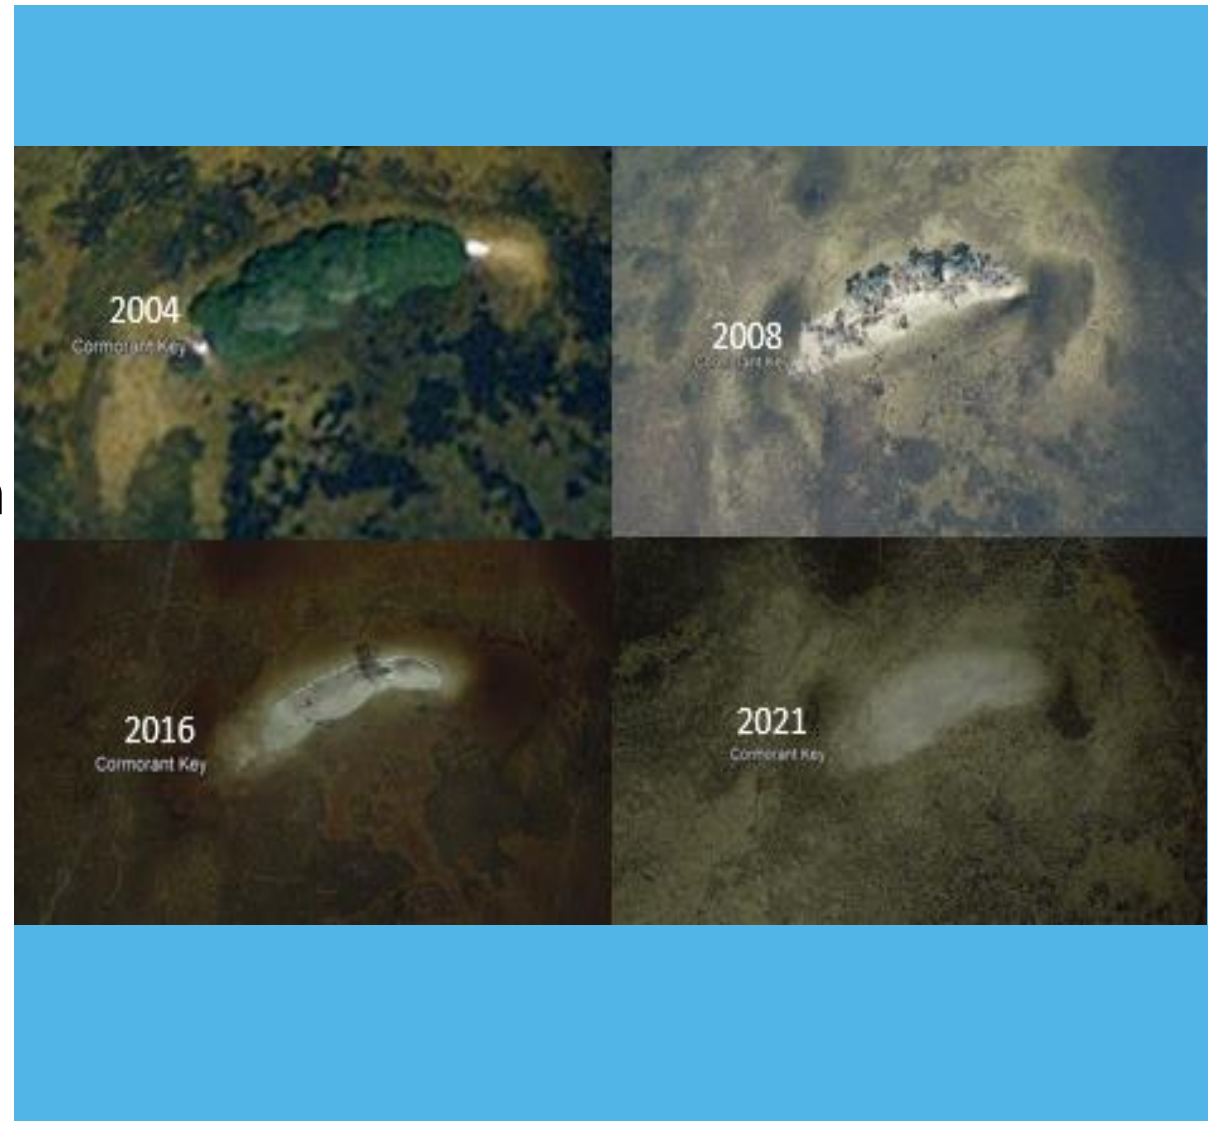
- Island and archaeological site in Charlotte Harbor that was severely damaged during Hurricane Charley in 2004.
- Experienced significant loss of mangroves along with severe erosion.
- Area identified as potential suitable location from The Nature Conservancy/Coastal and Heartland National Estuary Partnership oyster restoration suitability plan.
- CHAP partnered with Sanibel-Captiva Conservation Foundation (SCCF) for restoration project utilizing fossilized shell to create an oyster reef.

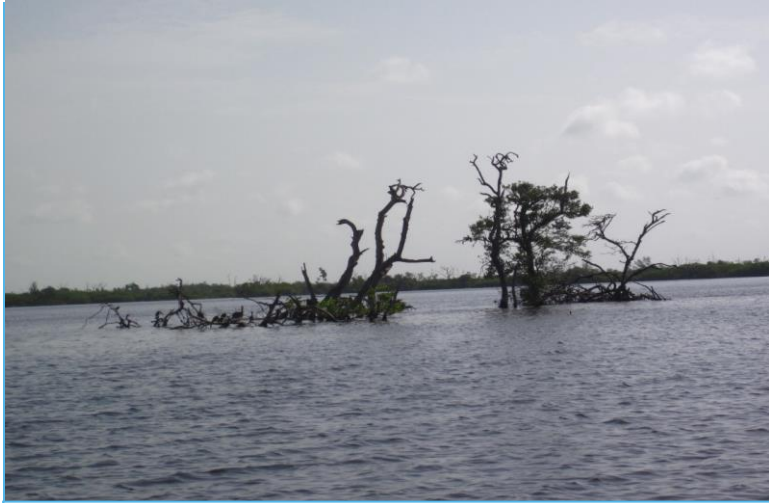
2012

CORMORANT KEY OVER TIME (PRE-RESTORATION)

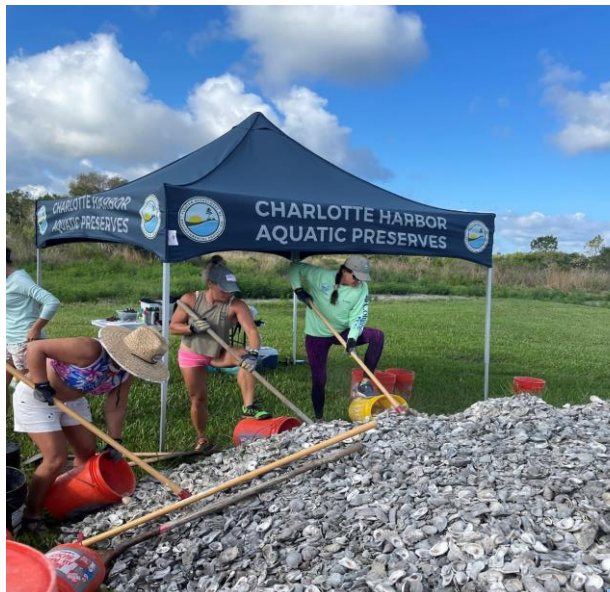
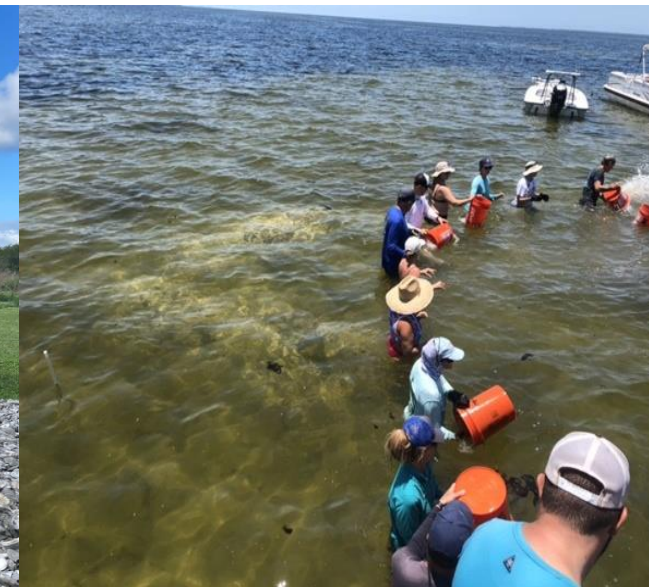
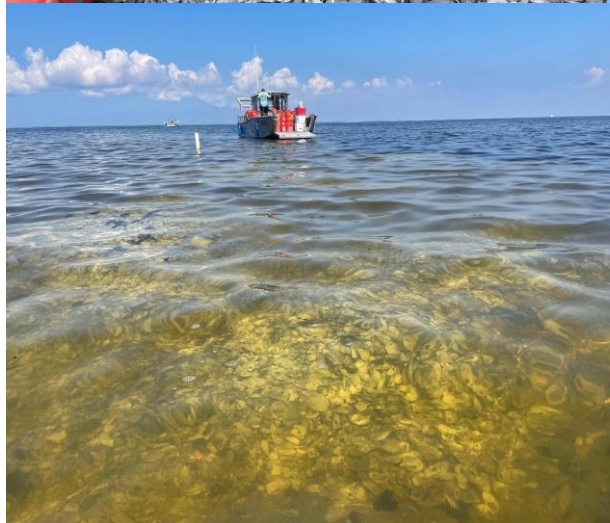
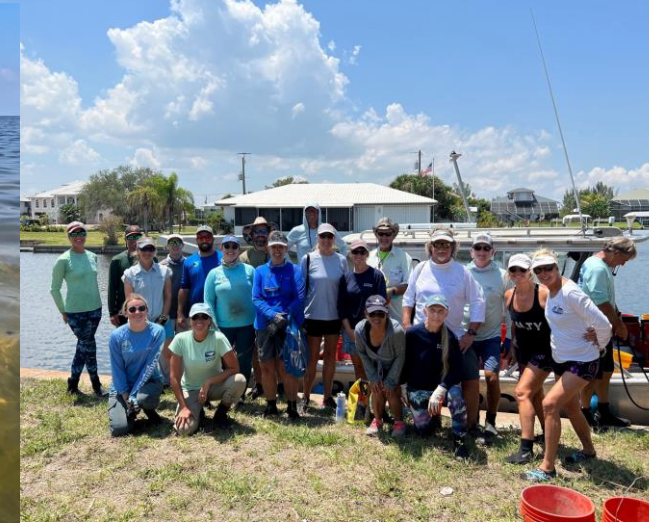
- 55 volunteers from 11 different organizations shoveled, transported and helped deploy over 800 buckets of loose shell (~12 tons) on Cormorant Key in May of 2022:
 - ❖ SCCF.
 - ❖ Friends of Charlotte Harbor Aquatic Preserves.
 - ❖ CrossFit Punta Gorda.
 - ❖ Florida Fish and Wildlife Conservation (FWC).
 - ❖ Charlotte County Sea Grant.
 - ❖ City of Cape Coral.
 - ❖ Charlotte Harbor Preserve State Park.
 - ❖ West Coast Inland Navigation District.
 - ❖ FWC Law Enforcement.
 - ❖ Punta Gorda Middle School Fishing Club.
 - ❖ Pirate Harbor Community.
- Shell serves as substrate for spat to attach & grow to form dense clusters known as oyster reefs or beds.

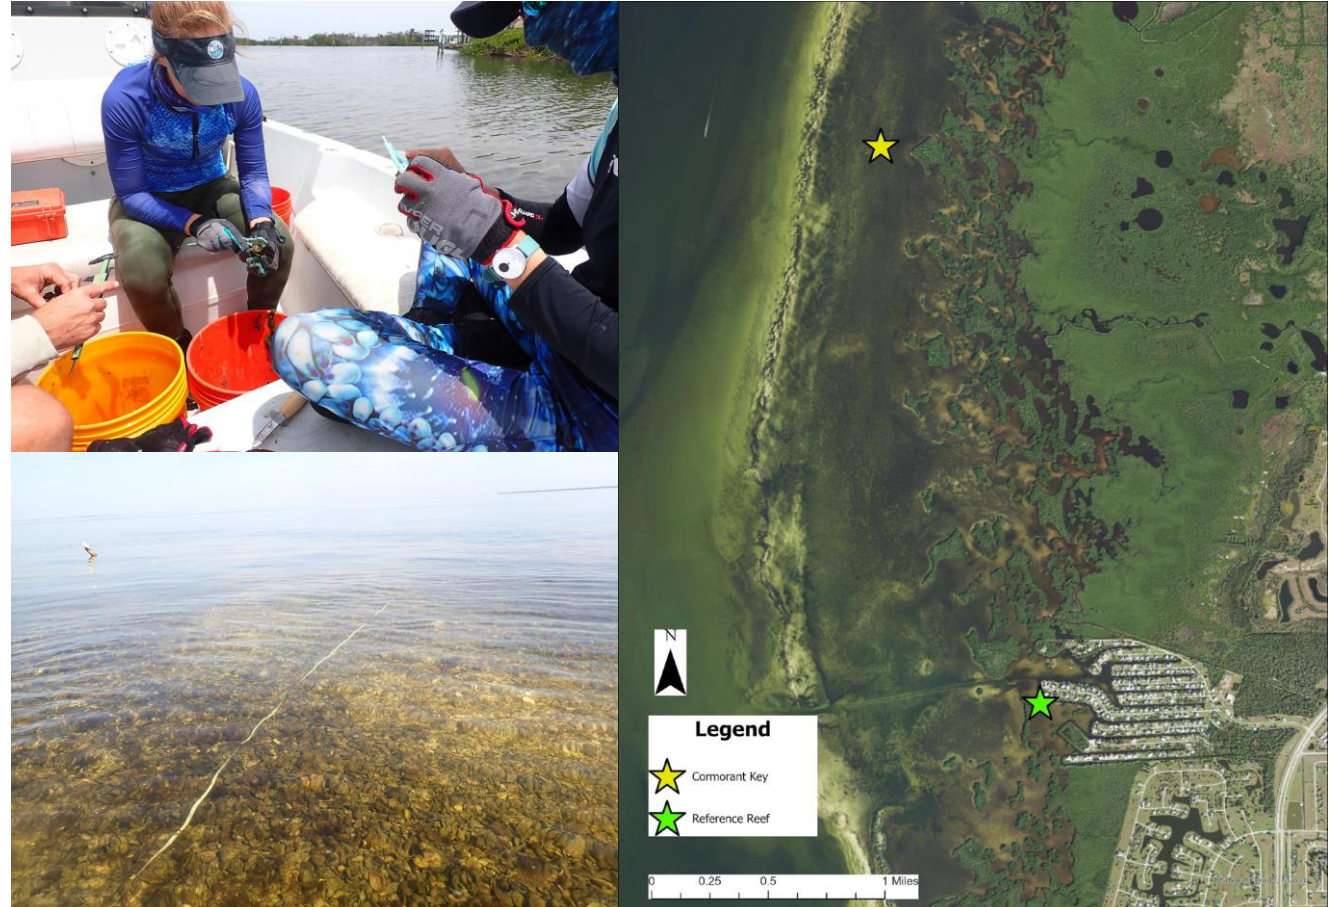
MONITORING METHODS IN CORMORANT KEY

- Monitored 6-months & 1-year after restoration.
- Collected five 0.0625m² quadrats.
- Measured oyster density & shell height.
- Compared to nearby reference reef.
- Will continue to be monitored annually.

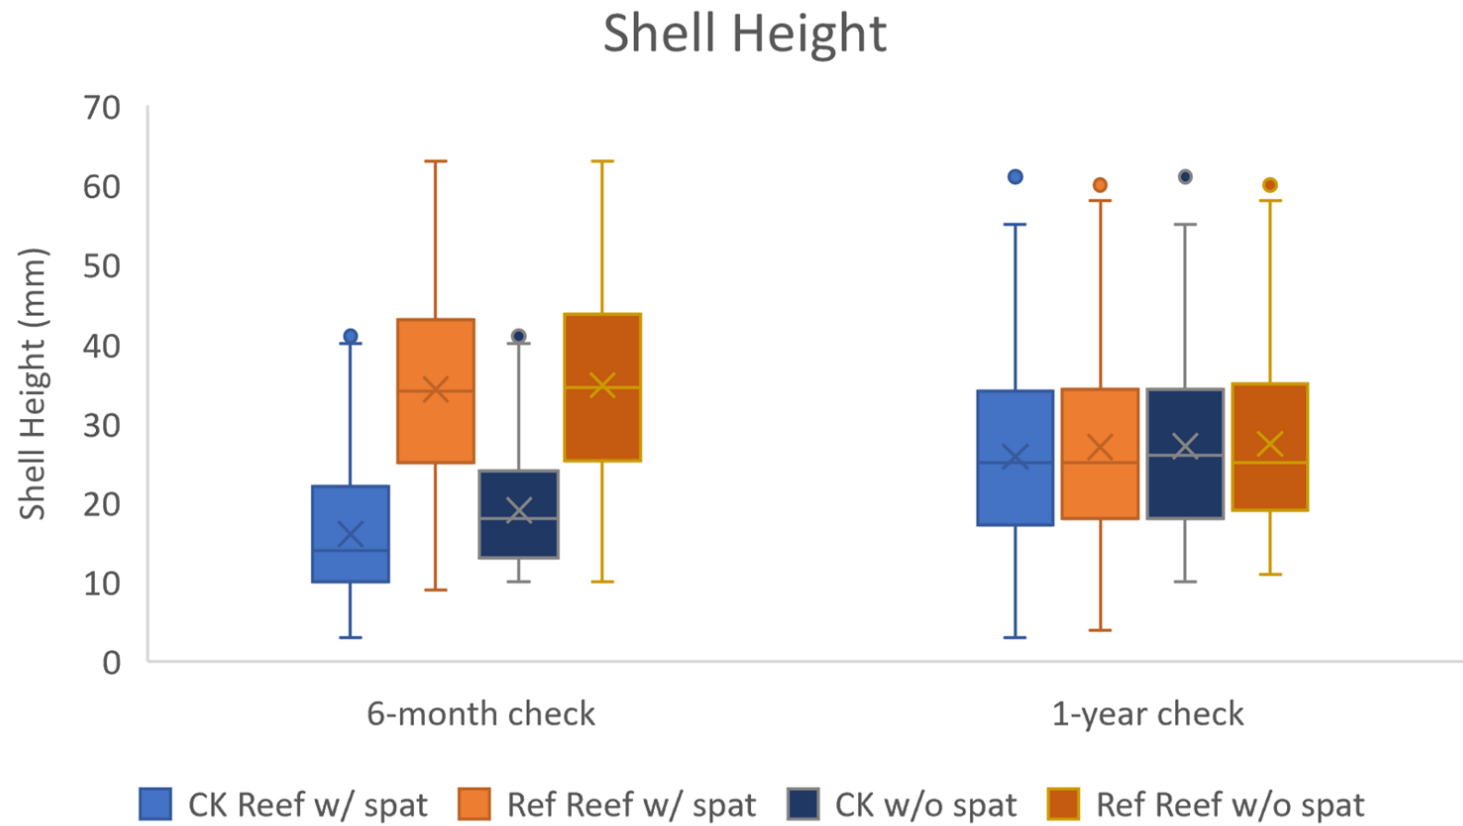
SHELL HEIGHT

RESULTS

- Cormorant Key appears to be following the pattern of other oyster restoration projects in this area with a large initial settlement event.
- Oyster density will drop after 2-3 years and shell heights will resemble those of reference reef- CK may be ahead of schedule as shell heights are already similar.
- Opportunities to add additional shell?

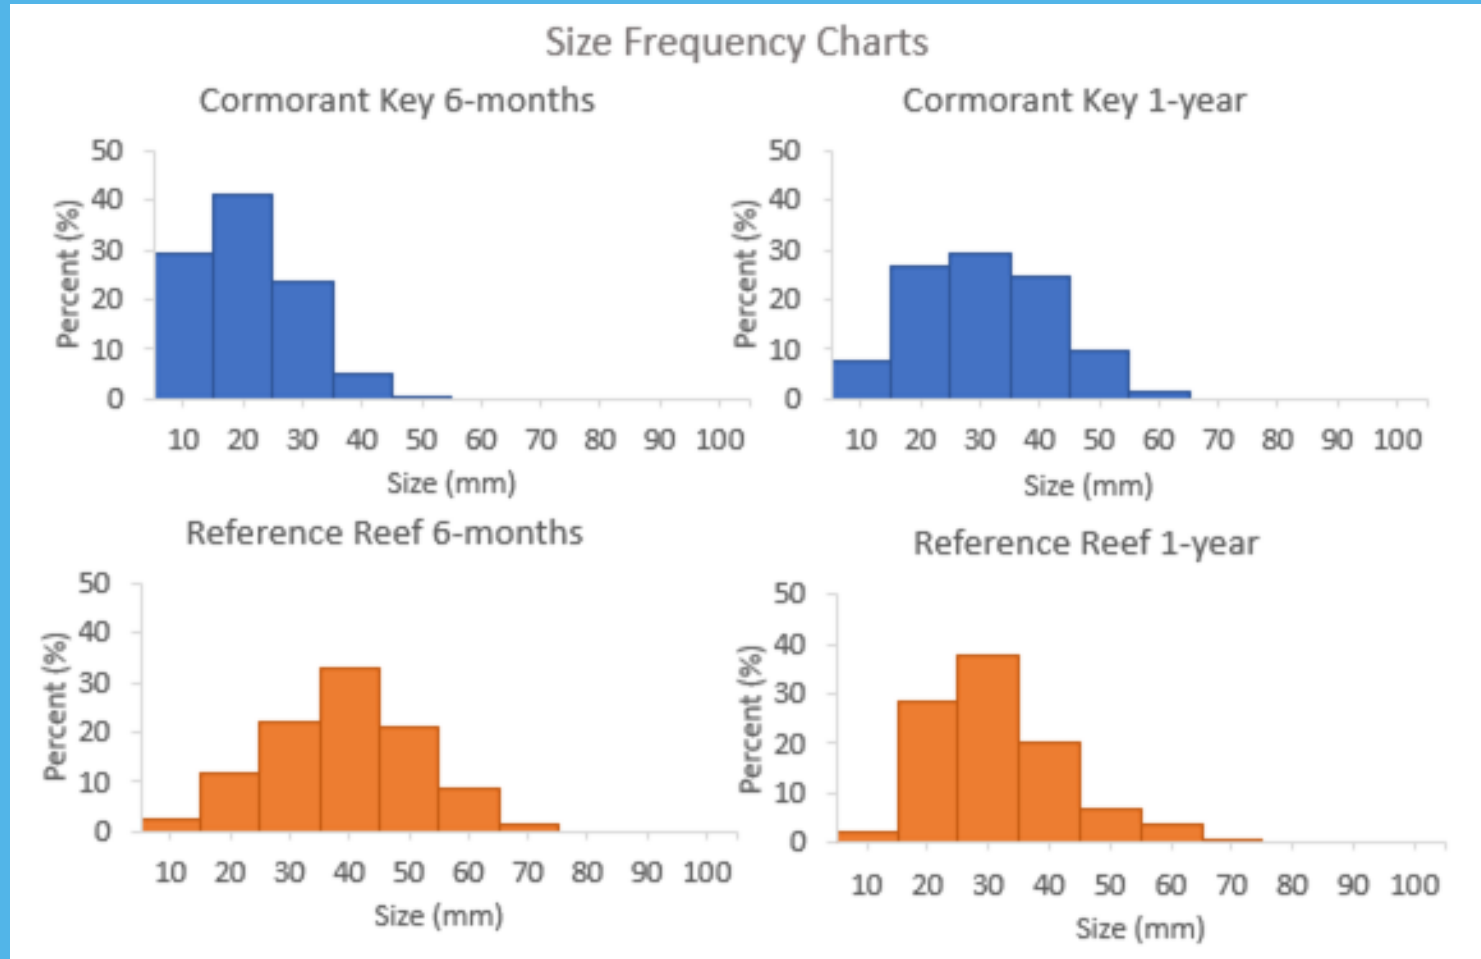
SIZE FREQUENCY

RESULTS

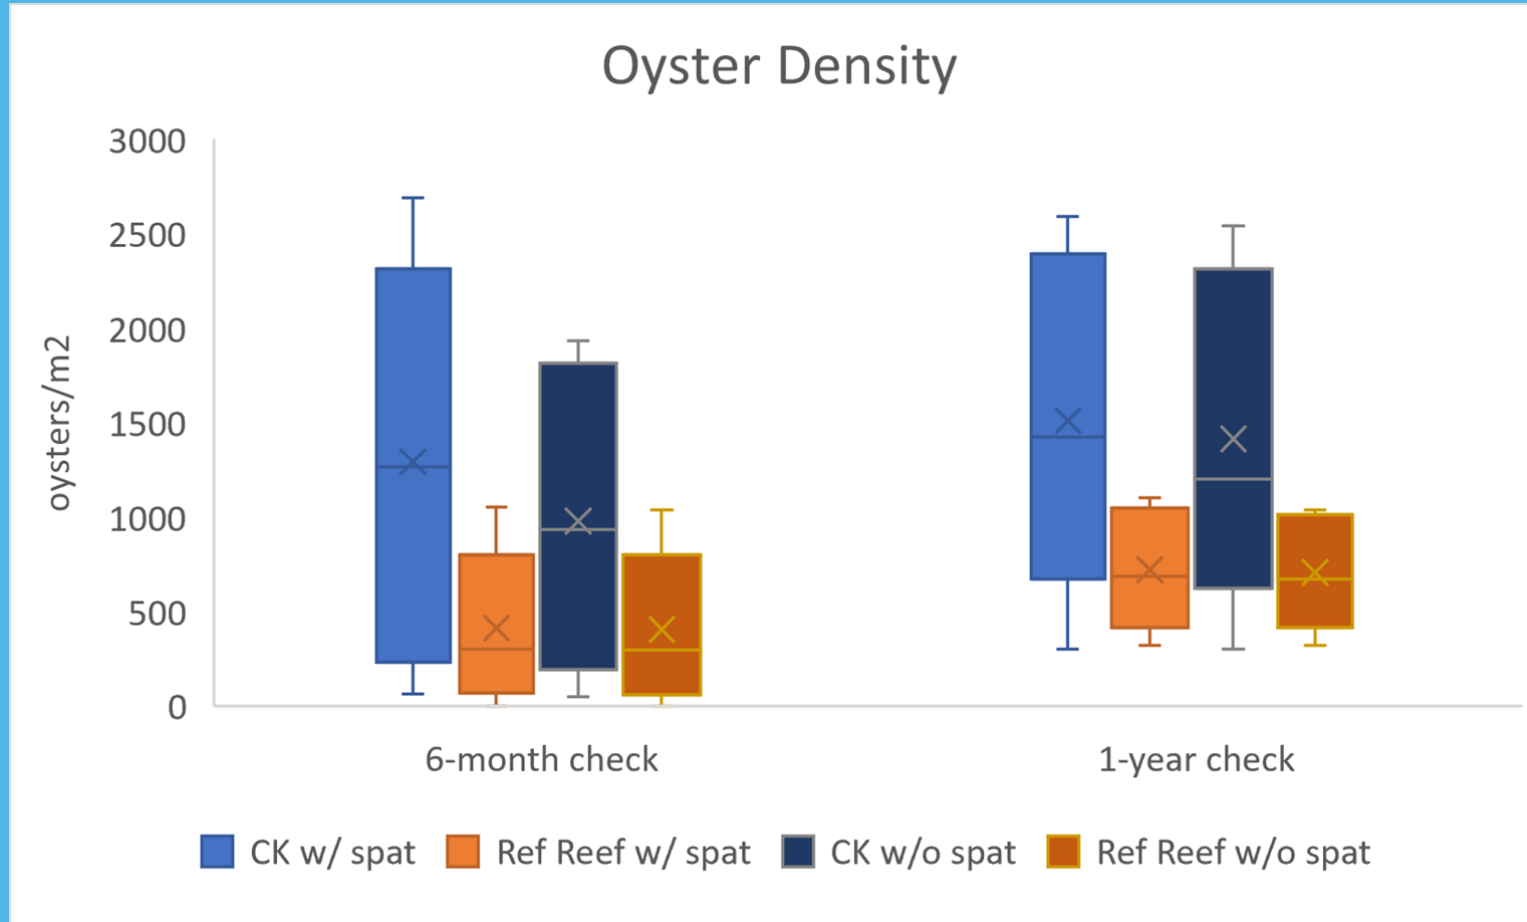
OYSTER DENSITY

RESULTS

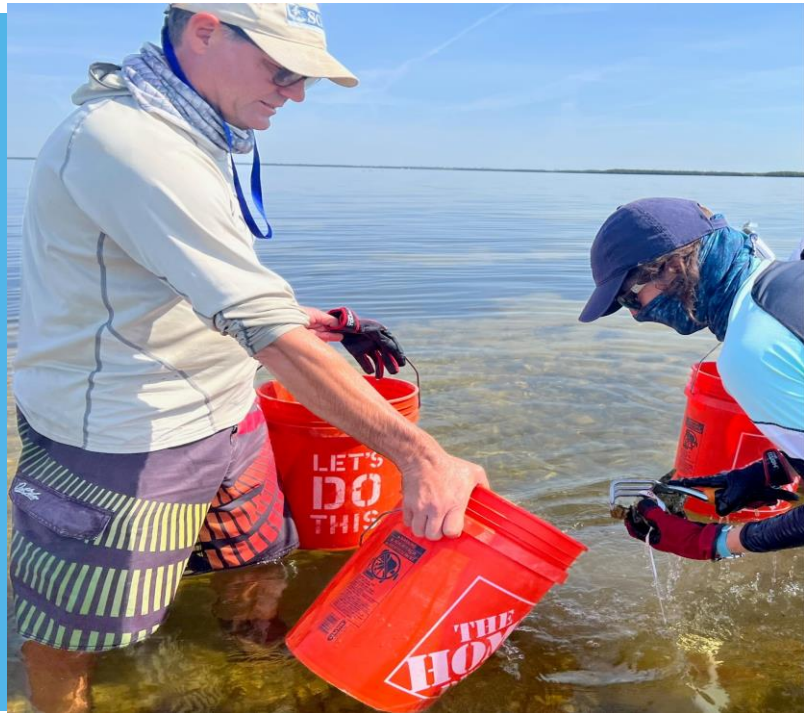
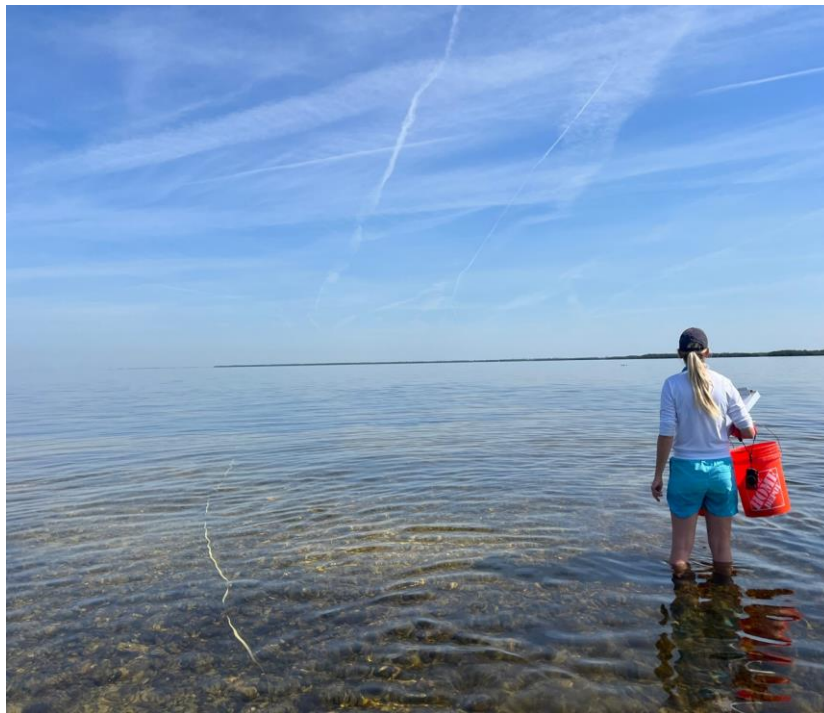
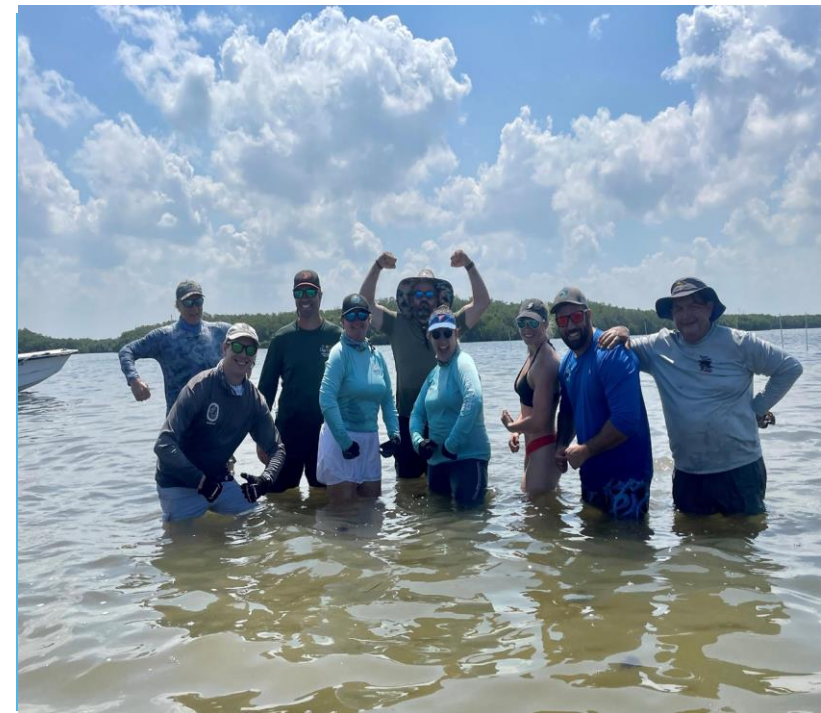
OYSTER SPAT/CORMORANT KEY
