Phytoplankton and Harmful Algal Bloom dynamics in the Caloosahatchee Estuary and nearshore Gulf of Mexico

Eric Milbrandt, Ph.D., Marine Laboratory, Sanibel-
Captiva Conservation Foundation

CHNEP Watershed Summit
06/21/2023

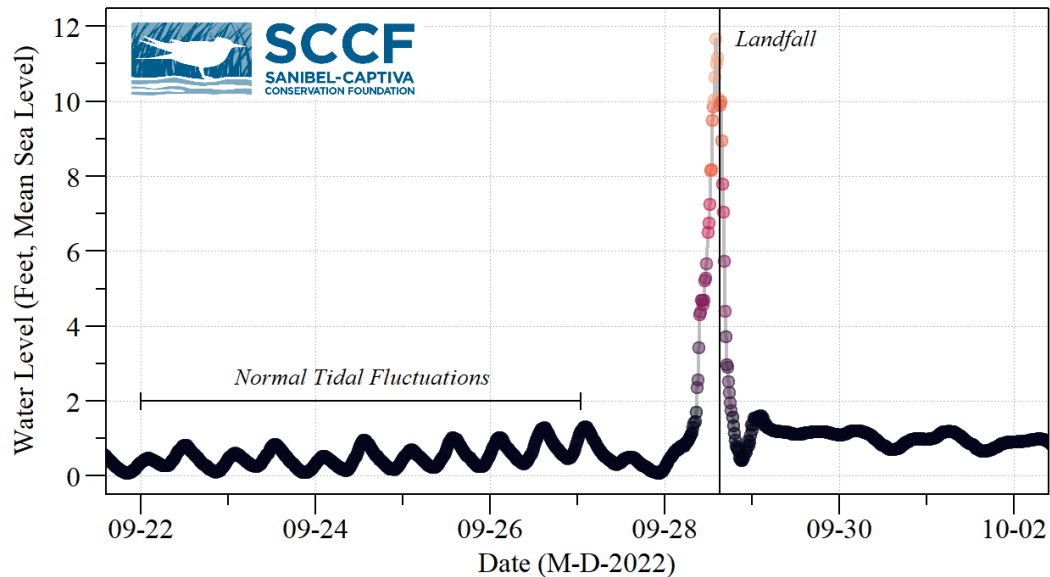
Hurricane Ian

Date: Wednesday September 28, 2022

Landfall: Cayo Costa, FL

Wind speed: Sustained ~150mph

Storm Surge: 12 - 13 ft on Sanibel, 3 - 6 feet on Captiva

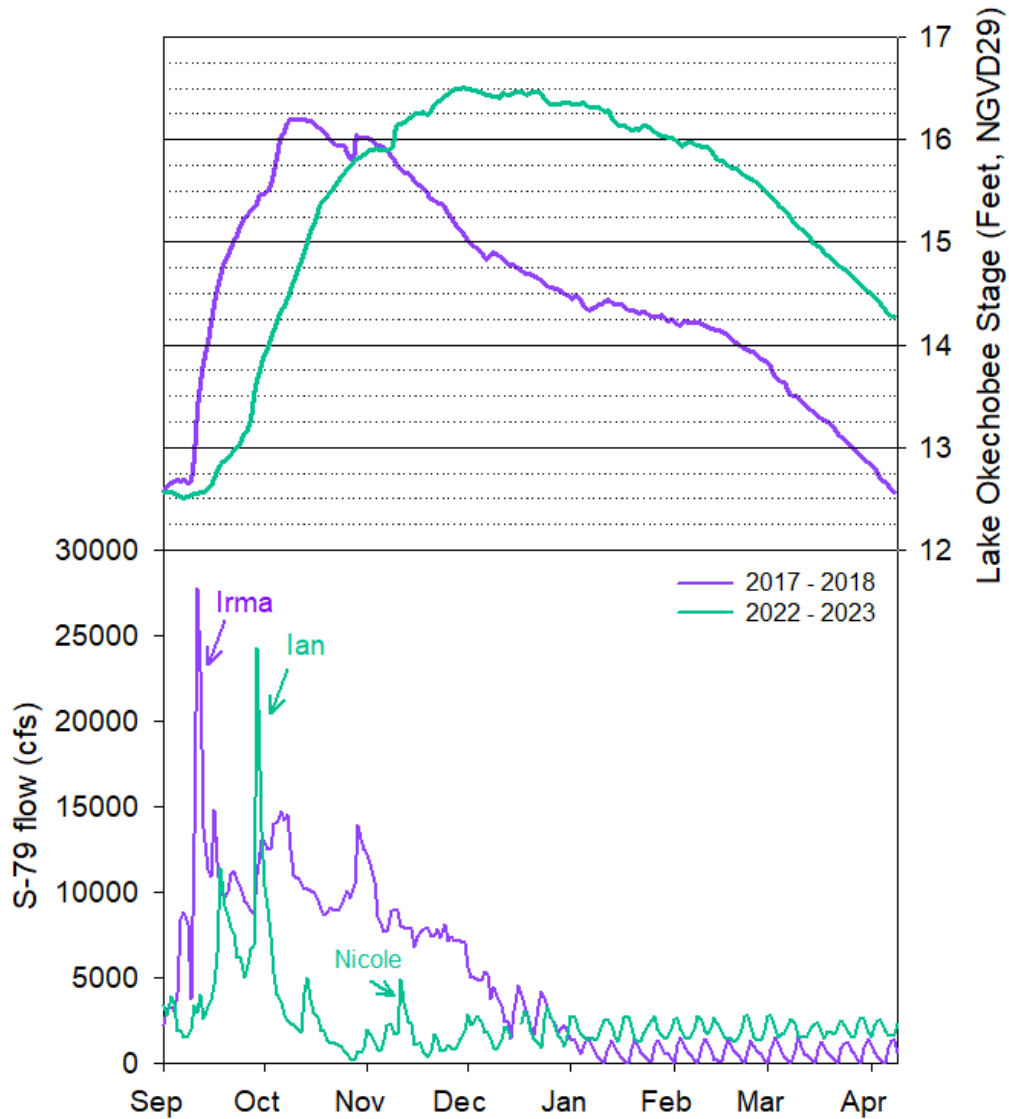
Irma versus Ian

- Lake levels rose quickly after each storm
- After Irma damaging releases were made for 4 months
- After Ian damaging releases were made for 6 weeks
- Receive nearly 3x as much water from S-79 after Irma than after Ian.
- This additional nutrient loading is thought to be a significant contribution to the harmful algal blooms that occurred in 2018.

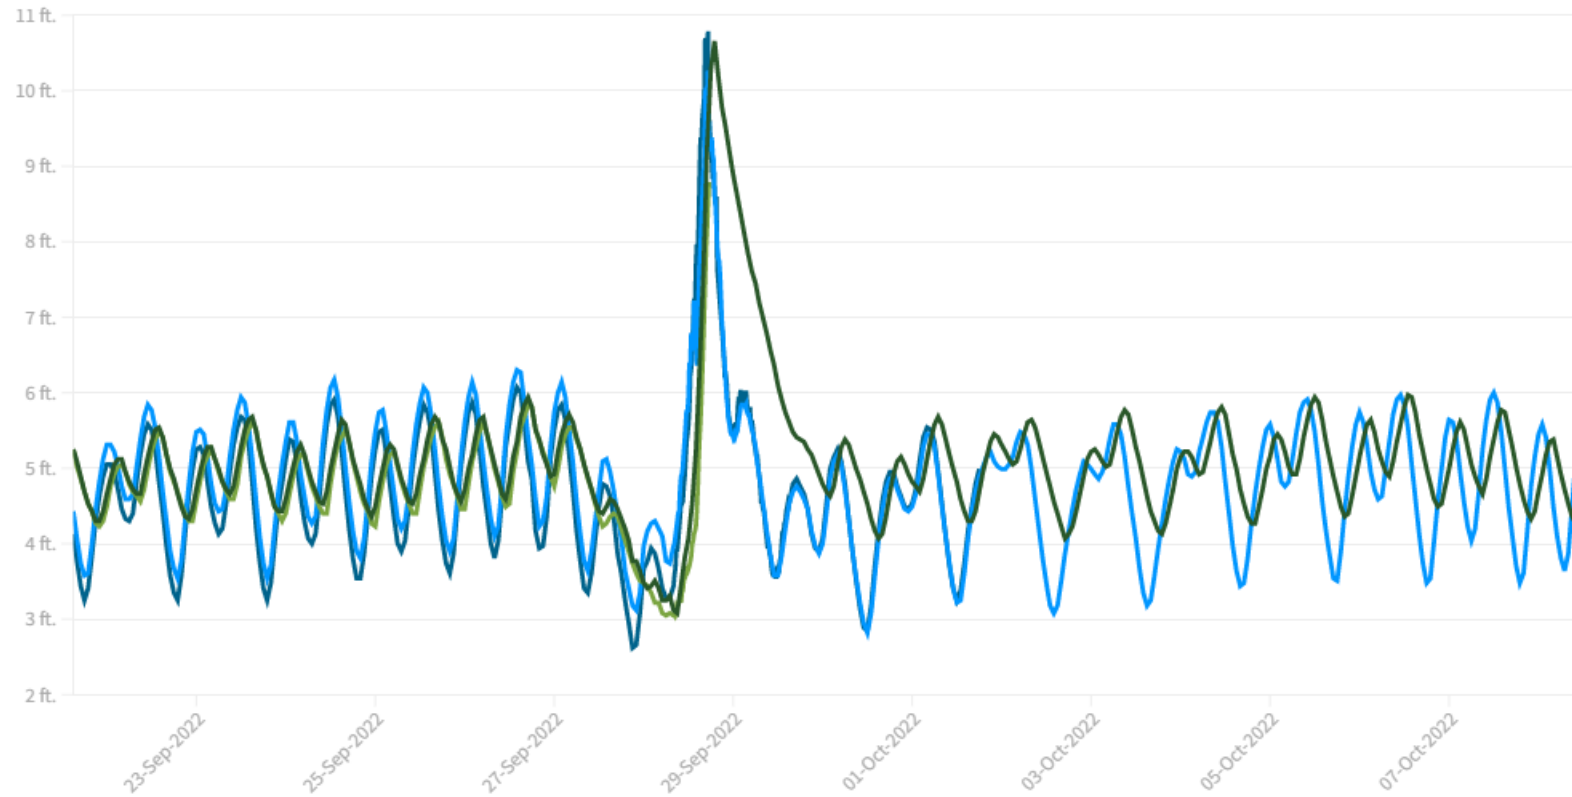
Water Level

SCCF RECON Sensor Depth

■ Tarpon Bay ■ McIntyre Creek ■ Beautiful Island ■ Yacht Basin

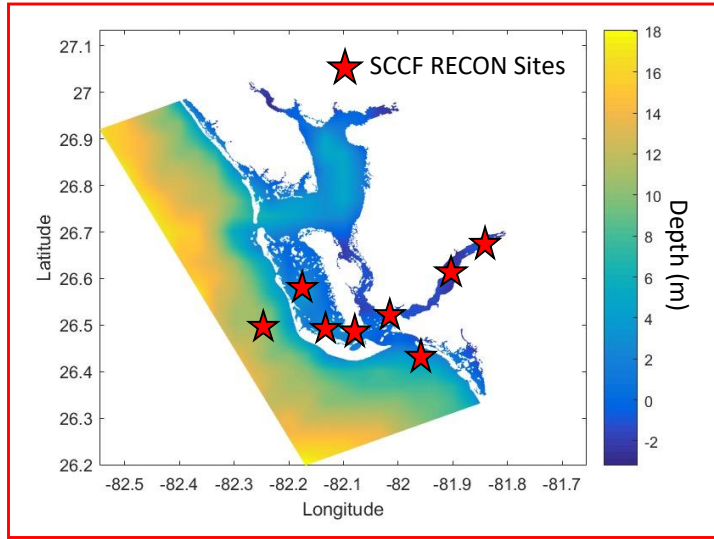
Charlotte Harbor COAWST Model

Collaboration with UF and USF to monitor and model all parts of the system; Lake, watershed and coastal drivers

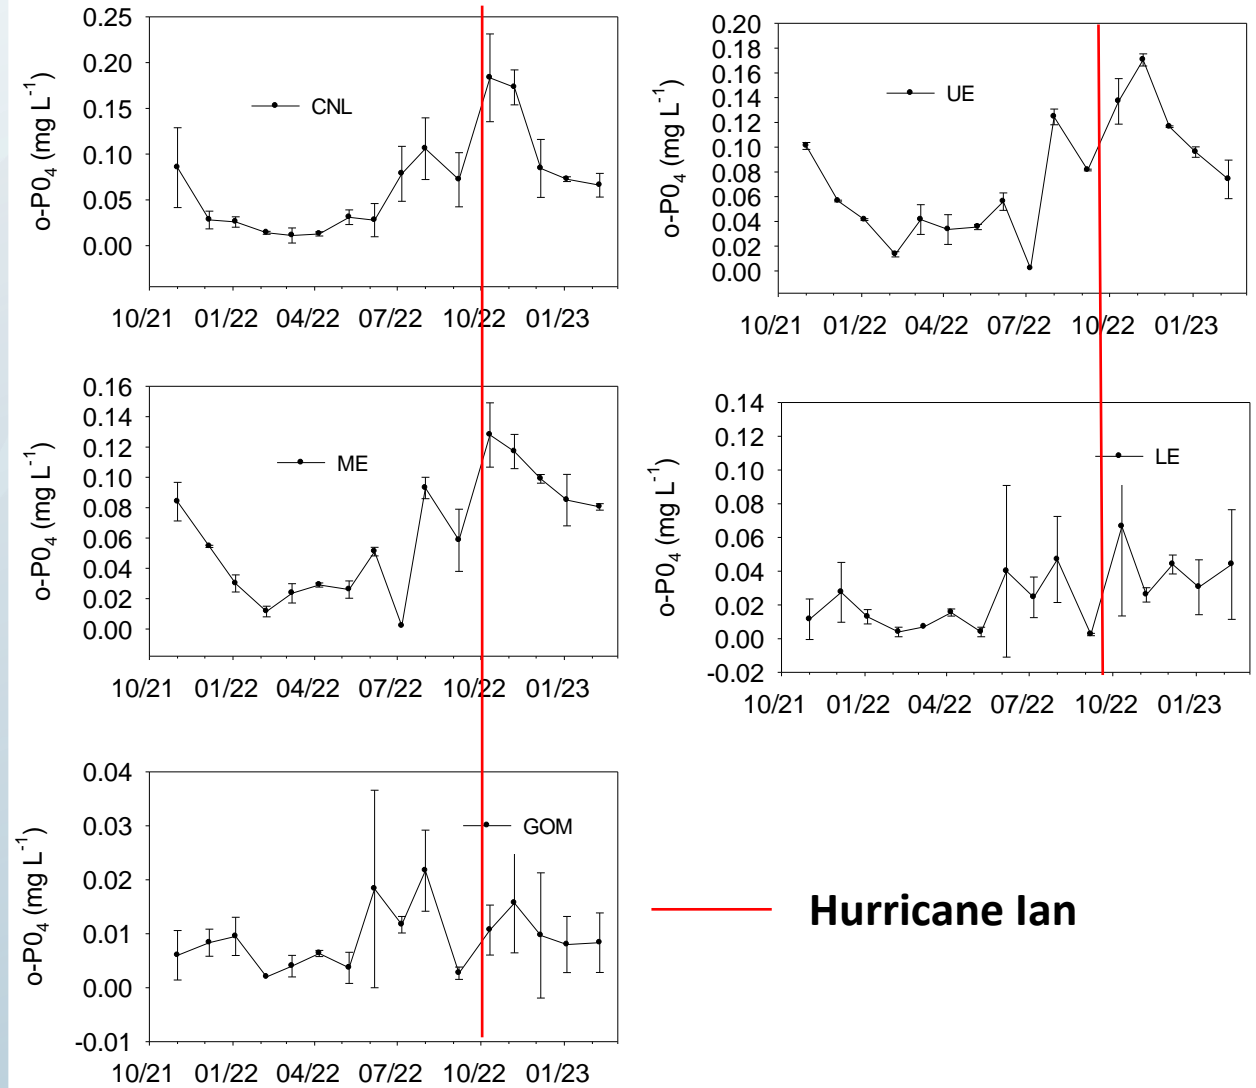
O-PO₄

- Higher in the winter (dry) for CNL, UE and ME, low in the winter (wet)
- Marine segments show a weaker seasonal pattern and opposite of the more FW segments (low in dry; high in wet)
- All sites show increases after Hurricane Ian

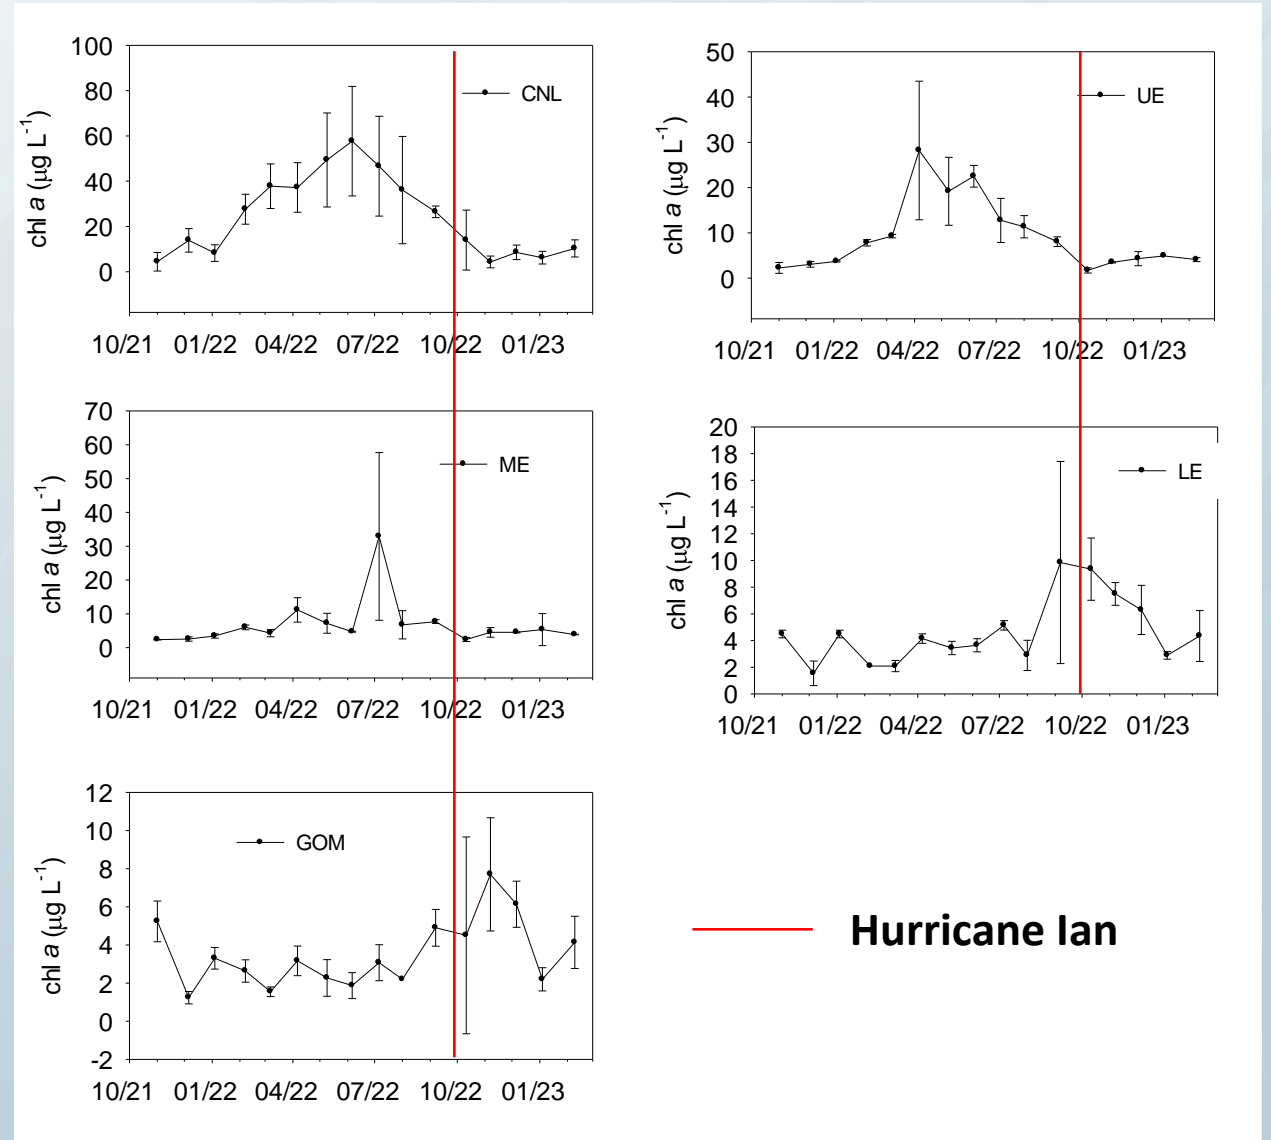
Chlorophyll *a* (corrected)

- Summer bloom in the canal (FW)
- Fall bloom in the LE and GOM (K. brevis driven)
 - Hurricane Ian occurred at the beginning of the fall bloom and preceded the K. brevis bloom)

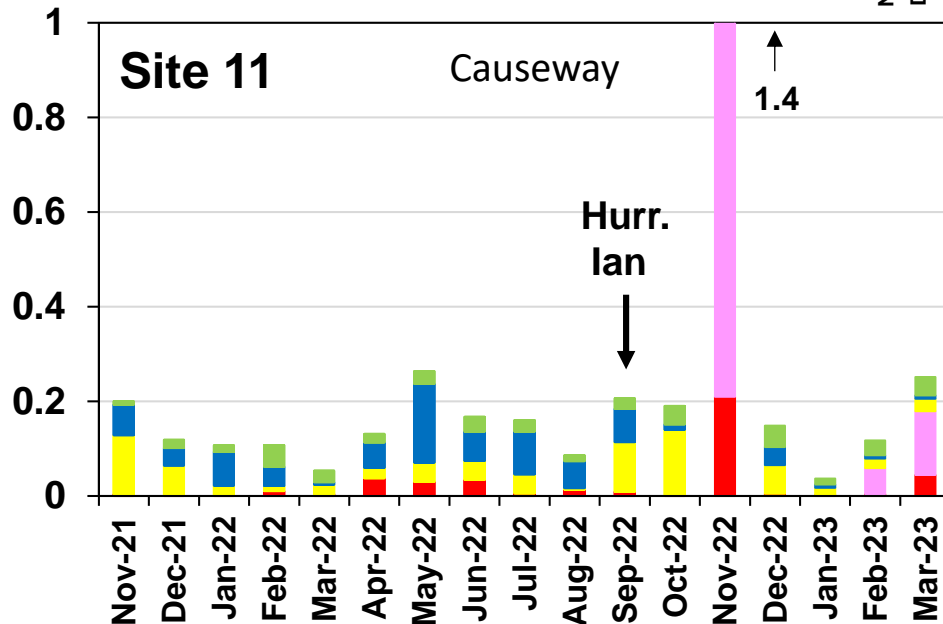
Mean Phytoplankton Biomass
mg Carbon L⁻¹

- The bloom was first detected October 18, 2022 near Venice, FL
- It is typical for red tide to start in the late fall with records dating to 1878
- Hurricane Ian provided excess nutrients for the bloom to expand over a greater area

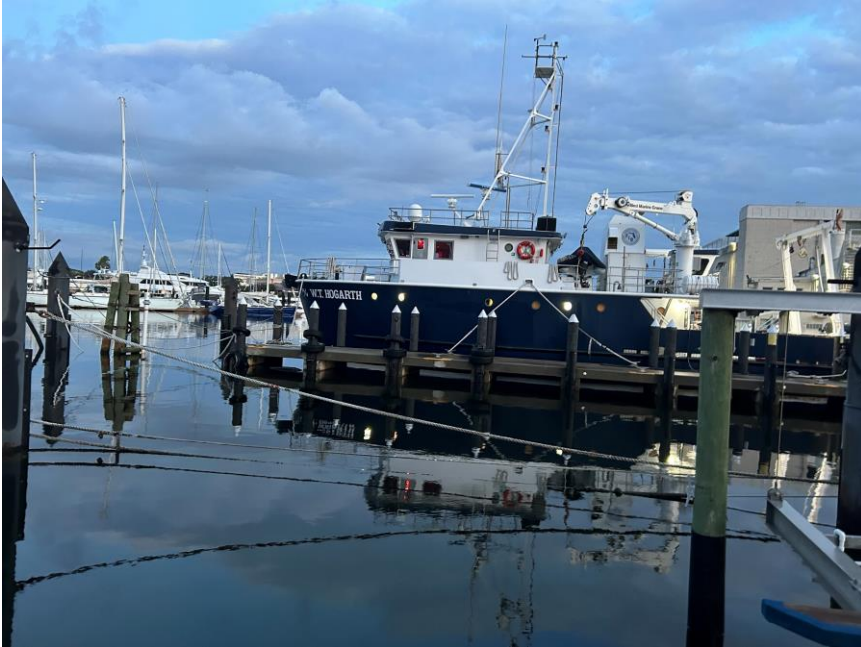
Cruise #1: 10/18-10/23/22
Cruise #2: 01/06-01/11/23
Cruise #3: April 2023

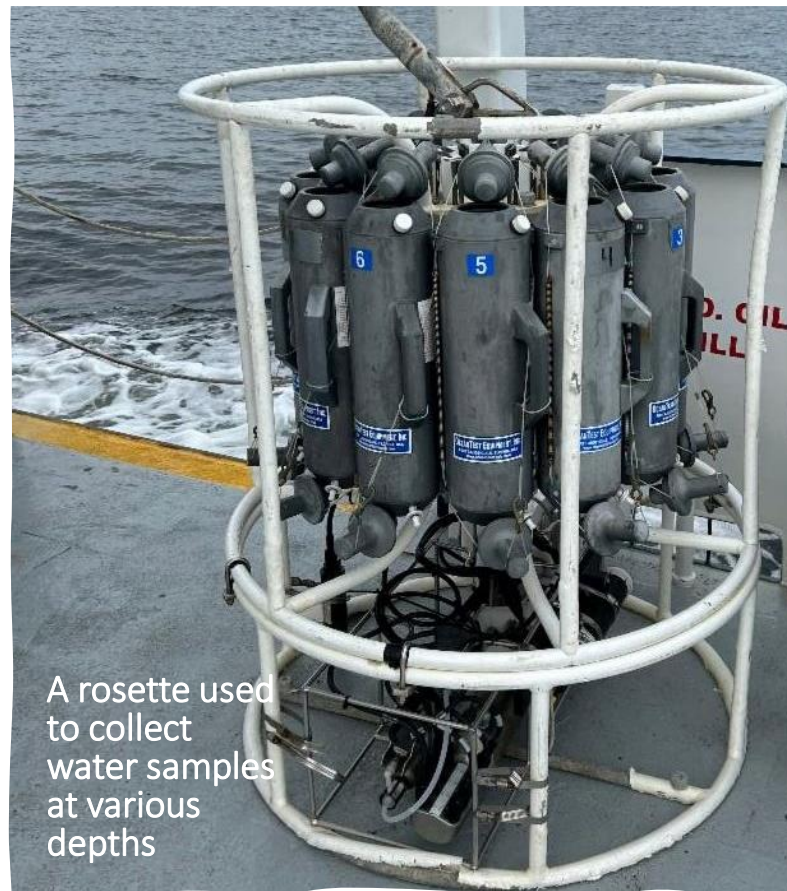
A rosette used to collect water samples at various depths

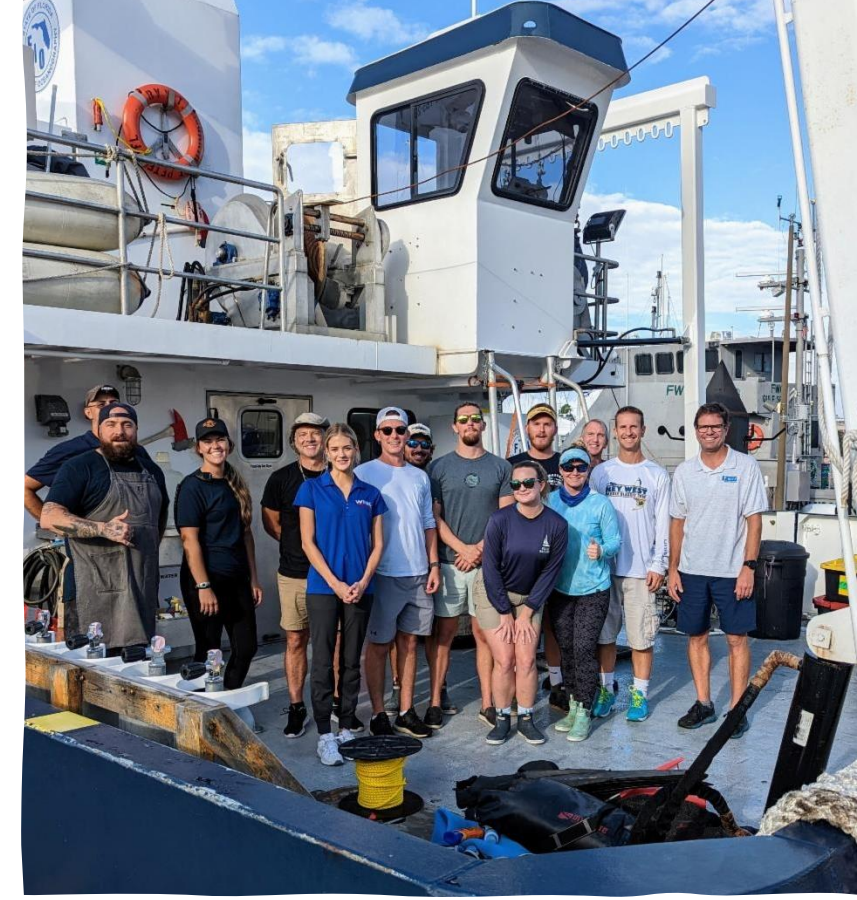
- Collaborative research cruise with Florida Institute of Oceanography
- 78 foot R/V Hogarth
- 7 Days, 50 sites from St. Pete to Marco Island

- There were areas of low dissolved oxygen around the tidal passes where the water column was stratified (Venice Inlet, Gasparilla Pass)
- Along a salinity front there were patches of *Karenia brevis*
- FDOM (fluorescent dissolved organic matter) analysis indicated a transition from terrestrial production to marine production along the front
