Seagrass in Pine Island Sound-Matlacha Pass

Fish, Wildlife, & Habitat Protection

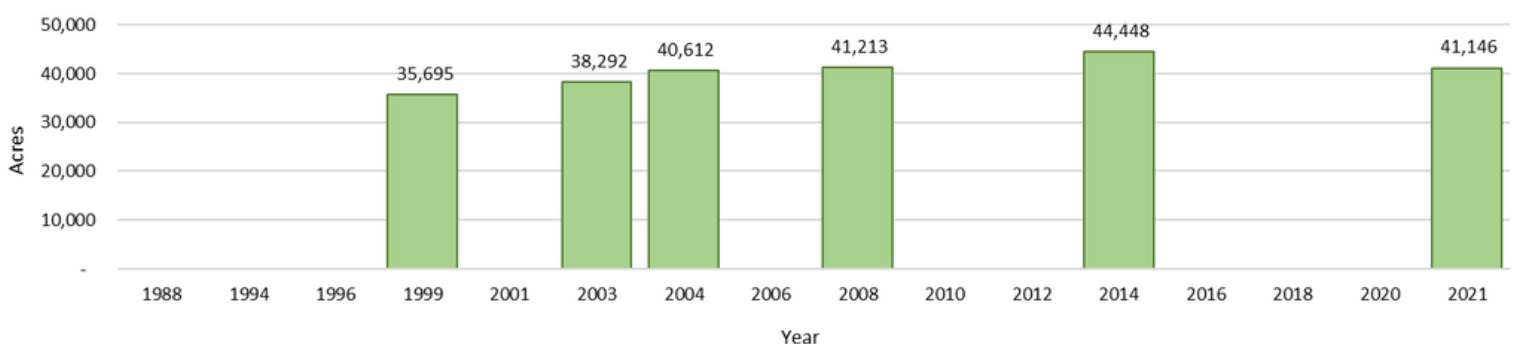
Seagrass Acreage Variation within Pine Island Sound-Matlacha Pass

The graphs below depict results from seagrass mapping in Pine Island Sound, Matlacha Pass, and San Carlos Bay from 1999–2021. Due to tidal flushing in Pine Island Sound, which hosts the majority of the region’s seagrass, acreages in this area have remained relatively stable over time since monitoring began. It is important to note, consistent mapping of acreage and locations with aerial photography is needed at least every 3-4 years in order to evaluate trends in seagrass acreage. Between 2014 and 2021, Pine Island Sound/Matlacha Pass lost 3,302 acres of seagrass, representing a 7% loss overall. The reason for this decline is complex and likely involves several factors. This includes impacts from recent storm events such as Hurricane Irma, increased temperatures and rainfall, additional nutrient runoff from land, as well as prolonged red tide and algae blooms in the region. The CHNEP continues to work with our partners to better understand causes and investigate solutions. Learn more about what the Partnership is doing protect and improve water quality in Pine Island Sound/Matlacha Pass (CHNEP.org).

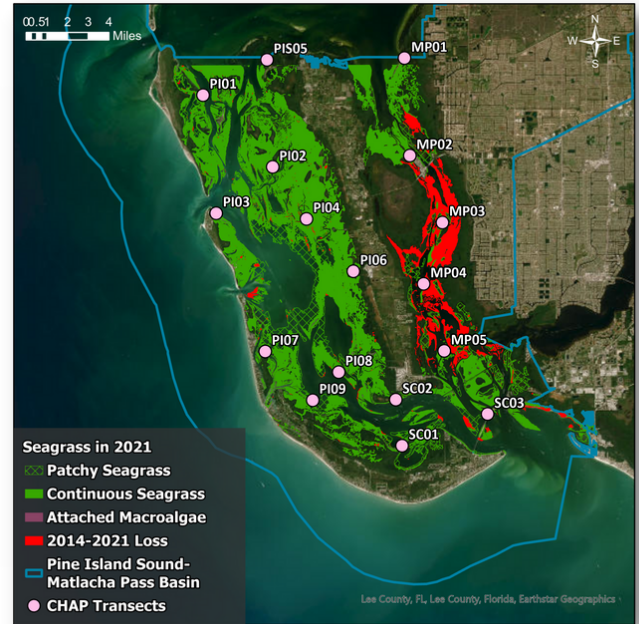
The map to the right shows locations of monitoring sites (highlighted in pink) in selected meadows in Pine Island Sound-Matlacha Pass by the Florida Department of Environmental Protection Aquatic Preserve staff. Annual seagrass monitoring in the Harbor examines species types, density, distribution and how deep the grass will grow (this is dependent on light availability).

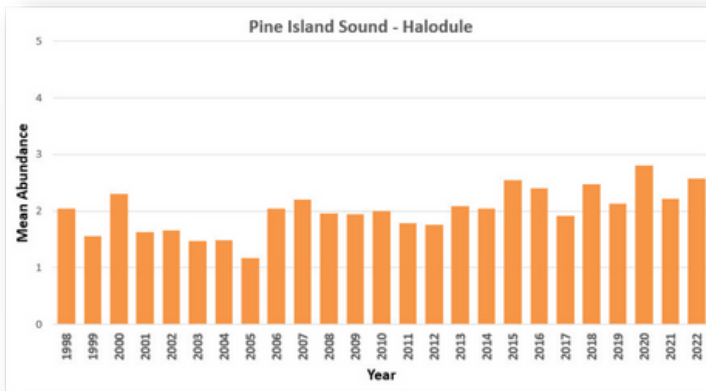
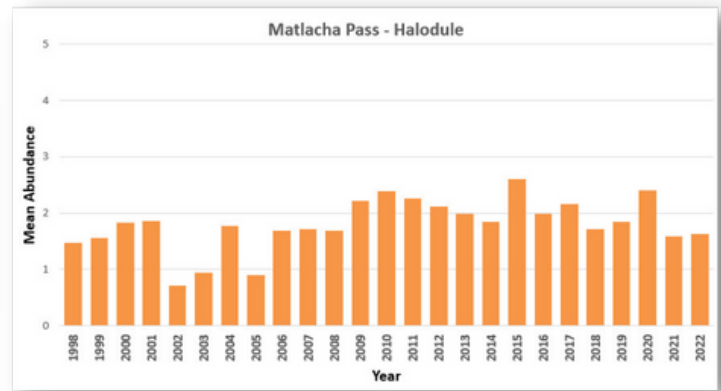
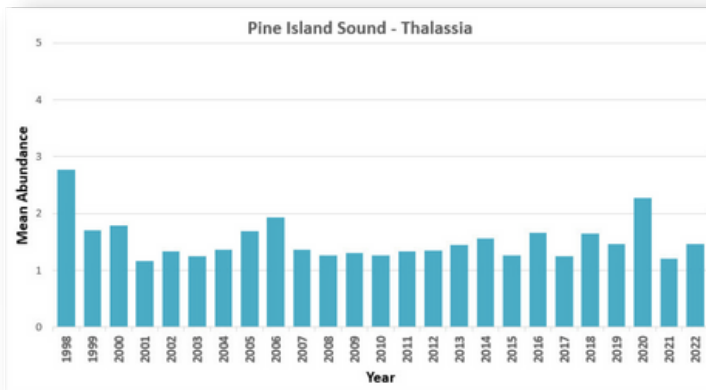
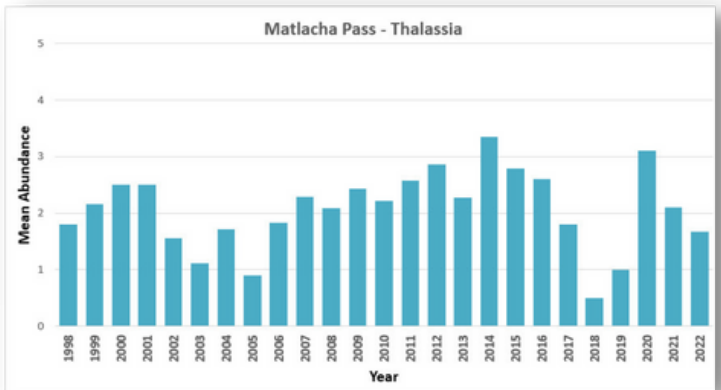
The bar graphs here depict the changes in presence of different species of seagrass found at monitored locations in the region. Since this region is so large, data shared in the graphs below are divided by two seagrass species at different monitoring locations in Pine Island Sound and Matlacha Pass for the years 1998–2021. Other types of seagrass are only found infrequently at these locations; there are not enough data to be graphed here.

Although both types of seagrass species experienced some declines at multiple monitoring locations starting as far back as 2016, numbers are relatively more stable in Pine Island Sound, which is mostly influenced by seawater from the nearby passes. Matlacha Pass (which receives freshwater flows from the Caloosahatchee River) has experienced more notable declines in seagrass in recent years due to a macroalgae issue (*Caulerpa fastigiata*). However, Data collected in 2020 showed modest gains (though not full recovery) throughout Matlacha Pass, however, data collected in 2021 demonstrate significant losses in overall seagrass abundance.
