Seagrass in Charlotte Harbor

FISH, WILDLIFE, & HABITAT PROTECTION

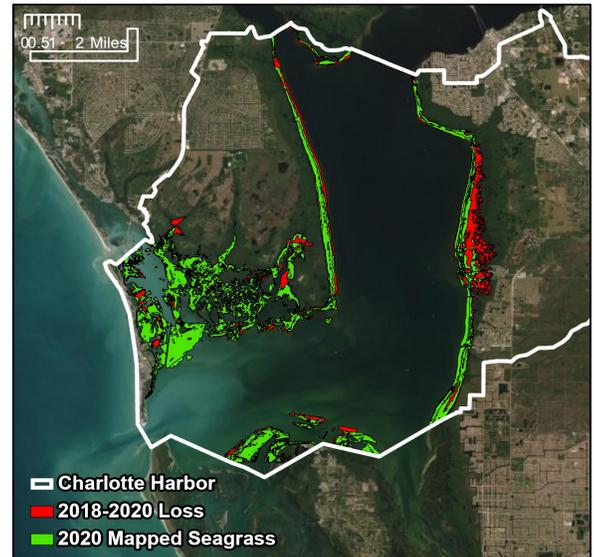
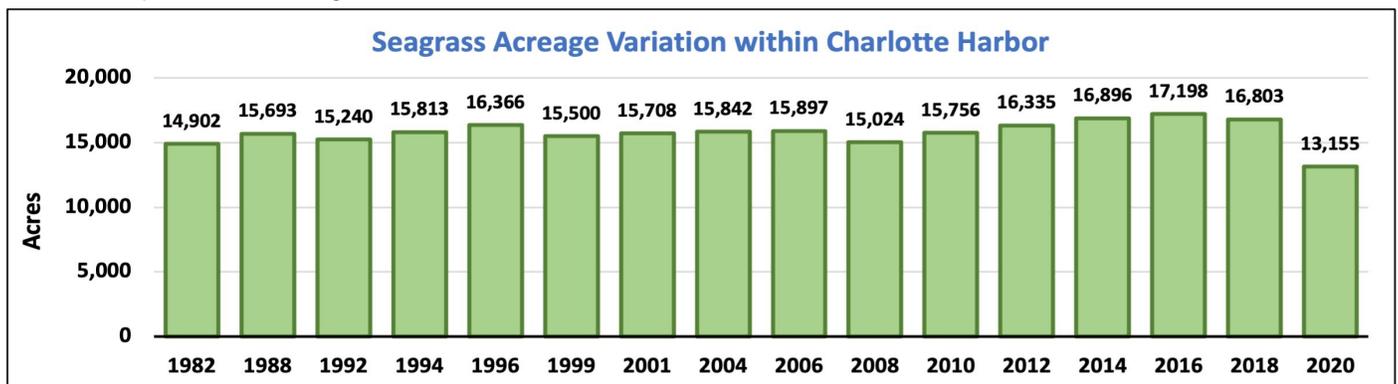
The graph below depicts results from bi-annual seagrass mapping in Charlotte Harbor from 1982-2020. Seagrass in this area has remained relatively stable over time since monitoring began, but acreage declined significantly in the Charlotte Harbor region between 2018 and 2020. In fact, between 2018 and 2020, the region lost 3,648 acres of seagrass, representing a 22% loss overall. The reason for this decline is complex and likely involves several factors; such as recent storm events, increased temperatures and rainfall, additional nutrient runoff from land, as well as prolonged red tide and algae blooms in the region. The CHNEP continues to work with our partners to investigate causes.

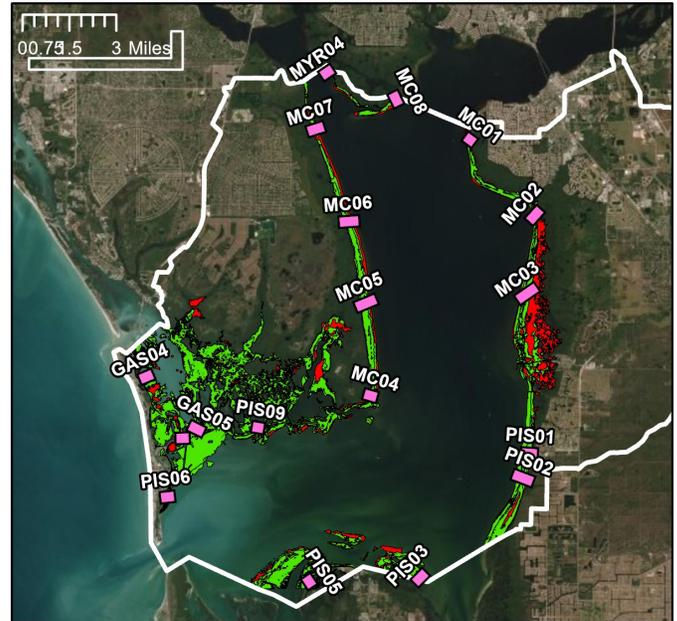
Monitoring is the repeated observation of a system to detect localized changes in a specific seagrass meadow over time in response to environmental conditions and light availability as well as measure overall health. The map to the right shows locations of monitoring sites (highlighted in pink) in selected meadows in Charlotte Harbor by the Florida Department of Environmental Protection Aquatic Preserve staff. Annual seagrass monitoring in the Harbor examines species types, density, distribution and how deep the grass will grow (this is dependent on light availability).

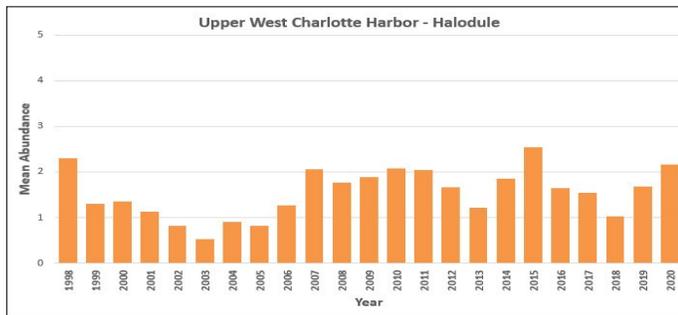
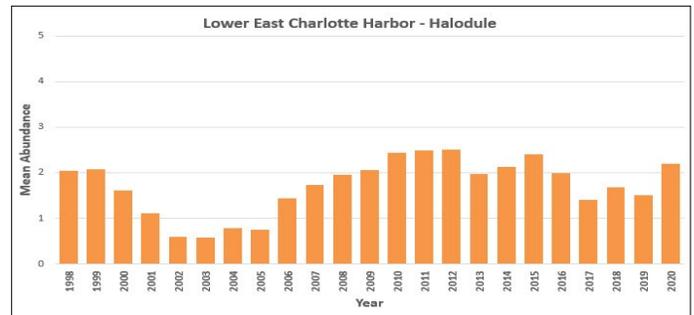
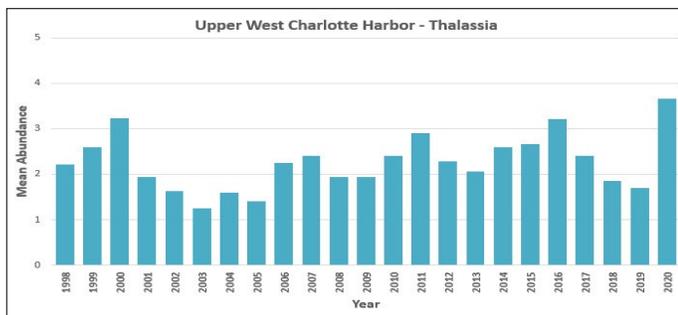
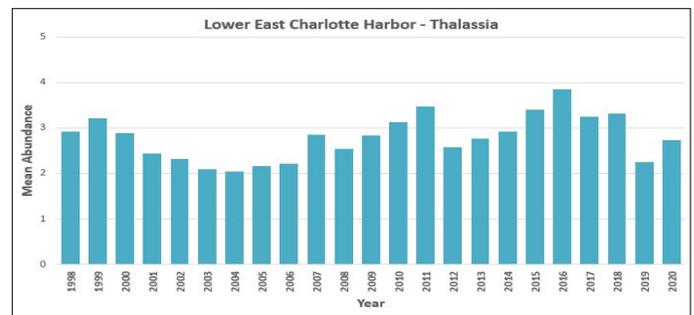
The bar graphs below show the total abundance for two seagrass species at different monitoring locations in Charlotte Harbor for the years 1998-2020: Shoalgrass (*Halodule wrightii*) shown in orange and Turtlegrass (*Thalassia testudinum*) shown in aqua. They demonstrate that both Shoalgrass and Turtlegrass saw declines in abundance at multiple monitoring locations starting as far back as 2016, preceding the decline in overall acreage observed between 2018 and 2020. However, data collected in 2020 demonstrates modest gains (though not full recovery) for both species throughout the Harbor. Note that a diverse seagrass species composition is an important indicator of a healthy seagrass meadow and serves as more complex habitat for fish and shellfish.

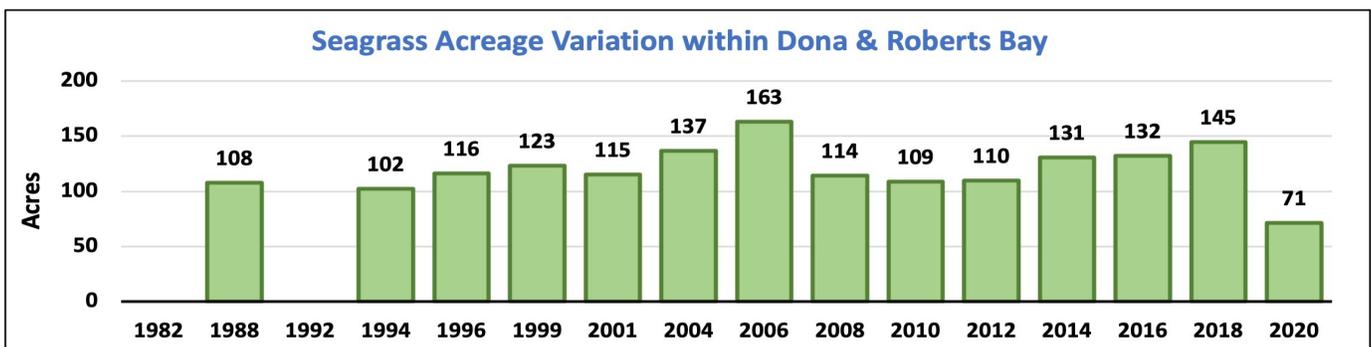
The below graphic depicts results from seagrass mapping in Dona & Roberts Bay from 1988-2020². Seagrass acreage in the Dona & Roberts Bay basin had been steadily increasing since 2010. In 2018, seagrass reached 145 acres, passing the target 112 acres for Dona & Roberts Bay. However, between 2018-2020, 73 acres of seagrass were lost, representing a 51% loss of total acreage. The cause of this decline is complex and involves several likely factors including red tide, increasing nutrient loads, hurricanes, rainfall pattern and others. The CHNEP continues to work with our partners to investigate causes.

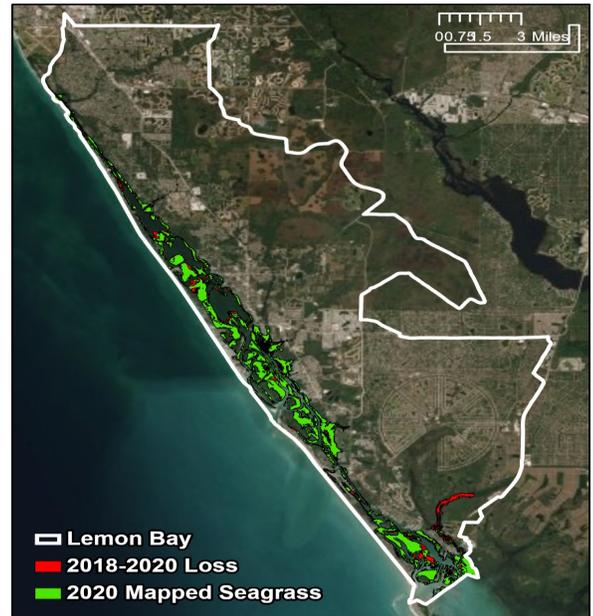
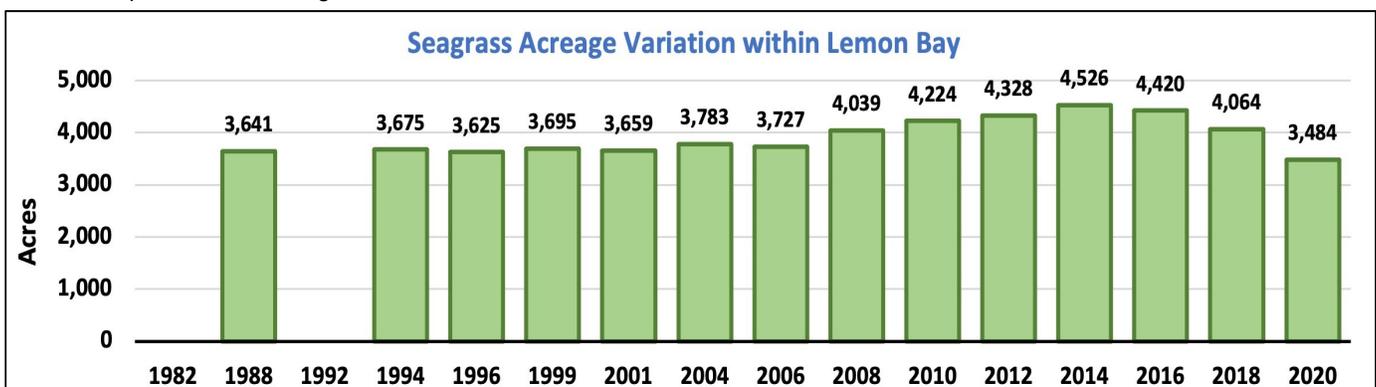
The below graphic depicts results from bi-annual seagrass mapping in Lemon Bay from 1988-2020². Seagrass in this area has increased since the 1990's and remained relatively stable since that time, but acreage began to decline in 2016 and demonstrated more loss between 2018 and 2020. In fact, between 2018 and 2020, Lemon Bay lost 579 acres of seagrass (14% loss overall). The reason for this decline is complex and likely involves several factors; such as recent storm events, increased temperatures and rainfall, additional nutrient runoff from land, as well as prolonged red tide and algae blooms in the region. The CHNEP continues to work with our partners to investigate causes.

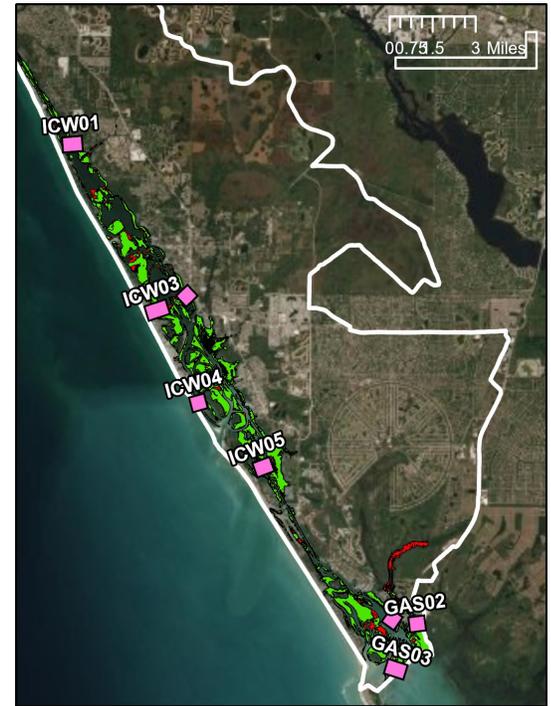
Monitoring is the repeated observation of a system to detect localized changes in a specific seagrass meadow over time in response to environmental conditions and light availability as well as measure overall health. The map to the right shows locations of monitoring sites (highlighted in pink) in selected meadows in Lemon Bay by the Florida Department of Environmental Protection Aquatic Preserve staff. Annual seagrass monitoring in the Harbor examines species types, density, distribution and how deep the grass will grow (this is dependent on light availability).

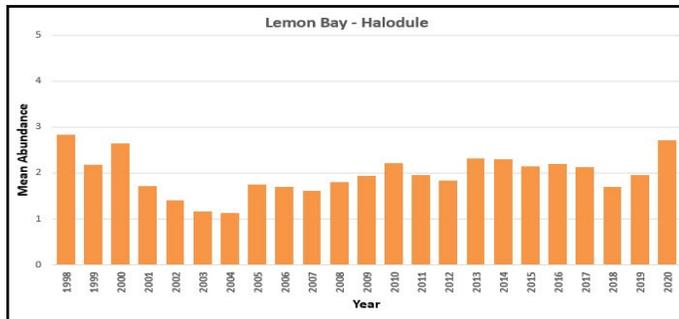
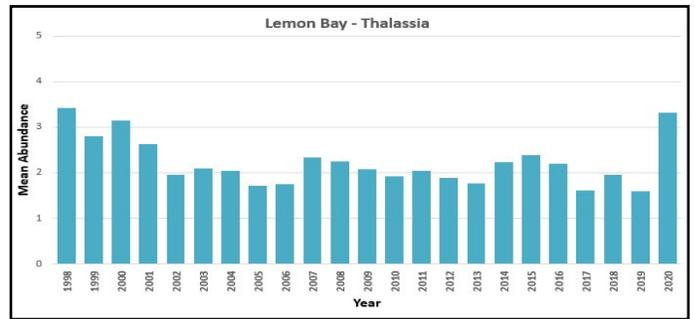
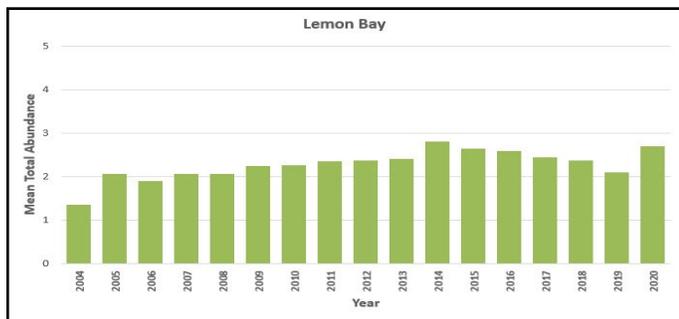
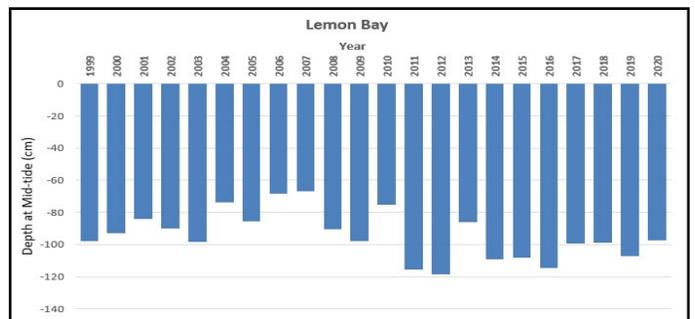
The bar graphs below show the total abundance for two seagrass species Shoalgrass (*Halodule wrightii*) and Turtlegrass (*Thalassia testudinum*), total amount of grass, and depth at which the grass was growing at selected monitoring locations in Lemon Bay area for the years 1998-2020³. They demonstrate that Shoalgrass (*Halodule wrightii*) and Turtlegrass (*Thalassia testudinum*) saw declines in abundance at multiple monitoring locations starting as far back as 2017, preceding the decline in overall acreage observed between 2018 and 2020³. However, data collected in 2020 demonstrates modest gains (though not full recovery) for both species throughout the area. Note that a diverse seagrass species composition is an important indicator of a healthy seagrass meadow and serves as more complex habitat for fish and shellfish.

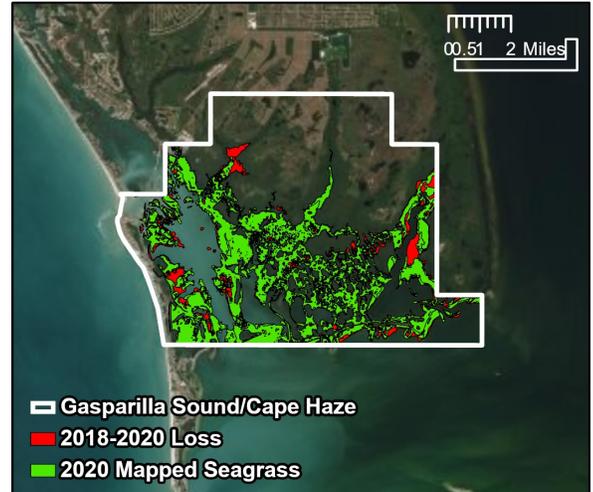
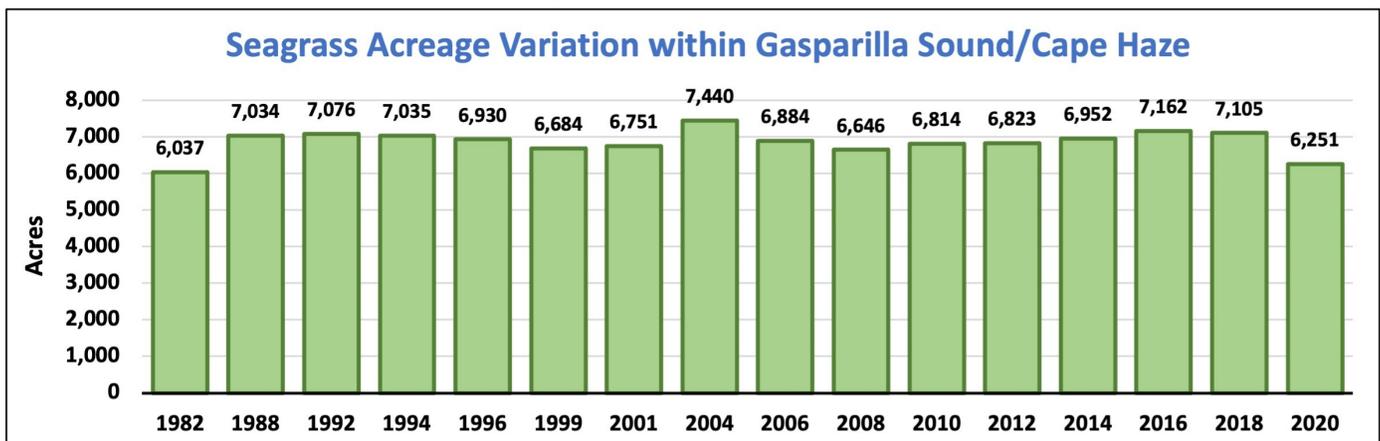
The below graphic depicts results from bi-annual seagrass mapping in Gasparilla Sound/Cape Haze from 1982-2020². Seagrass in this area has remained relatively stable over time since monitoring began, but acreage declined significantly in the region between 2018 and 2020. In fact, between 2018 and 2020, Gasparilla Sound/Cape Haze lost 854 acres of seagrass, representing a 12% loss overall. The reason for this decline is complex and likely involves several factors; such as recent storm events, increased temperatures and rainfall, additional nutrient runoff from land, as well as prolonged red tide and algae blooms in the region. The CHNEP continues to work with our partners to investigate causes.

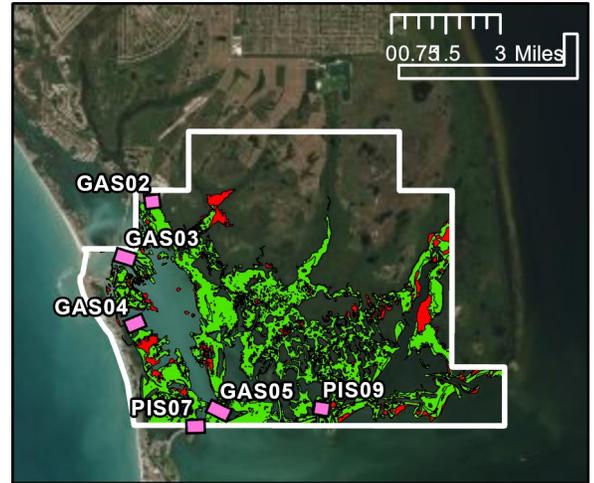
Monitoring is the repeated observation of a system to detect localized changes in a specific seagrass meadow over time in response to environmental conditions and light availability as well as measure overall health. The map to the right shows locations of monitoring sites (highlighted in pink) in selected meadows in Gasparilla Sound/Cape Haze by the Florida Department of Environmental Protection Aquatic Preserve staff. Annual seagrass monitoring in the Harbor examines species types, density, distribution and how deep the grass will grow (this is dependent on light availability).

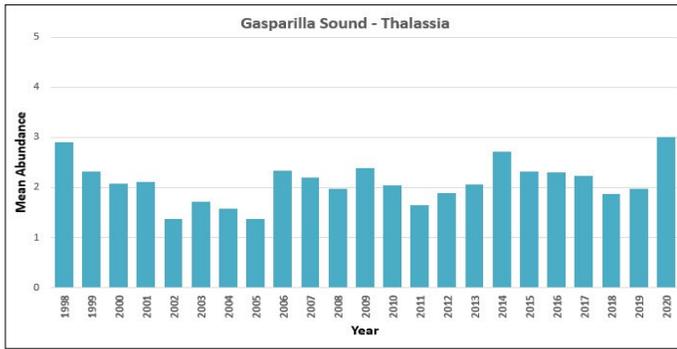
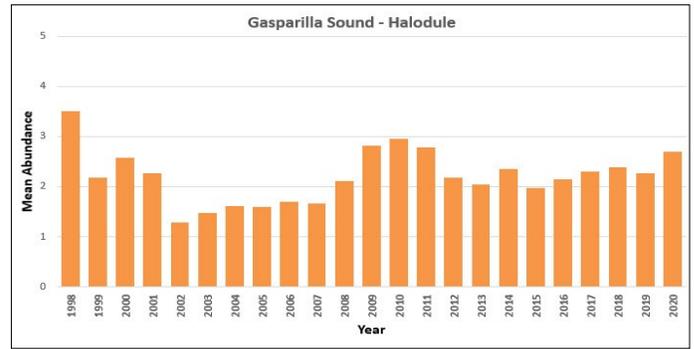
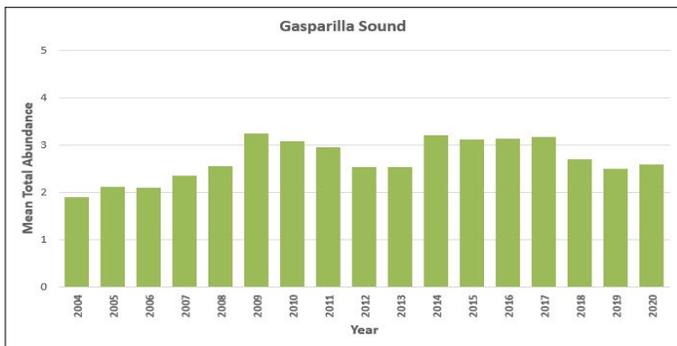
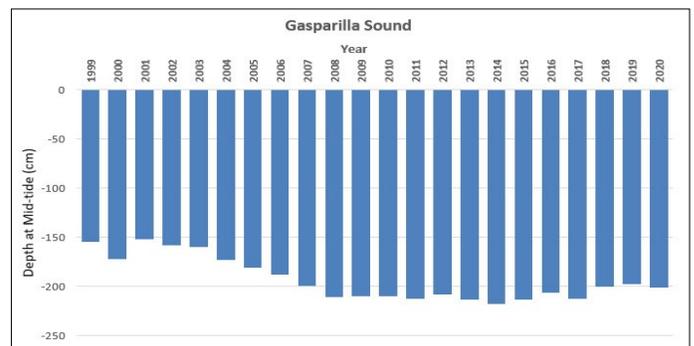
The bar graphs below show the total abundance for two seagrass species, Shoalgrass (*Halodule wrightii*) and Turtlegrass (*Thalassia testudinum*), total amount of grass, and depth at which the grass was growing at selected monitoring locations in Gasparilla Sound basin area for the years 1998-2020³. They demonstrate that Shoalgrass (*Halodule wrightii*) and Turtlegrass (*Thalassia testudinum*) saw declines in abundance at multiple monitoring locations starting as far back as 2017, preceding the decline in overall acreage observed between 2018 and 2020. However, data collected in 2020 demonstrates modest gains (though not full recovery) for both species throughout the area. Note that a stable meadow with diverse seagrass species composition is an important indicator of a healthy seagrass meadow and serves as more complex habitat for fish and shellfish.

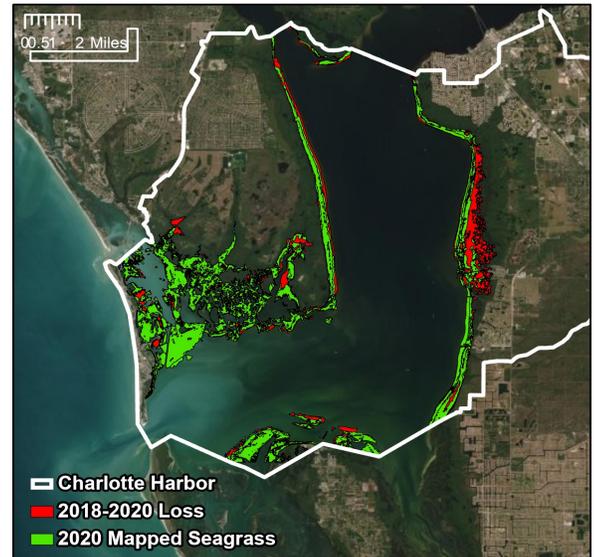
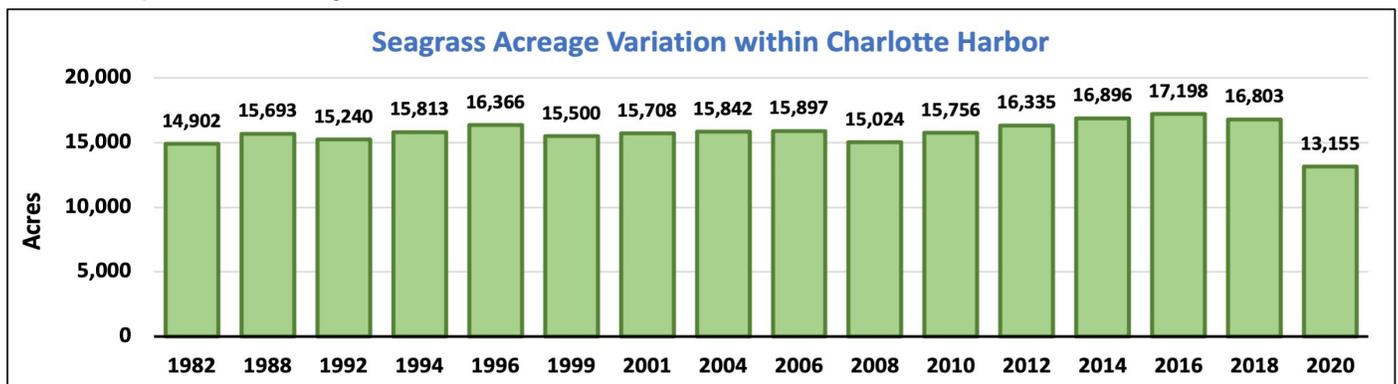
The graph below depicts results from bi-annual seagrass mapping in Charlotte Harbor from 1982-2020. Seagrass in this area has remained relatively stable over time since monitoring began, but acreage declined significantly in the Charlotte Harbor region between 2018 and 2020. In fact, between 2018 and 2020, the region lost 3,648 acres of seagrass, representing a 22% loss overall. The reason for this decline is complex and likely involves several factors; such as recent storm events, increased temperatures and rainfall, additional nutrient runoff from land, as well as prolonged red tide and algae blooms in the region. The CHNEP continues to work with our partners to investigate causes.

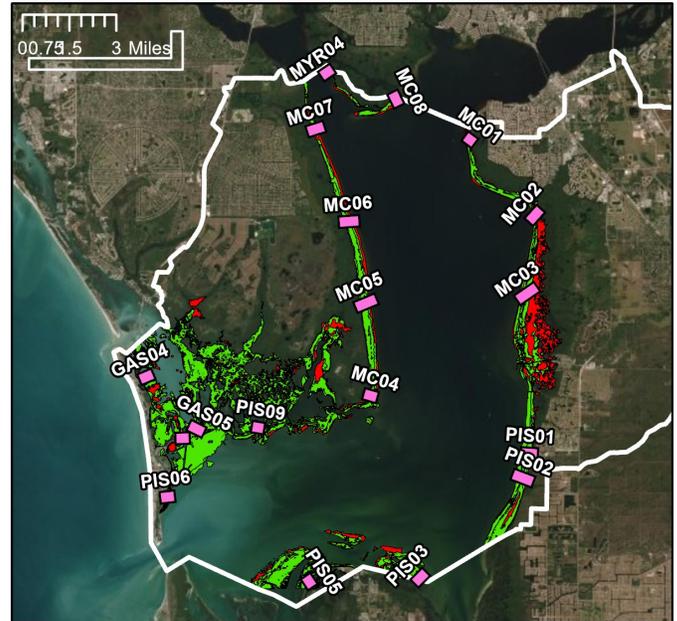
Monitoring is the repeated observation of a system to detect localized changes in a specific seagrass meadow over time in response to environmental conditions and light availability as well as measure overall health. The map to the right shows locations of monitoring sites (highlighted in pink) in selected meadows in Charlotte Harbor by the Florida Department of Environmental Protection Aquatic Preserve staff. Annual seagrass monitoring in the Harbor examines species types, density, distribution and how deep the grass will grow (this is dependent on light availability).

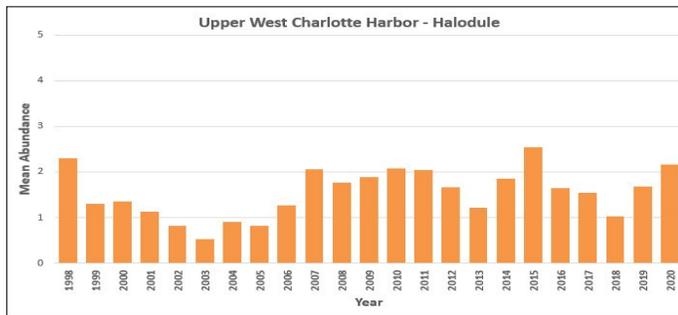
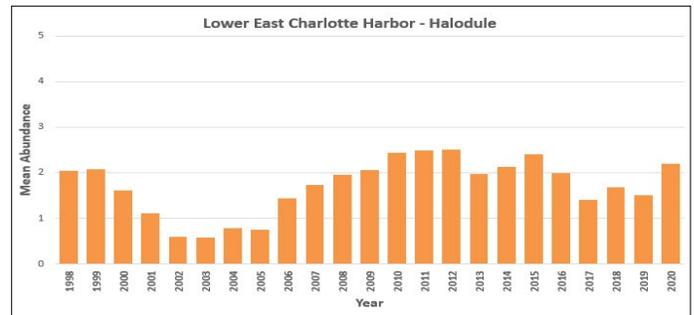
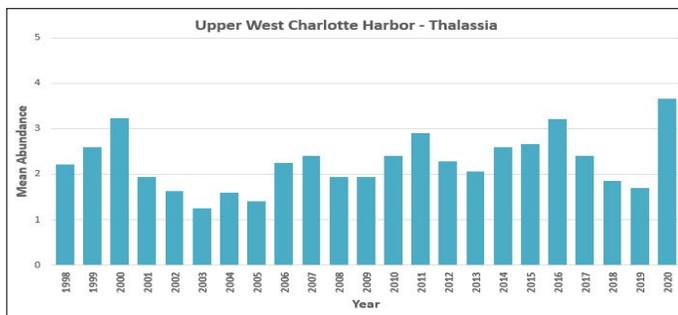
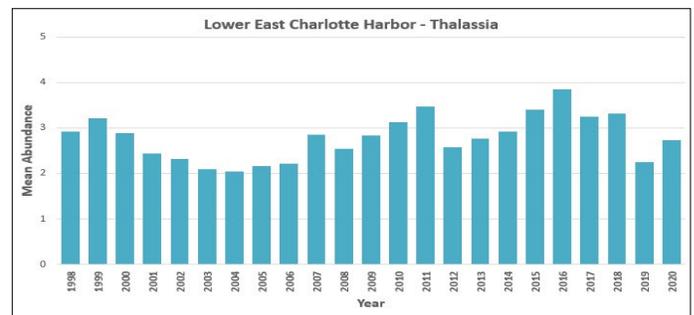
The bar graphs below show the total abundance for two seagrass species at different monitoring locations in Charlotte Harbor for the years 1998-2020: Shoalgrass (*Halodule wrightii*) shown in orange and Turtlegrass (*Thalassia testudinum*) shown in aqua. They demonstrate that both Shoalgrass and Turtlegrass saw declines in abundance at multiple monitoring locations starting as far back as 2016, preceding the decline in overall acreage observed between 2018 and 2020. However, data collected in 2020 demonstrates modest gains (though not full recovery) for both species throughout the Harbor. Note that a diverse seagrass species composition is an important indicator of a healthy seagrass meadow and serves as more complex habitat for fish and shellfish.

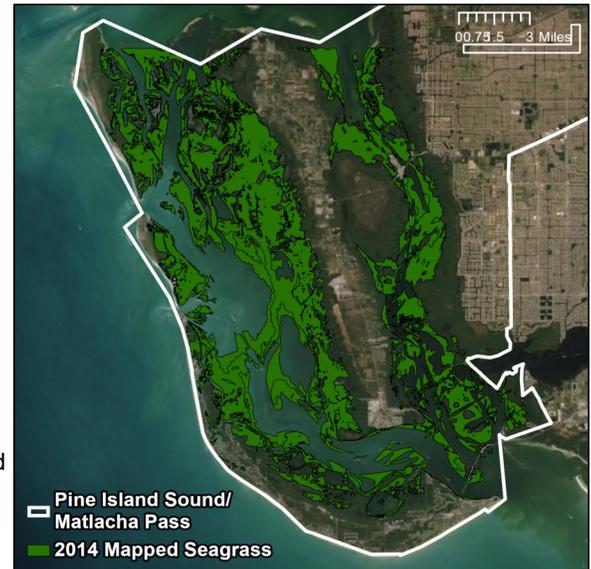
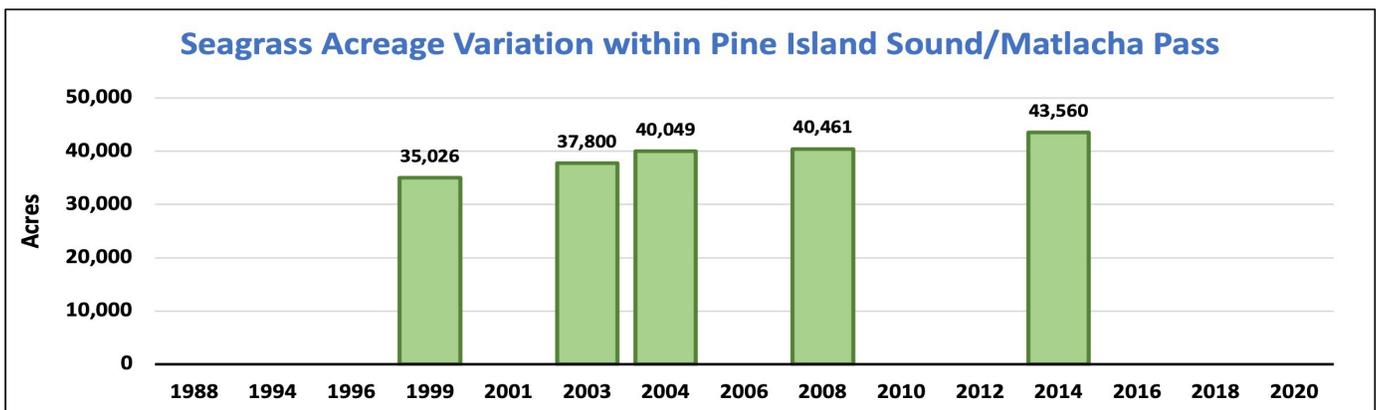
The below graphic depicts results from seagrass mapping in Pine Island Sound/Matlacha Pass from 1999-2014². Due to tidal flushing in Pine Island Sound, which hosts the majority of the regions seagrass, acreages in this area have remained relatively stable over time since monitoring began. However, consistent mapping of seagrass with aerial photography is needed at least every 3-4 years in order to evaluate trends in acreage. Updated data for the region was collected by the South Florida Water Management District (SFWMDC) in the winter of 2020-2021 and will become available in early 2022.

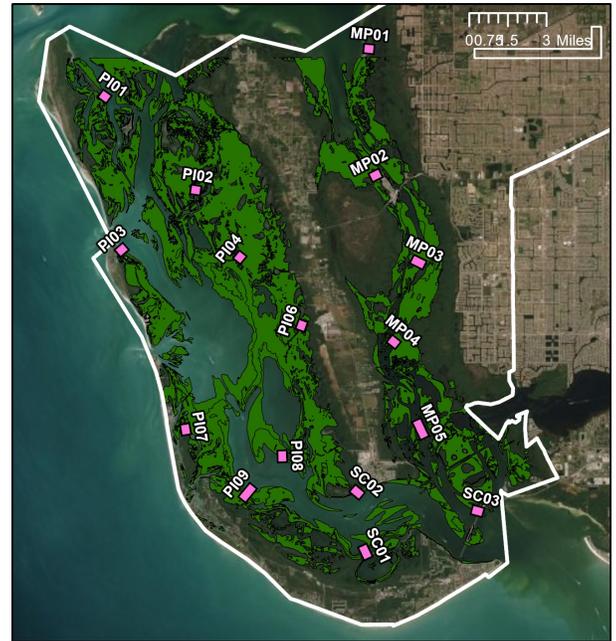
Monitoring is the repeated observation of a system to detect localized changes in a specific seagrass meadow over time in response to environmental conditions and light availability as well as measure overall health. The map to the right shows locations of monitoring sites (highlighted in pink) in selected meadows in the area by the Florida Department of Environmental Protection Aquatic Preserve staff. Annual seagrass monitoring examines species types, density, distribution and how deep the grass will grow (this is dependent on light availability).

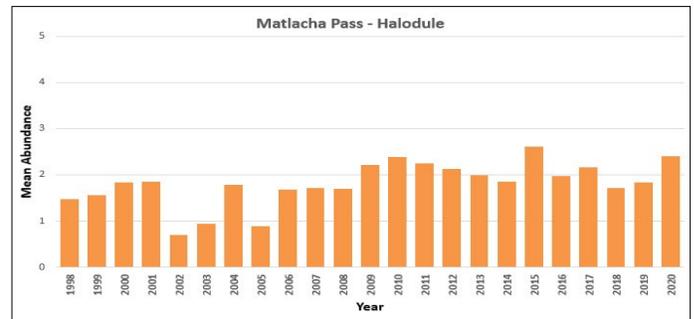
The bar graphs below show the total abundance for two seagrass species at different monitoring locations in Pine Island Sound area (PI01-09) and Matlacha Pass (MP01-04) for the years 1998-2020³. They demonstrate that while Shoalgrass (*Halodule wrightii*) and Turtlegrass (*Thalassia testudinum*) remain relatively stable in the Pine Island Sound area, which is mostly influenced by seawater from the nearby passes, Matlacha Pass (which receives freshwater flows from the Caloosahatchee River) has experienced recent declines in both Shoalgrass (*Halodule wrightii*) and Turtlegrass (*Thalassia testudinum*). However, data collected in 2020 demonstrates modest gains (though not full recovery) for both species throughout the area. Note that a diverse seagrass species composition is an important indicator of a healthy seagrass meadow and serves as more complex habitat for fish and shellfish.

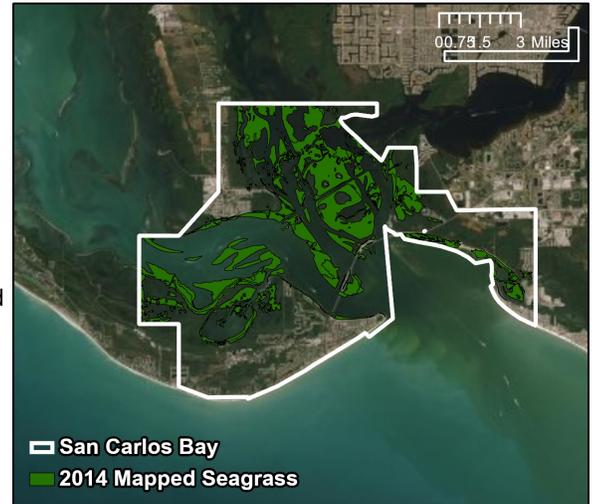
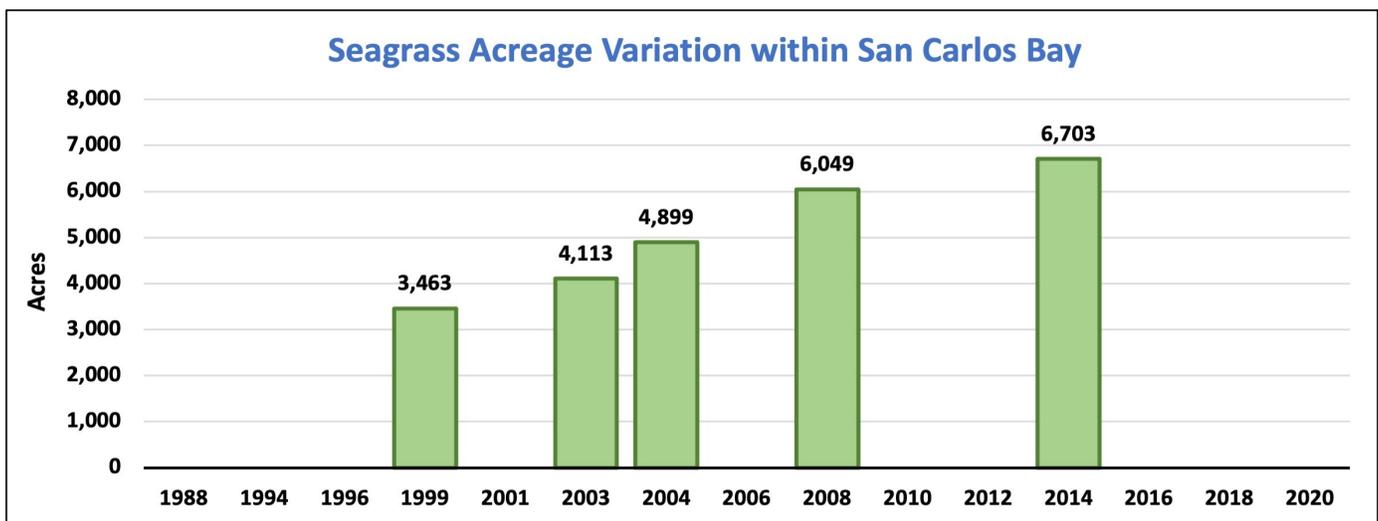
The below graphic depicts results from seagrass mapping in San Carlos Bay from 1999-2014². Seagrass in this area appears to have increased over time since monitoring began. However, consistent mapping of seagrass with aerial photography is needed at least every 3-4 years in order to evaluate trends in acreage. Updated data for the region was collected by the South Florida Water Management District (SFWMD) in the winter of 2020-2021 and will become available in early 2022.

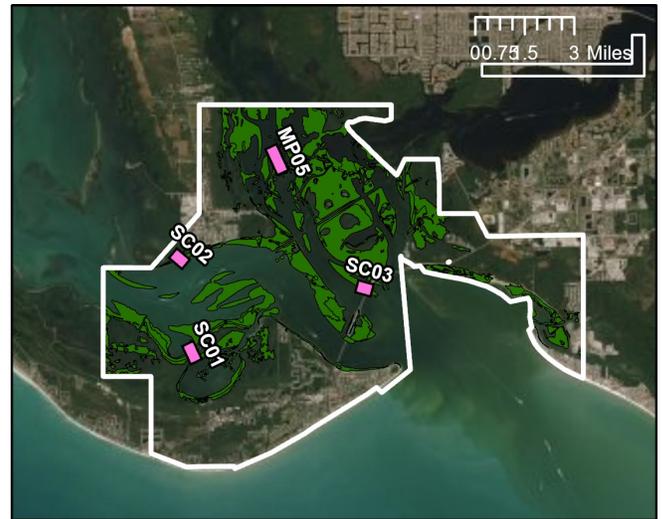
Monitoring is the repeated observation of a system to detect localized changes in a specific seagrass meadow over time in response to environmental conditions and light availability as well as measure overall health. The map to the right shows locations of monitoring sites (highlighted in pink) in selected meadows in San Carlos Bay by the Florida Department of Environmental Protection Aquatic Preserve staff. Annual seagrass monitoring in the Bay examines species types, density, distribution, and how deep the grass will grow (this is dependent on light availability).

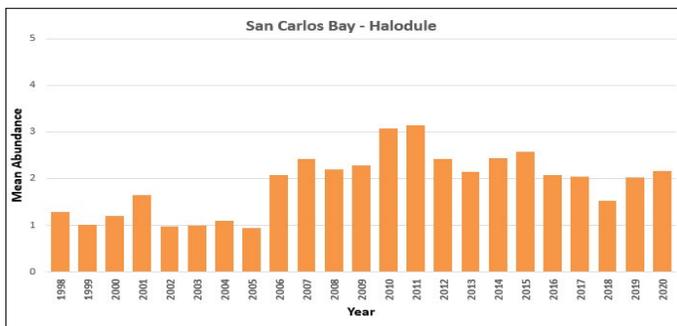
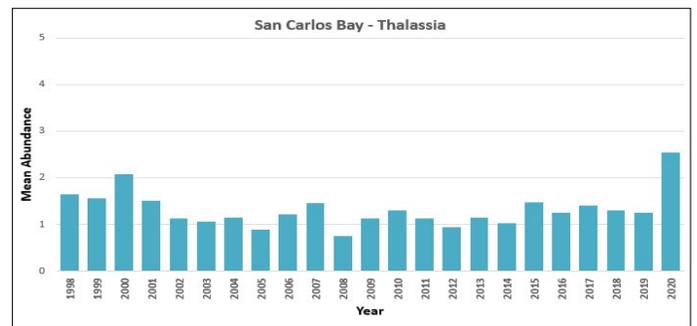
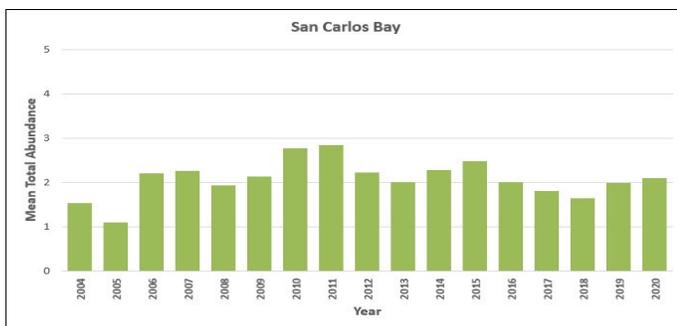
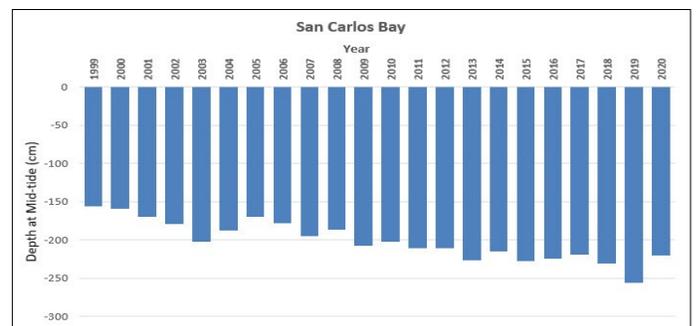
The bar graphs below show the total abundance for two seagrass species at monitoring locations in San Carlos Bay, total amount of grass, and depth at which the grass was growing at these same monitoring sites in the years 1998-2020³. They demonstrate that both Shoalgrass (*Halodule wrightii*) and Turtlegrass (*Thalassia testudinum*) have been declining since 2016. However, data collected in 2020 demonstrates modest gains (though not full recovery) for both species throughout the area. Note that a diverse and stable seagrass species composition is an important indicator of a healthy seagrass meadow and serves as more complex habitat for fish and shellfish.

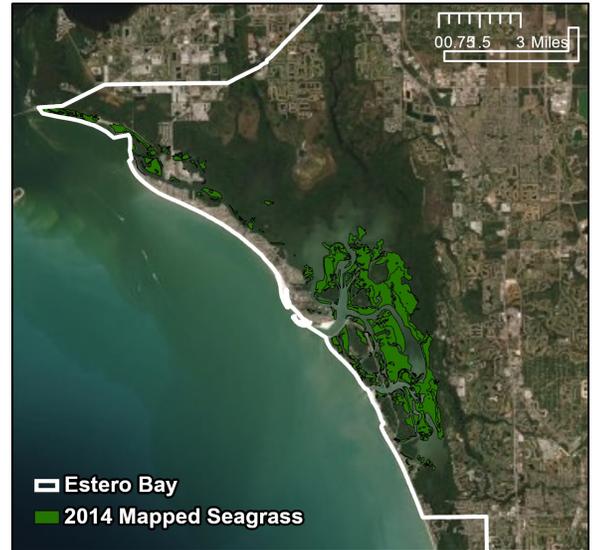
The below graphic depicts results from seagrass mapping in Estero Bay from 1999-2014². From 2004 to 2014, seagrass acreage in the Estero Bay basin appears relatively stable with slight increases. However, consistent mapping of seagrass with aerial photography is needed at least every 3-4 years in order to evaluate trends in acreage. Updated data for the region was collected by the South Florida Water Management District (SFWMD) in the winter of 2020-2021 and will become available in early 2022.

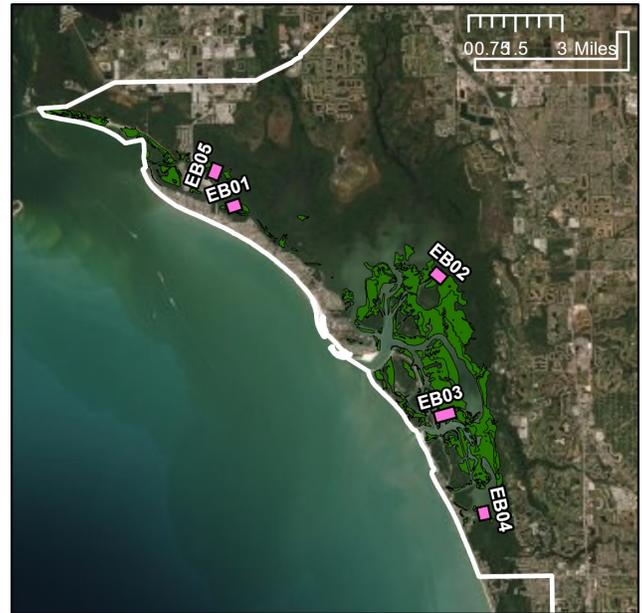
Monitoring is the repeated observation of a system to detect localized changes in a specific seagrass meadow over time in response to environmental conditions and light availability as well as measure overall health. The map to the right shows locations of monitoring sites (highlighted in pink) in selected meadows in Estero Bay by the Florida Department of Environmental Protection Aquatic Preserve staff. Annual seagrass monitoring in the Bay examines species types, density, distribution and how deep the grass will grow (this is dependent on light availability).

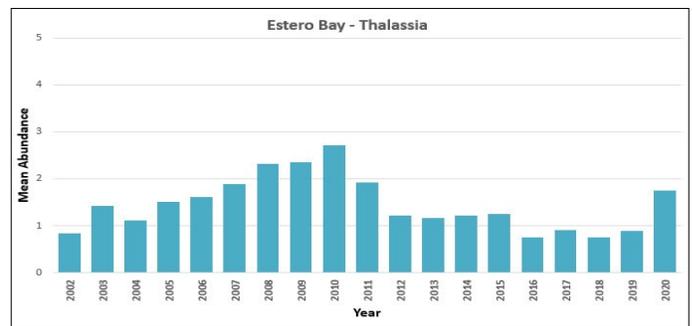
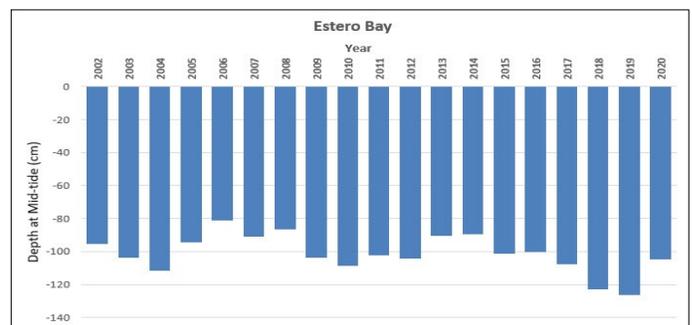
The bar graphs below show the total abundance for two seagrass species, Shoalgrass (*Halodule wrightii*) and Turtlegrass (*Thalassia testudinum*), total amount of grass, and depth at which the grass was growing at the monitoring sites in Estero Bay for the years 2002-2020³. They demonstrate that while Shoalgrass (*Halodule wrightii*) remains relatively stable throughout the system, seagrass and Turtlegrass (*Thalassia testudinum*) saw declines in abundance at multiple monitoring locations starting as far back as 2011. However, data collected in 2020 shows modest gains (though not full recovery) for Turtlegrass throughout the area. Note that a diverse seagrass species composition is an important indicator of a healthy seagrass meadow and serves as more complex habitat for fish and shellfish.

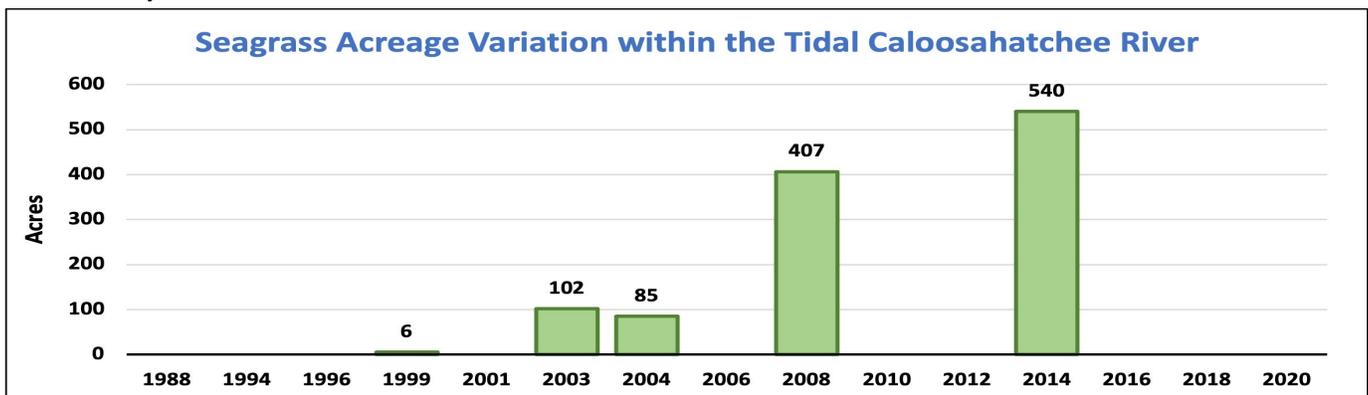
The below graphic depicts results from seagrass mapping in the tidal portion of the Caloosahatchee River from 1999-2014². From 2006 to 2014 seagrass acreage in the tidal Caloosahatchee River appears to have increased. However, consistent mapping of seagrass with aerial photography is needed at least every 3-4 years in order to evaluate trends in acreage. Updated data for the region was collected by the South Florida Water Management District (SFWMD) in the winter of 2020-2021 and will become available in early 2022.

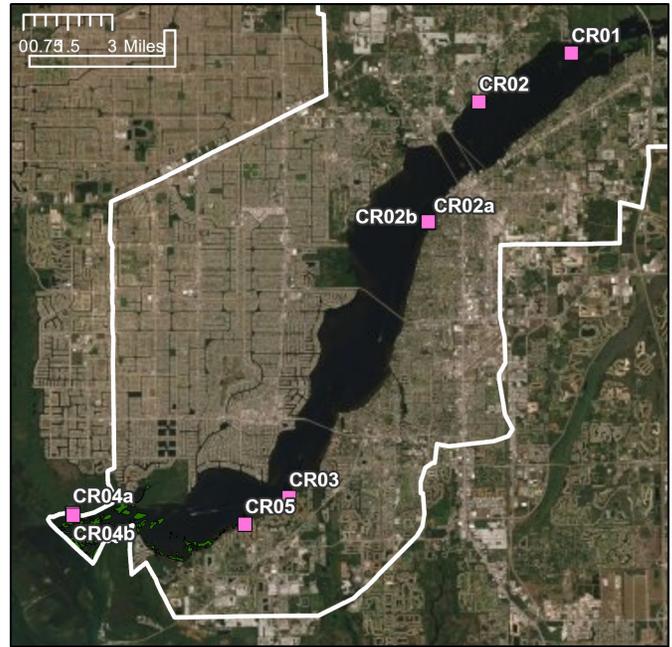
Monitoring is the repeated observation of a system to detect localized changes in a specific seagrass meadow over time in response to environmental conditions and light availability as well as measure overall health. The map to the right shows locations of monitoring sites (highlighted in pink) in selected meadows in by the Florida Department of Environmental Protection and Water Management District. Annual seagrass monitoring examines species types, density, distribution and how deep the grass will grow (this is dependent on light availability).

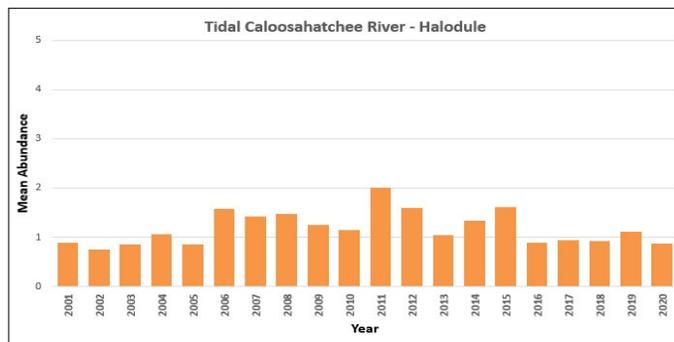
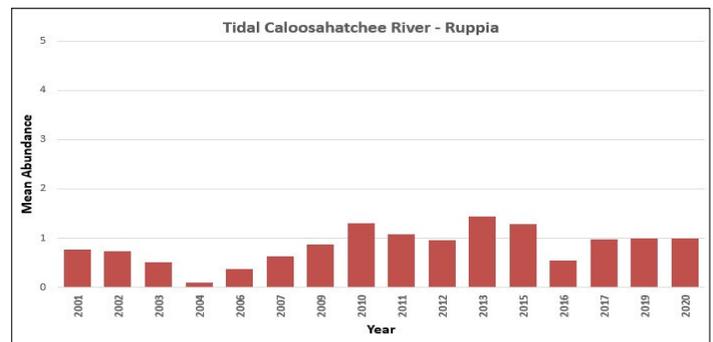
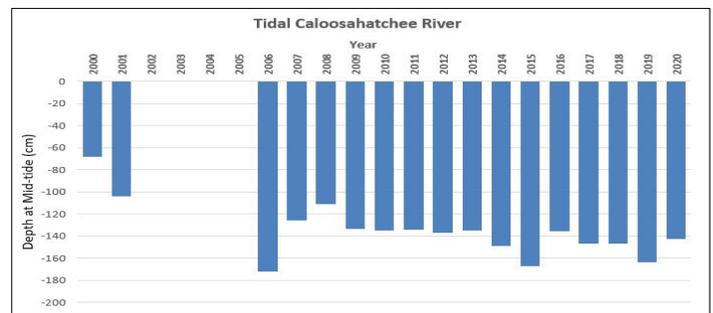
The bar graphs below show the total abundance for two seagrass species, Shoalgrass (*Halodule wrightii*) and Widgeongrass (*Ruppia maritima*), total amount of grass, and depth at which the grass was growing at selected sites in the tidal Caloosahatchee the years 2001 -2020³. Although seagrass total acreage appears to be increasing in aerial imagery, seagrass abundance at the six monitoring stations depicted does not appear to remain stable or is declining. Note that a diverse seagrass species composition is an important indicator of a healthy seagrass meadow and serves as more complex habitat for fish and shellfish.

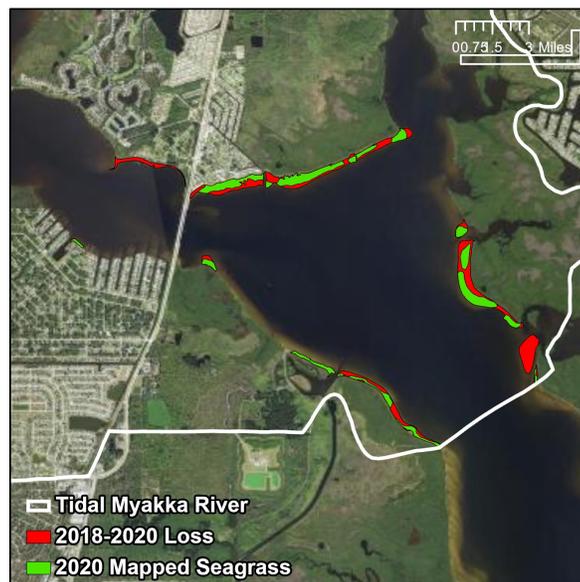
The below graphic depicts results from seagrass mapping in the tidal portion of the Myakka River from 1982-2020². Although seagrass acreage was increasing from 2010-2016, it began to decline in 2018 and demonstrated more losses from 2018 to 2020. In fact, between 2018 and 2020, the Tidal Myakka River lost 66 acres of seagrass, representing a 47% loss overall. The reason for this decline is complex and likely involves several factors; such as recent storm events, increased temperatures and rainfall, additional nutrient runoff from land, as well as prolonged red tide and algae blooms in the region. The CHNEP continues to work with our partners to investigate causes.

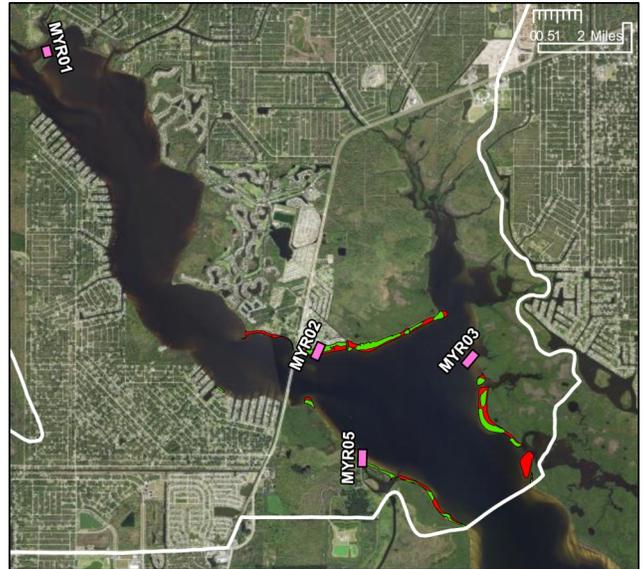
Monitoring is the repeated observation of a system to detect localized changes in a specific seagrass meadow over time in response to environmental conditions and light availability as well as measure overall health. The map to the right shows locations of monitoring sites (highlighted in pink) in selected meadows in Tidal Myakka River by the Florida Department of Environmental Protection Aquatic Preserve staff. Annual seagrass monitoring in the Harbor examines species types, density, distribution, and how deep the grass will grow (this is dependent on light availability).

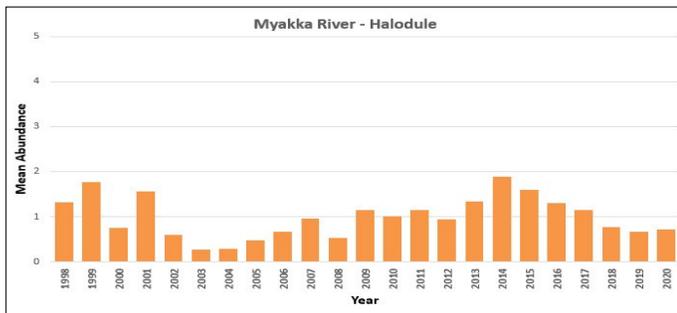
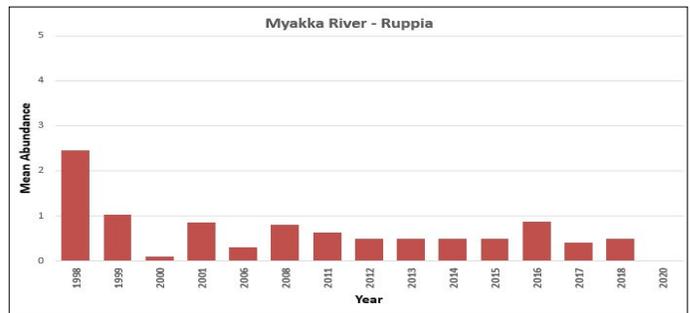
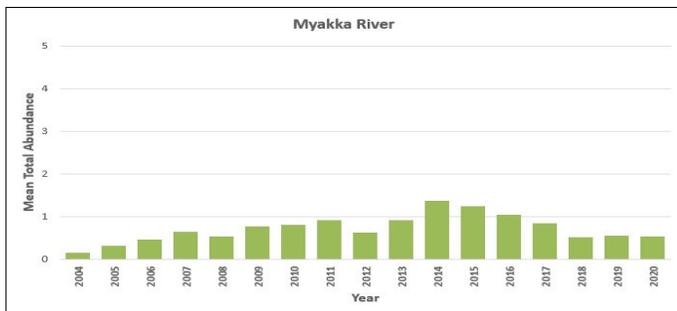
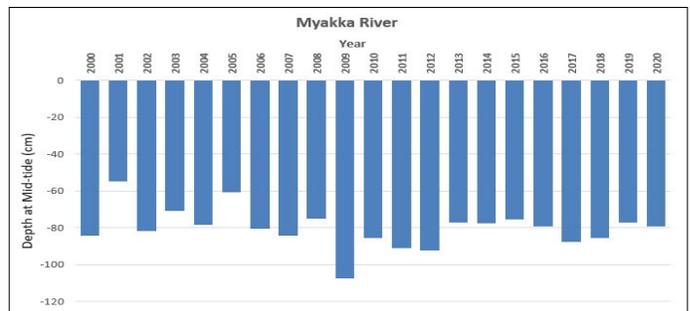
have seen declines in abundance at multiple monitoring locations starting as far back as 2015, preceding the decline in overall acreage observed between 2018 and 2020. However, data collected in 2020 demonstrates modest gains from 2019-2020 for Shoalgrass (*Halodule wrightii*) in the area. Note that a diverse seagrass species composition is an important indicator of a healthy seagrass meadow and serves as more complex habitat for fish and shellfish.

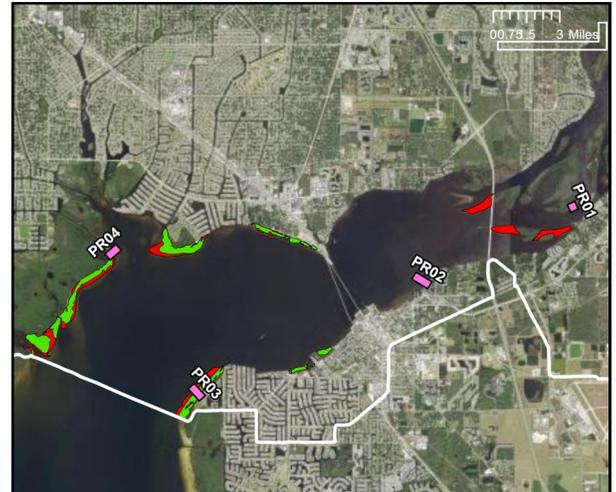
Monitoring is the repeated observation of a system to detect localized changes in a specific seagrass meadow over time in response to environmental conditions and light availability as well as measure overall health. The map to the right shows locations of monitoring sites (highlighted in pink) in selected meadows in Tidal Peace River by the Florida Department of Environmental Protection Aquatic Preserve staff. Annual seagrass monitoring in the Harbor examines species types, density, distribution, and how deep the grass will grow (this is dependent on light availability).
