Seagrass in Charlotte Harbor

FISH, WILDLIFE, & HABITAT PROTECTION

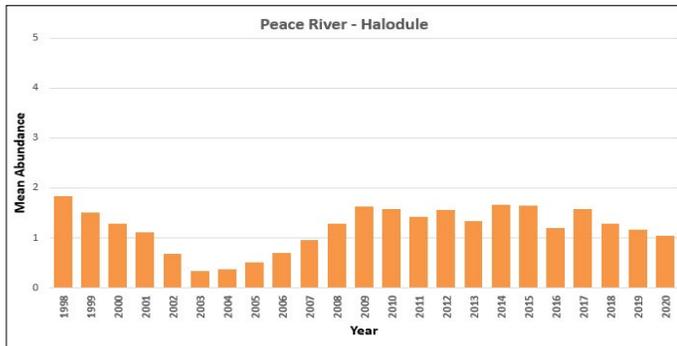
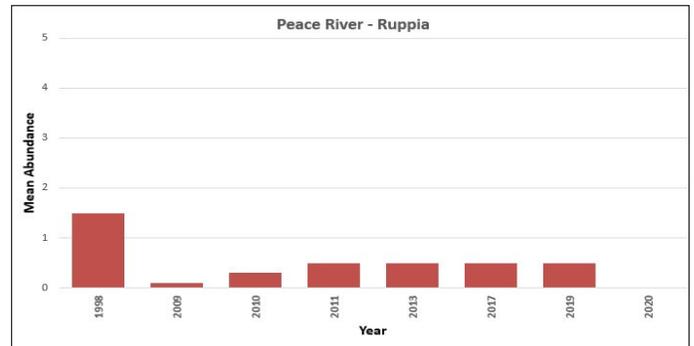
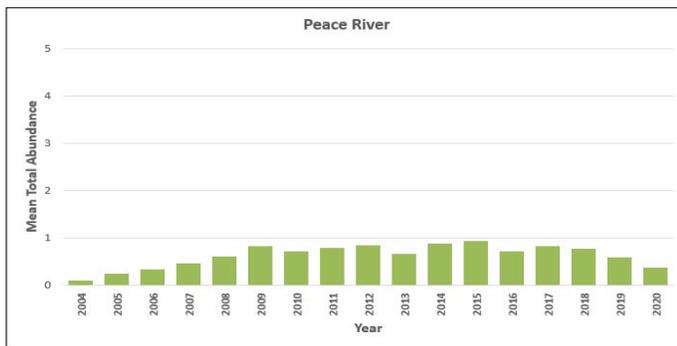
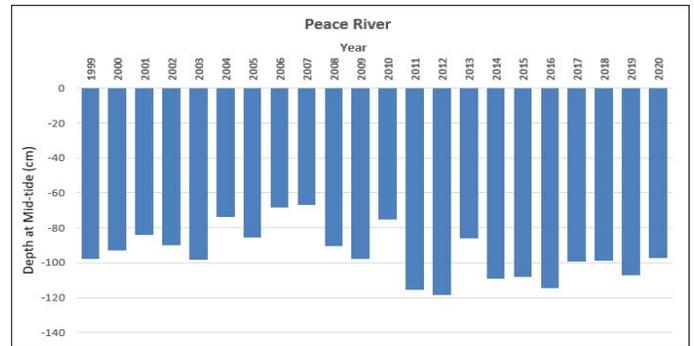
The bar graphs below show the total abundance for two seagrass species Shoalgrass (*Halodule wrightii*) and Widgeongrass (*Ruppia maritima*), total amount of grass, and depth at which the grass was growing at selected monitoring locations in Tidal Peace area for the years 1998-2020³. They demonstrate that overall density of seagrass, Shoalgrass (*Halodule wrightii*), and Widgeongrass (*Ruppia maritima*) have seen declines in abundance at multiple monitoring locations starting as far back as 2017, preceding the decline in overall acreage observed between 2018 and 2020. Note that a diverse seagrass species composition is an important indicator of a healthy seagrass meadow and serves as more complex habitat for fish and shellfish.

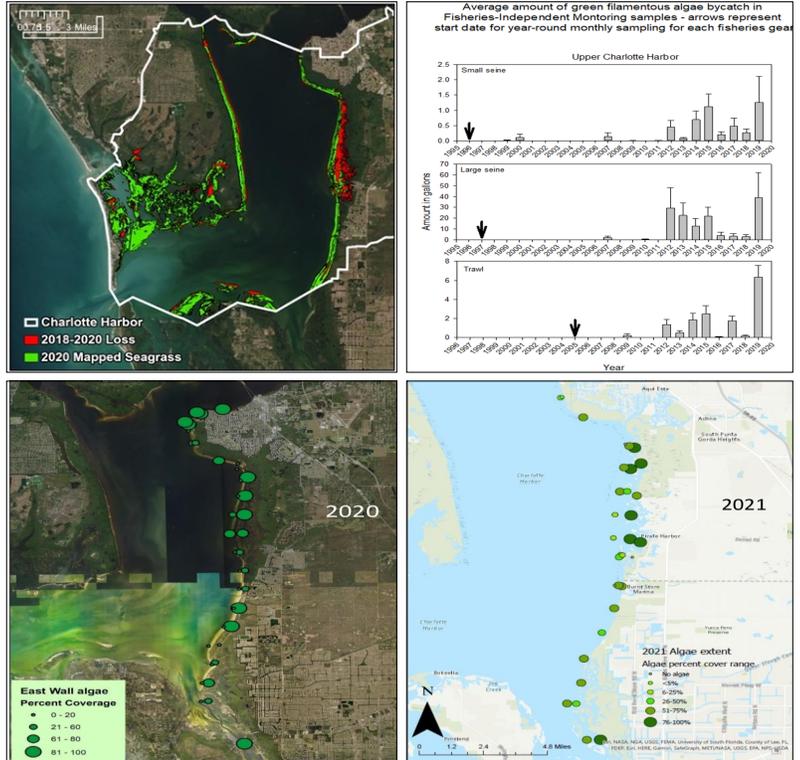
Seagrass meadows along the Harbor's East Wall appear to have been severely damaged due in part to the bloom event (top left).
