Seagrass in San Carlos Bay

FISH, WILDLIFE, & HABITAT PROTECTION

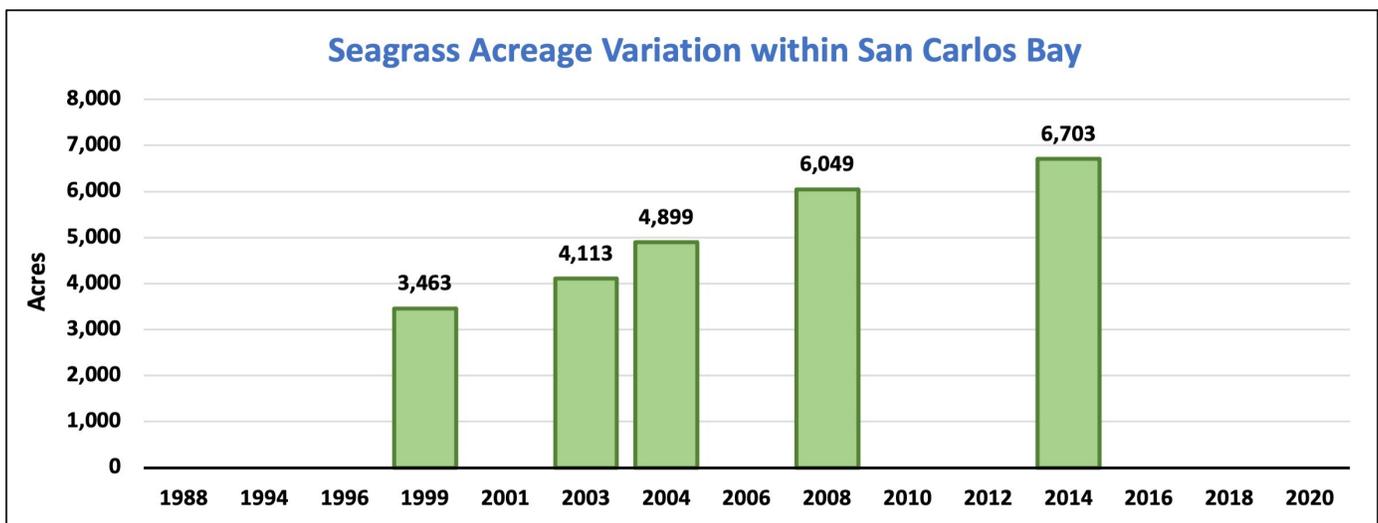
The below graphic depicts results from seagrass mapping in San Carlos Bay from 1999-2014². Seagrass in this area appears to have increased over time since monitoring began. However, consistent mapping of seagrass with aerial photography is needed at least every 3-4 years in order to evaluate trends in acreage. Updated data for the region was collected by the South Florida Water Management District (SFWMD) in the winter of 2020-2021 and will become available in early 2022.

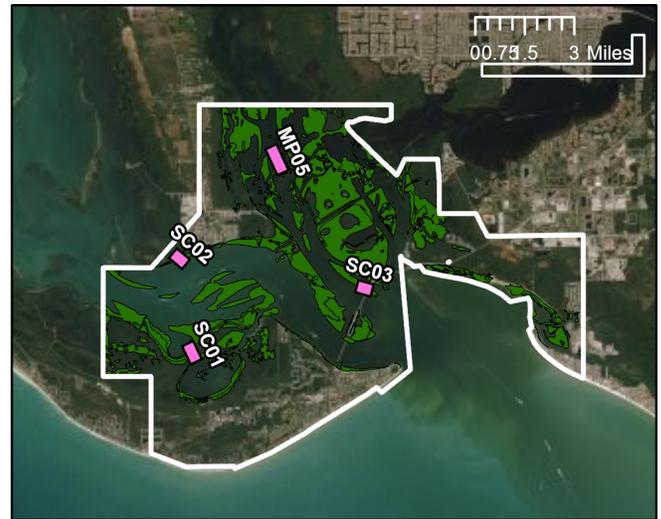
Monitoring is the repeated observation of a system to detect localized changes in a specific seagrass meadow over time in response to environmental conditions and light availability as well as measure overall health. The map to the right shows locations of monitoring sites (highlighted in pink) in selected meadows in San Carlos Bay by the Florida Department of Environmental Protection Aquatic Preserve staff. Annual seagrass monitoring in the Bay examines species types, density, distribution, and how deep the grass will grow (this is dependent on light availability).

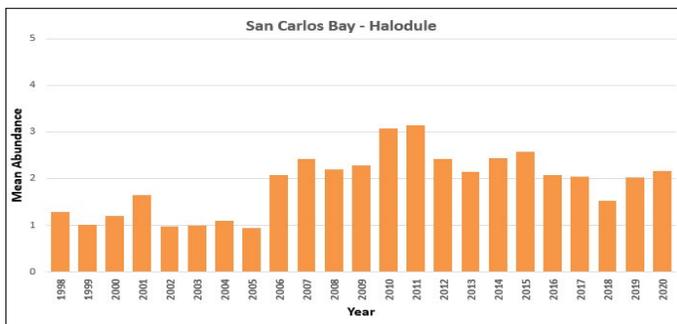
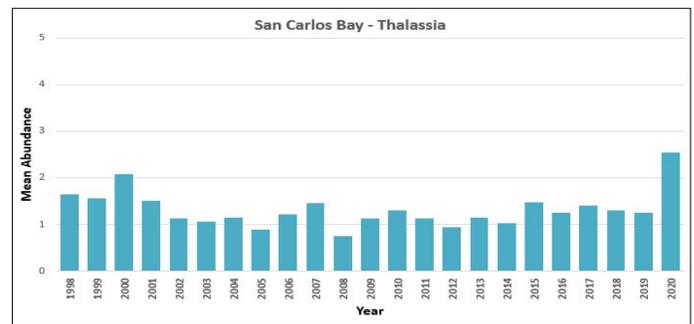
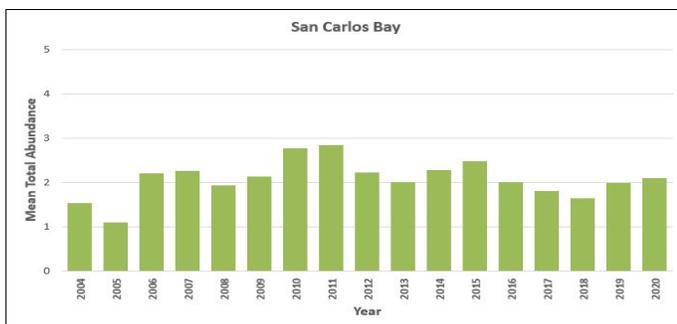
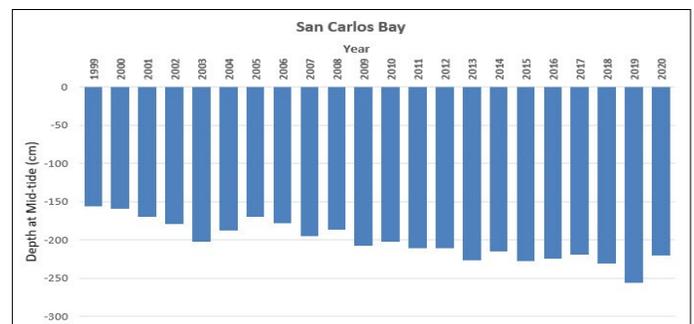
The bar graphs below show the total abundance for two seagrass species at monitoring locations in San Carlos Bay, total amount of grass, and depth at which the grass was growing at these same monitoring sites in the years 1998-2020³. They demonstrate that both Shoalgrass (*Halodule wrightii*) and Turtlegrass (*Thalassia testudinum*) have been declining since 2016. However, data collected in 2020 demonstrates modest gains (though not full recovery) for both species throughout the area. Note that a diverse and stable seagrass species composition is an important indicator of a healthy seagrass meadow and serves as more complex habitat for fish and shellfish.
