Estero Bay Basin Water Quality Status Report

WATER QUALITY IMPROVEMENT

Summary

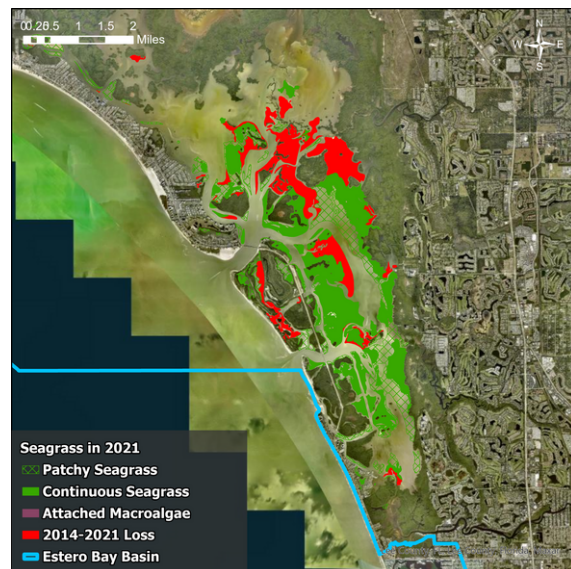
Seagrass Acreage

The graph below depicts results from seagrass mapping in Estero Bay from 1999-2021. From 2004 to 2021, seagrass acreage has remained relatively stable. However, it is important to note that these numbers do not reflect potential changes in seagrass bed abundance from 'continuous' to 'patchy', which may affect habitat value. Additionally, consistent mapping of acreage and locations with aerial photography is needed at least every 3–4 years in order to evaluate trends in seagrass acreage. Between 2014 and 2021, Estero Bay lost 840 acres of seagrass, representing a 23% loss overall. The reason for this decline is complex and likely involves several factors. This includes impacts from storm events such as Hurricane Irma, increased temperatures and rainfall, additional nutrient runoff from land, as well as prolonged red tide and algae blooms in the region.

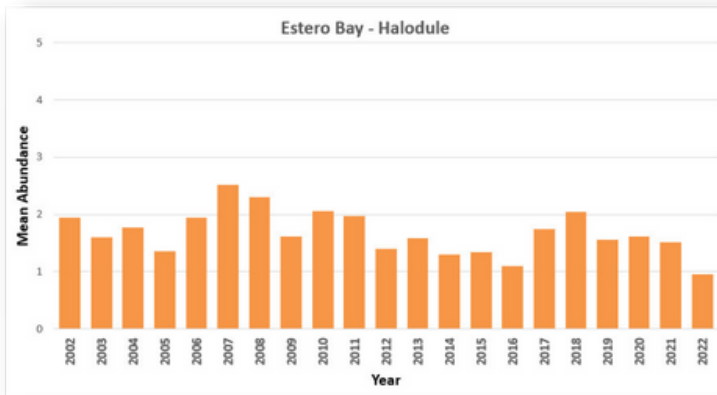
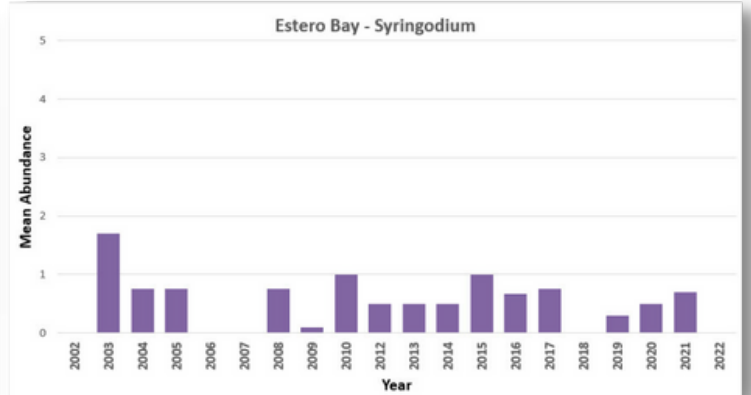
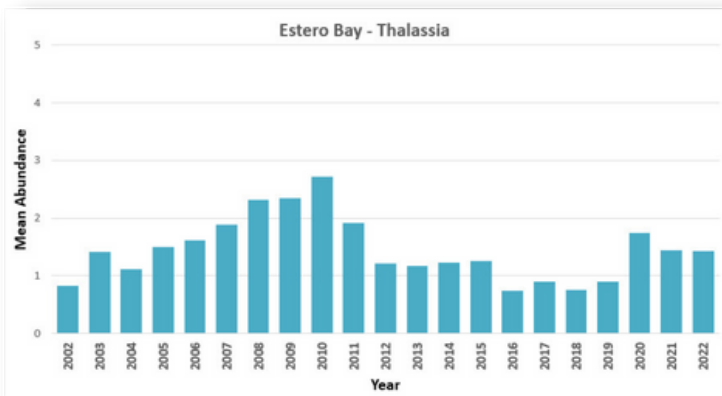
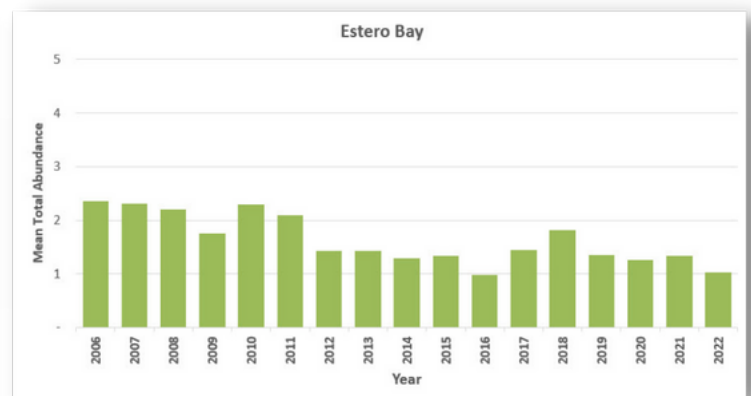
Seagrass Diversity and Health

The bar graphs here depict the changes in presence of different species of seagrass found at monitored locations in the region. Data shared in the graphs below are focused primarily on four seagrass species Shoal grass (*Halodule wrightii*) and Turtle grass (*Thalassia testudinum*), Widgeon grass (*Ruppia maritima*), and Manatee grass (*Syringodium filiforme*) for the years 2002–2022. Other types of seagrass are only found infrequently at these locations; there are not enough data to be graphed here.
