# Pine Island Sound Basin Water Quality Status Report

## WATER QUALITY IMPROVEMENT

# Seagrass in Pine Island Sound Basin

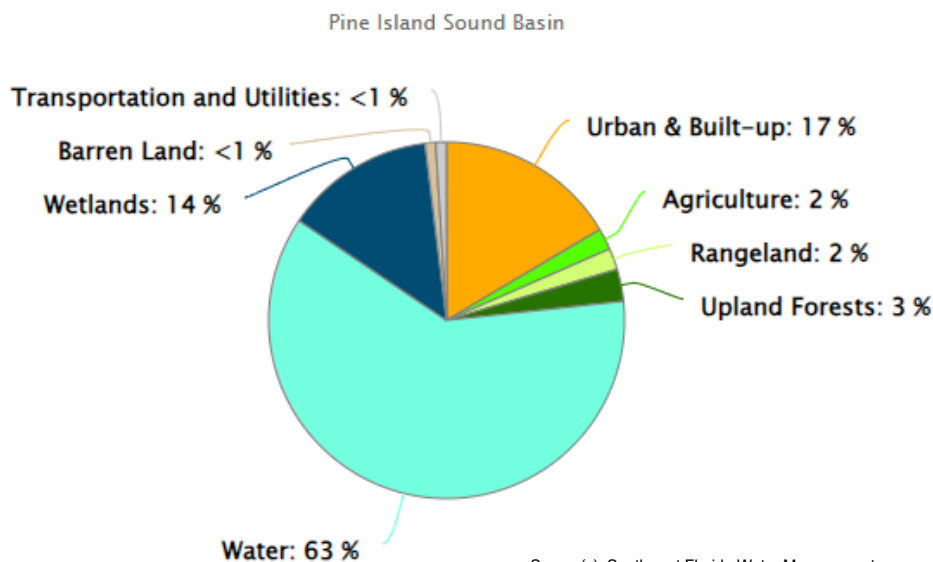
### Land Use / Land Cover Categories as a Percentage of Basin Area

Source(s): Southwest Florida Water Management District; South Florida Water Management District

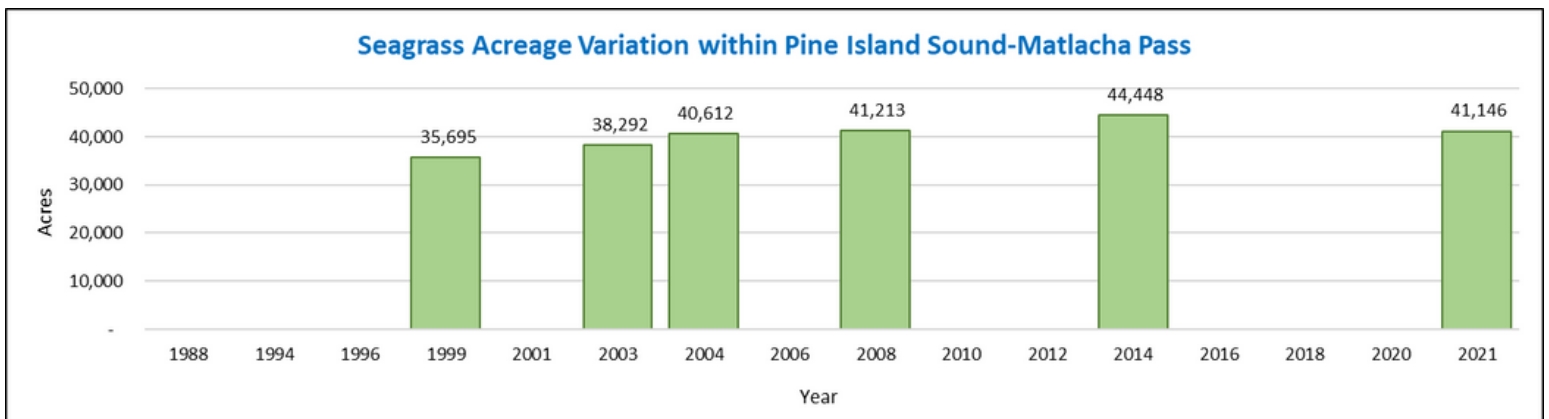
The graphs below depict results from seagrass mapping in Pine Island Sound, Matlacha Pass, and San Carlos Bay from 1999–2021. Due to tidal flushing in Pine Island Sound, which hosts the majority of the region’s seagrass, acreages in this area have remained relatively stable over time. Note that consistent mapping of acreage and locations with aerial photography is needed at least every 3–4 years in order to evaluate trends in seagrass acreage. Between 2014 and 2021, Pine Island Sound/Matlacha Pass lost 3,302 acres of seagrass, representing a 7% loss overall. The reason for this decline is complex and likely involves several factors. This includes impacts from storm events such as Hurricane Irma, increased temperatures and rainfall, additional nutrient runoff from land, as well as prolonged red tide and algae blooms in the region. CHNEP continues to work with our partners to better understand causes and investigate solutions.

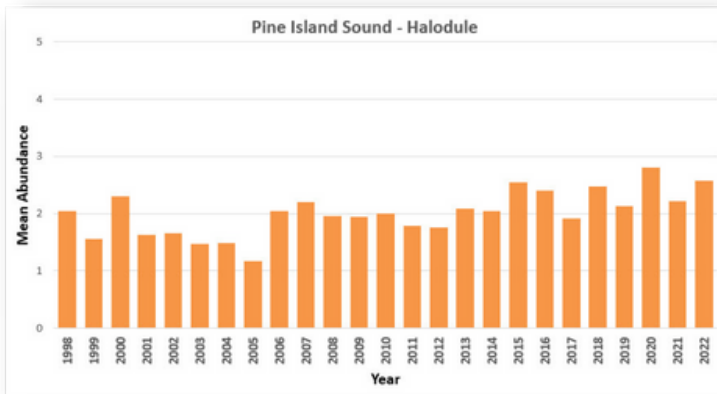
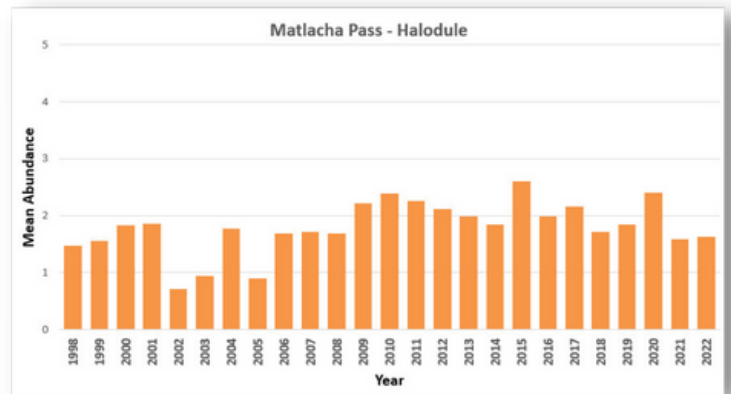
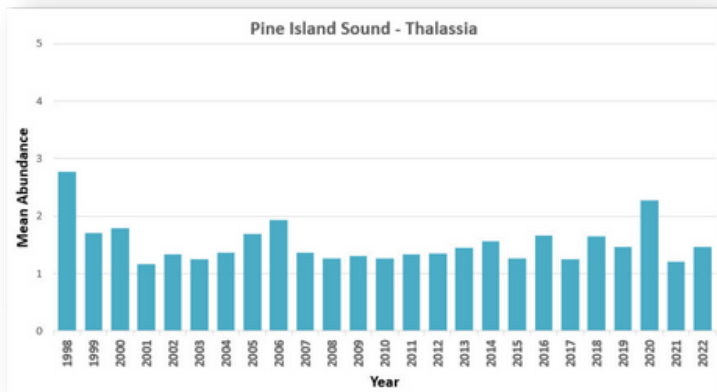
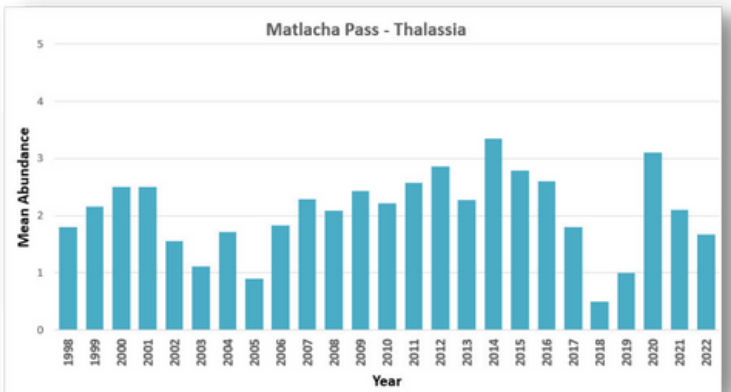
The bar graphs here depict the changes in presence of different species of seagrass found at monitored locations in the region. Since this region is so large, data shared in the graphs below are divided by two seagrass species at different monitoring locations in Pine Island Sound and Matlacha Pass for the years 1998–2021. Other types of seagrass are only found infrequently at these locations; there are not enough data to be graphed here.

Although both types of seagrass species experienced some declines at multiple monitoring locations starting as far back as 2016, numbers are relatively more stable in Pine Island Sound, which is mostly influenced by seawater from the nearby passes. Matlacha Pass (which receives freshwater flows from the Caloosahatchee River) has experienced more notable declines in seagrass in recent years due to a macroalgae issue (*Caulerpa fastigiata*).
