# Peace River Basin Water Quality Status Report

## WATER QUALITY IMPROVEMENT

# Seagrass in Peace River Basin

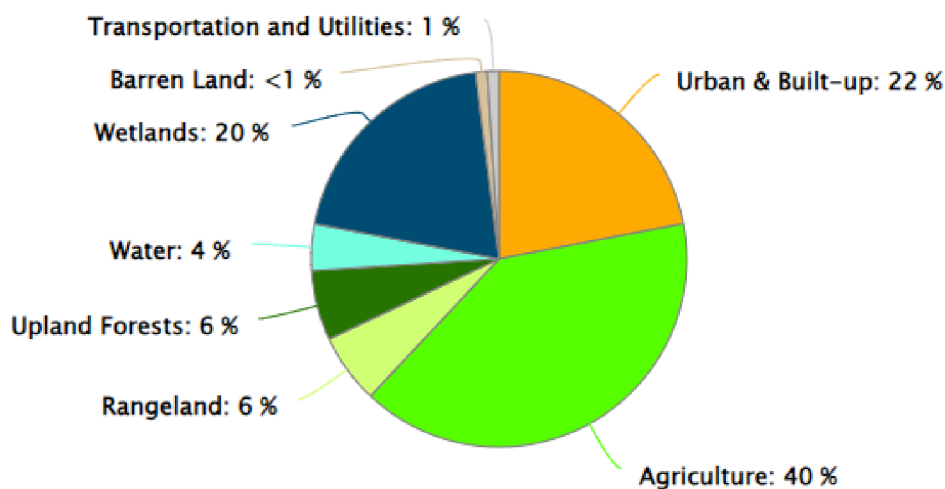
### Land Use / Land Cover Categories as a Percentage of Basin Area

Peace River Basin

Source(s): Southwest Florida Water Management District

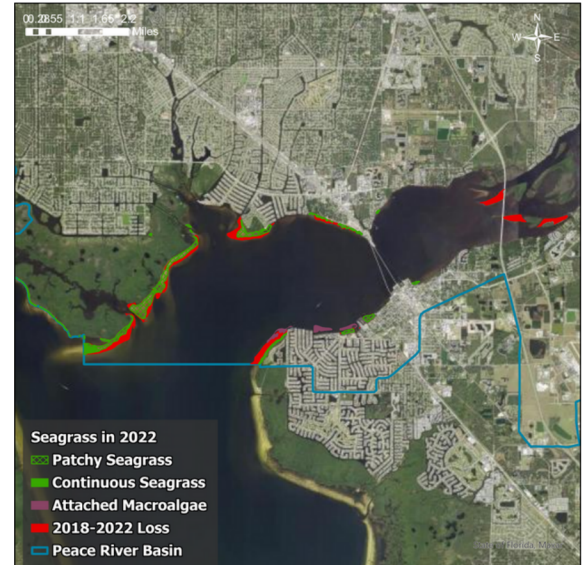
Seagrass beds provide many benefits. It is nursery habitat for fish and shellfish and it contributes to better water quality by trapping sediments, storing carbon, and filtering nutrients from stormwater runoff. Seagrass requires clean water and ample sunlight to grow, and therefore it is used by agencies and local governments as a way to measure water quality. This is documented in two ways:

- Mapping changes in seagrass acreage and location over time with aerial photography (spatial coverage). This is valuable for estimating seagrass locations, acres and broad changes over time.
- On-the-ground monitoring of changes in species composition, estimation of bottom cover in a seagrass bed (abundance), and maximum depth in which seagrass can grow due to light availability and water clarity (deep edge). This monitoring works to characterize the density, complexity, and stability of those seagrass meadows.

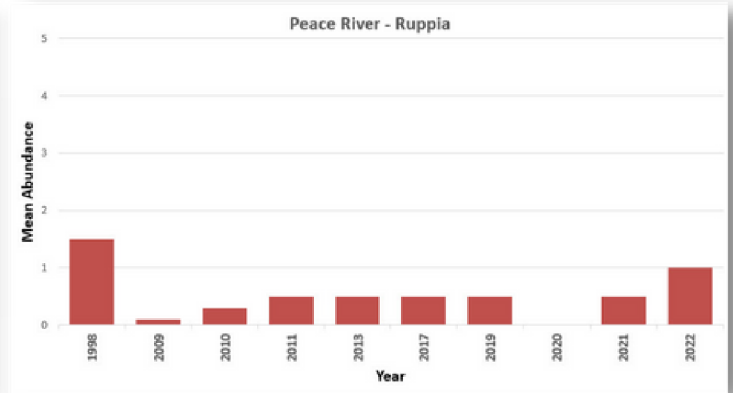
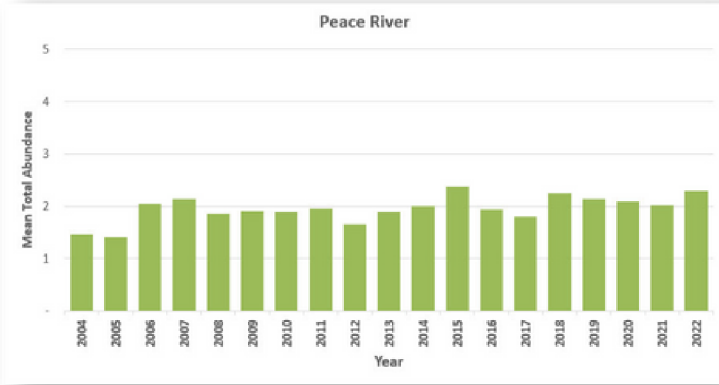
## Seagrass Diversity and Health

The bar graphs here depict the changes in presence of different species of seagrass found at monitored locations in the region. In the Tidal Peace River, this includes Shoal grass (*Halodule wrightii*) and Widgeon grass (*Ruppia maritima*), which is found in areas that are less salty, for the years 1998–2021. Overall, seagrass experienced declines starting as far back as 2016, preceding the loss in seagrass acreage seen between 2018 and 2020. However, data collected in 2021 demonstrate modest gains (though not full recovery) in total seagrass abundance. Shoal grass has gained abundance overall since 2003, with declines in some years, and another recent gain in 2021. Widgeon grass was not found at monitoring sites in 2020, although reappeared in low abundance in 2021.
