A Snapshot of Changes in Seagrass Habitat Along the West Coast and the Caloosahatchee River Estuary, Florida

**Coastal & Heartland National Estuary
Partnership
2023 Watershed Summit**

Submerged Aquatic Vegetation Monitoring

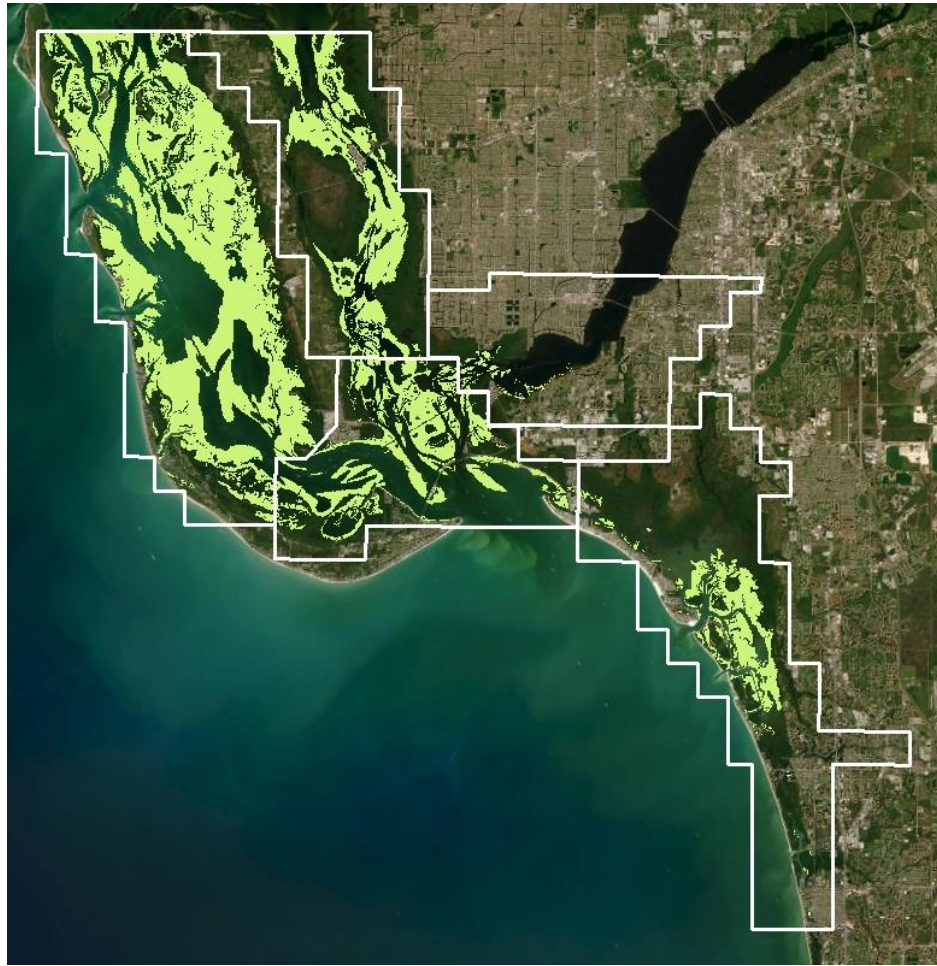
Matlacha Pass

<u>Results</u>	<u>Acres</u>
2014 Seagrass	8,272
2021 Seagrass	4,510
Net Change	- 3,769
Changes 2014 – 2021	
No Change	4,101
Gains	410
Losses	4,178

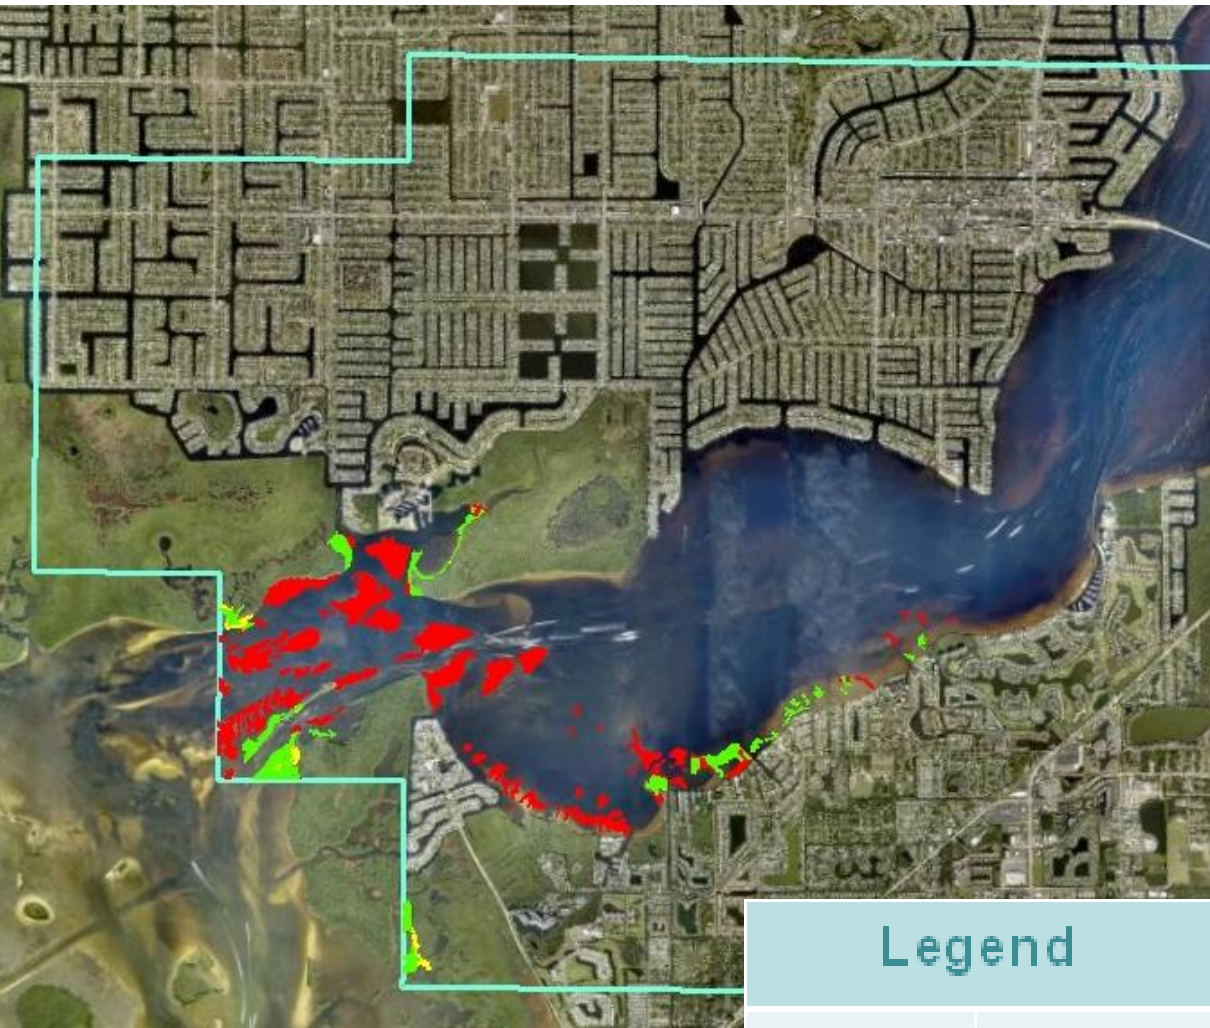
Tidal Caloosahatchee

<u>Results</u>	<u>Acres</u>
2014 Seagrass	411
2021 Seagrass	114
Net Change	- 297

Changes 2014 – 2021	
No Change	102
Gains	12
Losses	309

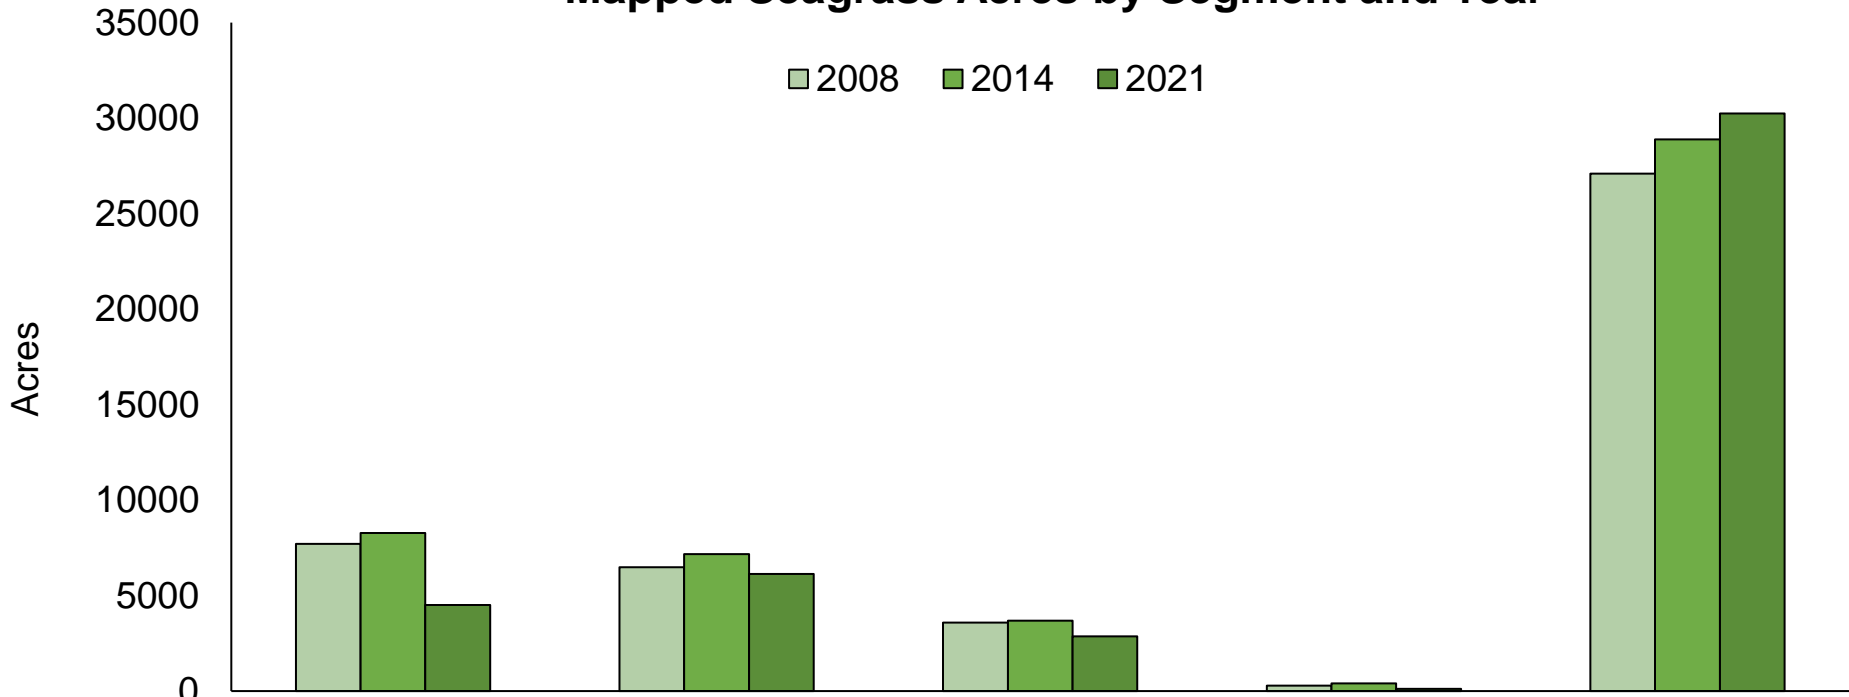
Mapped Seagrass Acres by Segment and Year

Matlacha Pass	San Carlos Bay	Estero Bay	Tidal Caloosahatchee	Pine Island Sound
Loss/Gain	- 3,769	- 1,041	- 816	- 297	+ 1,355
% Change	↓ 46 %	↓ 15 %	↓ 22 %	↓ 72 %	↑ 4 %

- Significant loss in seagrass acreage 2014 – 2021
- *Thalassia* & *Halodule* are the most abundant species
- Mean Percent Cover remains < 20 %

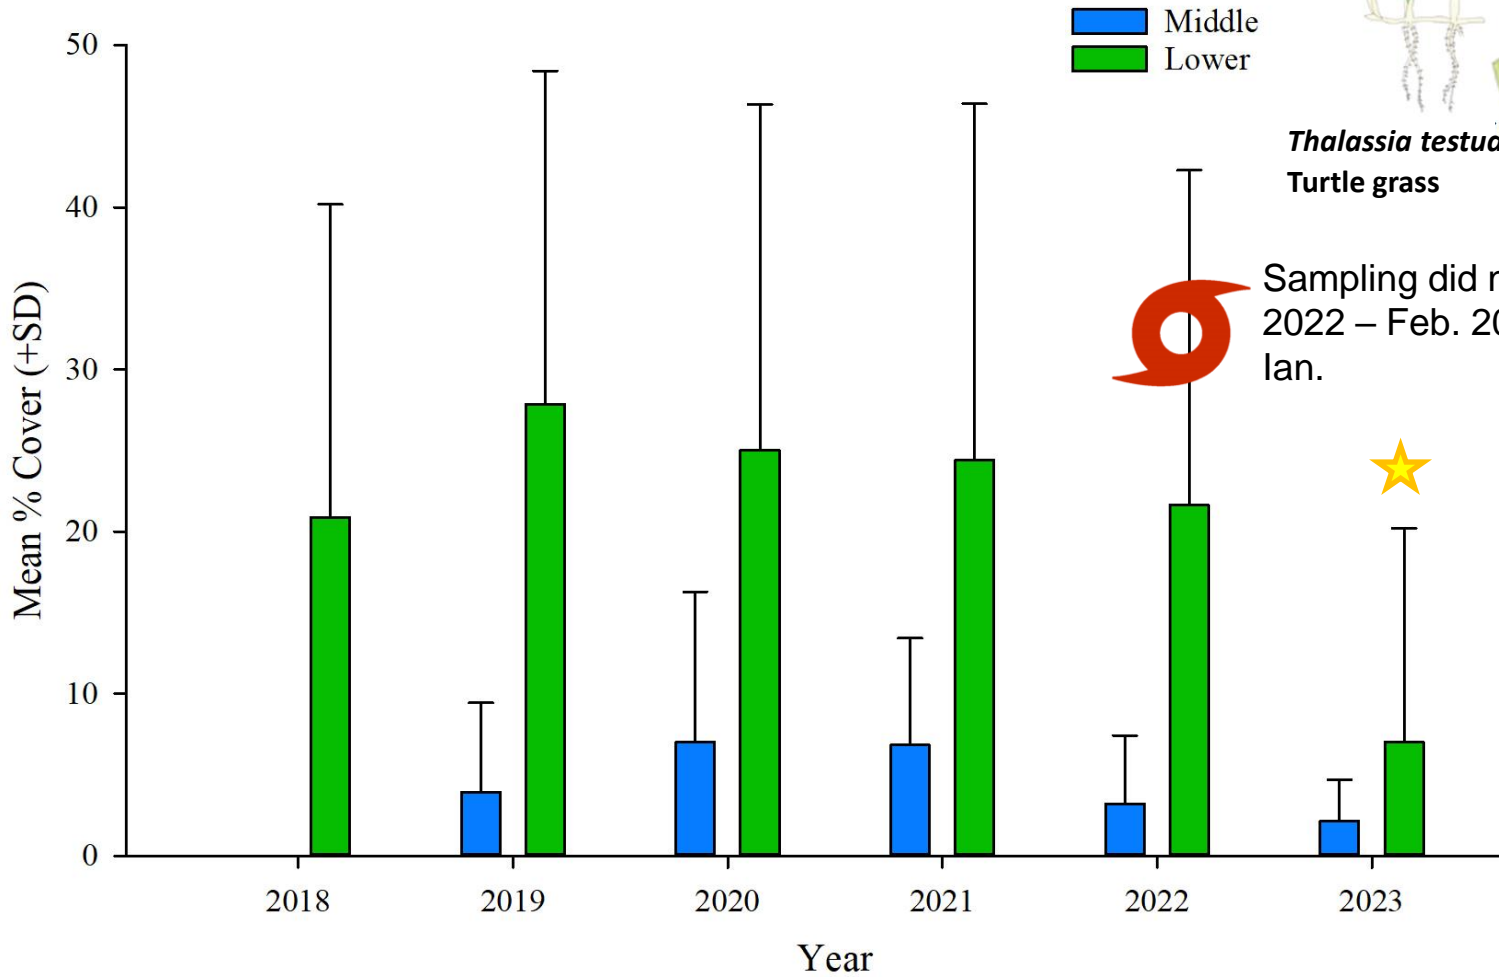
Total SAV Coverage

Sampling did not occur between Oct. 2022 – Feb. 2023 due to Hurricane Ian.

★ 2023 only includes March 2023 sampling.

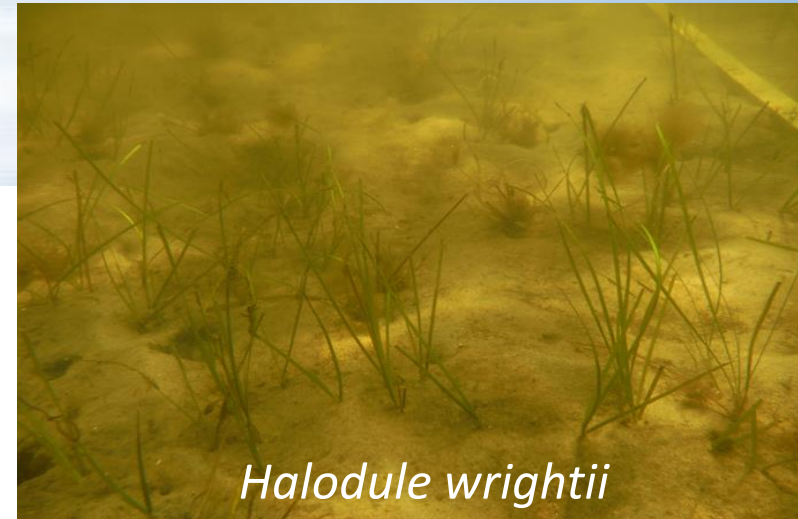
Middle Estuary

Sampling did not occur between Oct. 2022 – Feb. 2023 due to Hurricane Ian.

★ 2023 only includes March 2023 sampling.

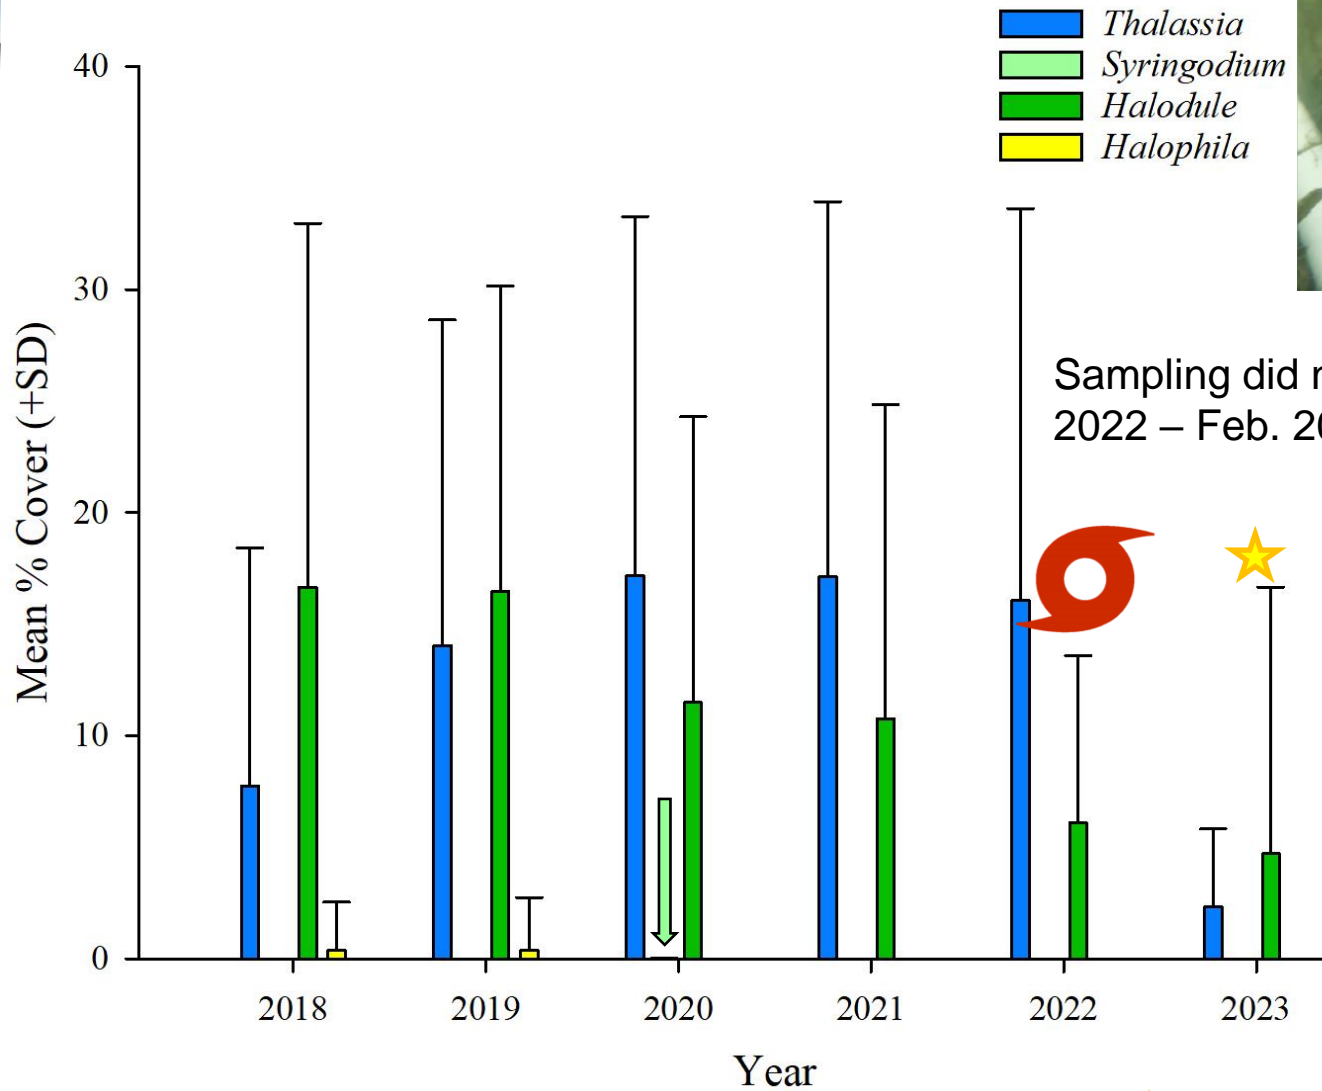
Lower Estuary

Sampling did not occur between Oct. 2022 – Feb. 2023 due to Hurricane Ian.

★ 2023 only includes March 2023 sampling.
