Myakka Headwaters Preserve Project

Lee Amos, Conservation Foundation of the Gulf Coast Nathan Hoffman, Beautiful Ponds, Inc. December 2023 On behalf of the: Coastal & Heartland National Estuary Partnership (CHNEP)

Introduction / Background

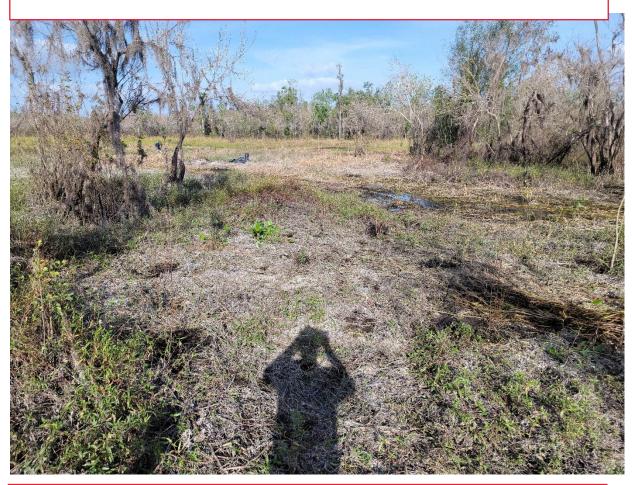
Ogleby Creek - Post Planting - Note effective WIMG treatment

Treatment of WIMG prior to planting was successful and will be repeated on future projects.

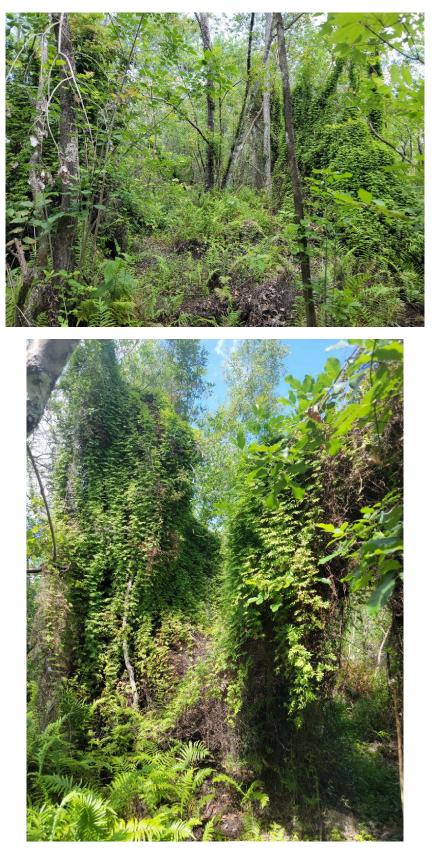
Figure 4 - Photos (before)

Lygodium Pre-Treatment Photos April 15, 2023

Lygodium treatment at MHP proved difficult and not as effective from initial inspection to final inspection. While two treatments were applied, the long-term outcome is less than optimal, in that many vines have started to re-grow twelve months later. Upon final inspection on November 9, 2023, many new plants were observed within the areas of treatment (see photo examples for pre-treatment, initial post-treatment inspection and final inspection, Figure 4).

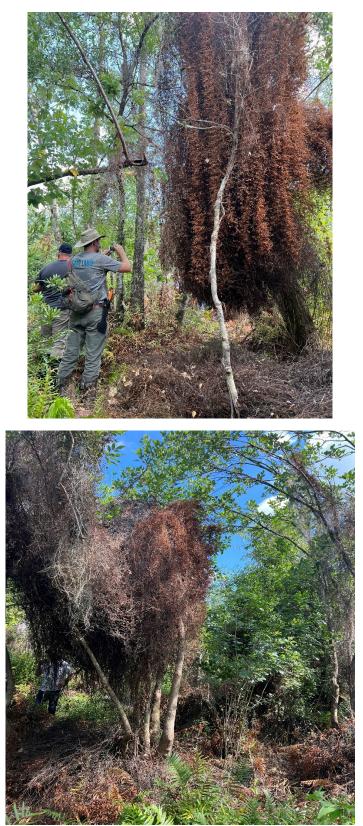
Figure 4 - Photos (after)

Lygodium was inspected on May 17, 2023 and the observed death rate at that time appeared to be 97% or better.

Lygodium Initial Post-Treatment Photos May 17, 2023

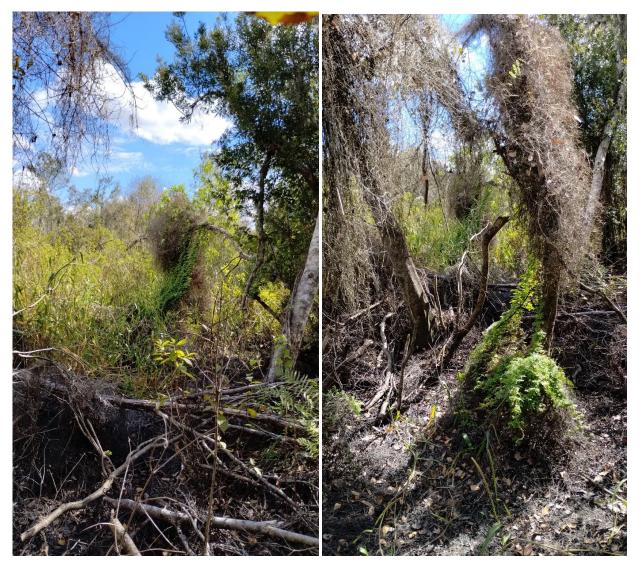
Lygodium Treatment Area

Photos showing re-growing lygodium

Fish and Wildlife Conservation Commission, who shared that his observation is that plants usually re-grow from spores within a treatment area, and that multiple treatments are needed over a period of five years to achieve control. SWFWMD staff noted that creeks can create wind channels for spores to move, spores can also be left behind when a waterway recedes after staging up. Finally, game trails along rivers are also corridors for spore transport. These items should be considered this when choosing where to prioritize treatment, choosing areas that are easily accessed for continued treatment and less subject to introductions of new spores via the abovementioned pathways. CFGC will continue to monitor and treat *Lygodium* on the Property.

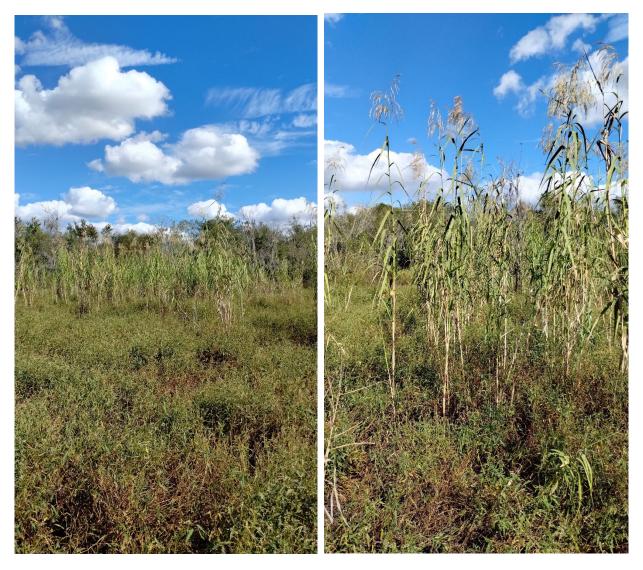
Ogleby Creek Area

Planted phramites are thriving in this location.

Native *Phragmites* was harvested from Myakka River State Park under a FDACS permit and nursery-grown. The plants were easy to harvest and propagate. Two areas were planted with *Phragmites* – one area along Myakka Creek and one along Ogleby Creek. At both sites, *Phragmites* established readily and is thriving. No mortality was observed.

The Ogleby Creek plants are performing significantly better than the Myakka Creek plantings, with the former standing nine or ten feet tall, and the latter about seven feet tall. It is not known why the sites have performed differently, but it may be related to soil type or hydroperiod.

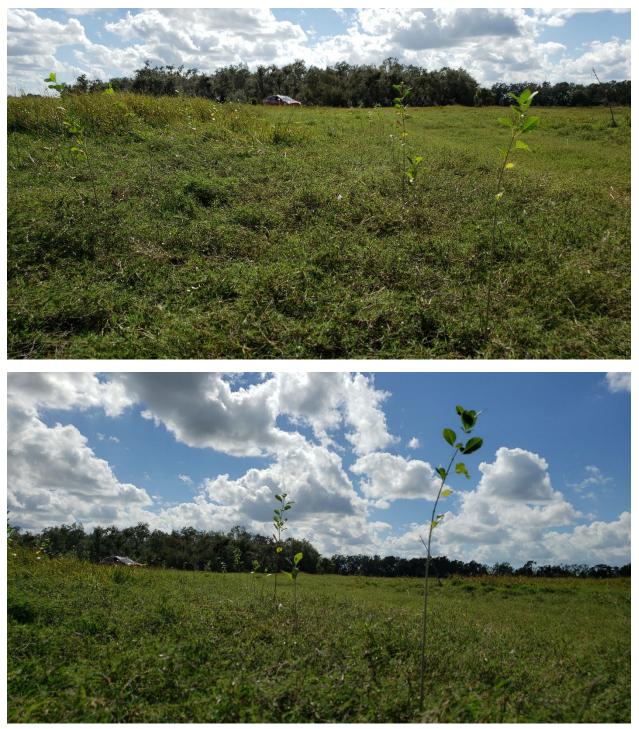
Ogleby Creek Area - 2" popash appear to have fared better than 3-gallon.

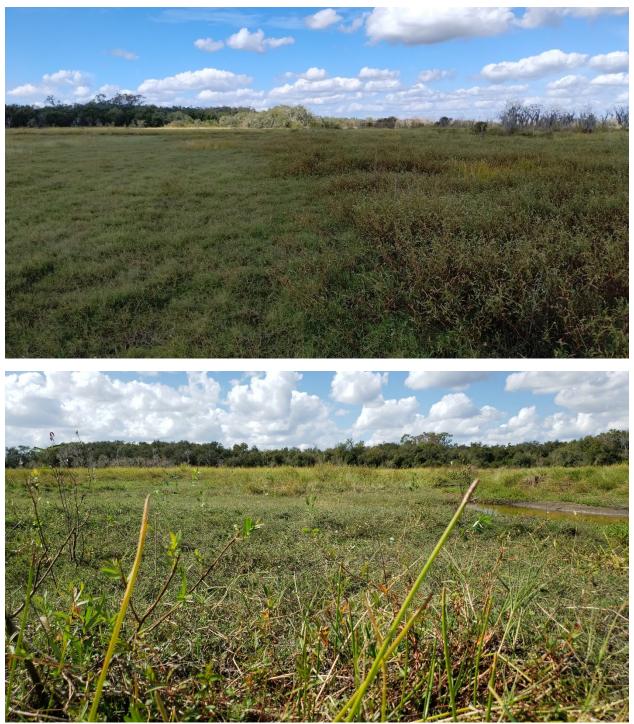
Ogleby Creek area, top photo showing dominating ground cover of smartweed.

One interesting, but tenuous, possible cause of tree mortality is that dotted smartweed, *Persicaria punctata*, is allelopathic. The logic is that dotted smartweed recruited strongly to the planting sites, formed a monoculture on this site, commonly forms monocultures on other properties, and that several other plants in the *Polyganaceae* are known to be alleopathic and even invasive (Lun et al. 2023; Kato-Noguchi, 2021; Fan et al. 2009). This possibility should be investigated further.

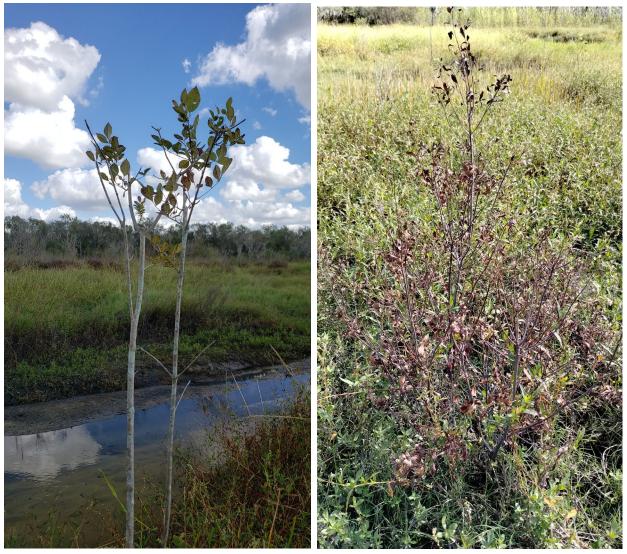
Ogleby Creek area, surviving 3-gallon popash photo left and dead wax myrtle, photo right.

A certain number of trees must have succumbed to flood waters – either peak flood depth or a combination of peak flood depth times duration of inundation (Figure 3, Figure 6). For instance, wax myrtle is found throughout the swamps, but is usually growing on tussocks in the swamp. It likely succumbed to a problem of flooding too deeply for too long of a time. Similarly, the 18"-tall pop ash trees likely were submerged too long in water, along with multiple other species. While these species are found throughout the swamps on the property, establishment may be possible only during dry years, or if the plants are planted on an artificial tussock of some sort as small changes in elevation can change water depths and hydroperiods.

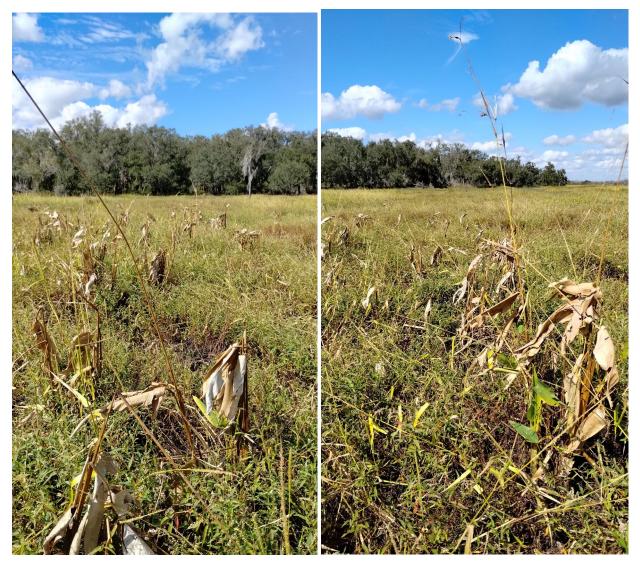
Mixed Planting Area

Thalia did not survive as well as expected, cause unknown.

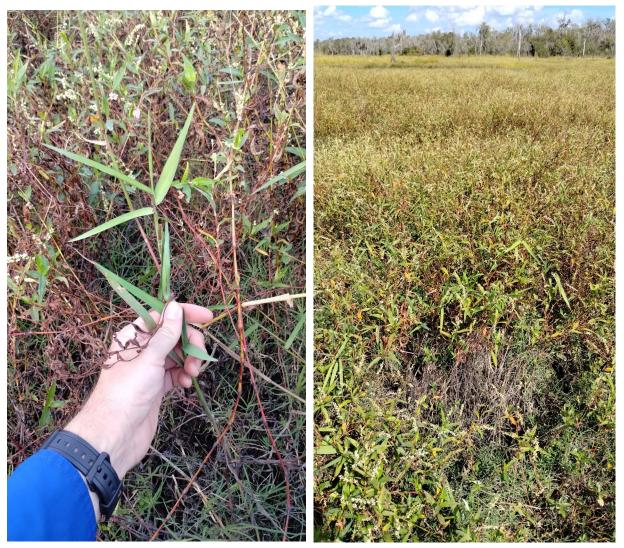
Northern Maidencane Area

Northern Maidencane area, dominated by smartweed, photo right, with 50% survival of planted grass, photo left.

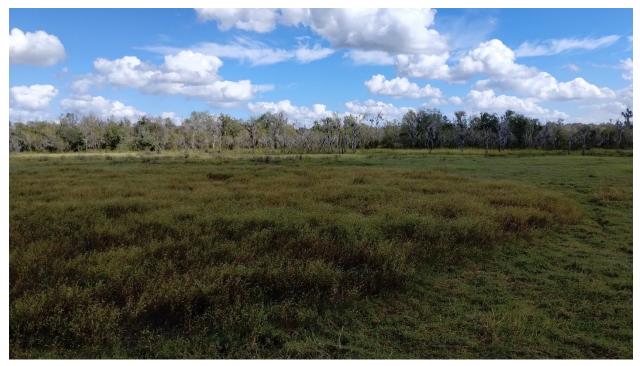
Northern maidnencane area, dominated by smartweed.

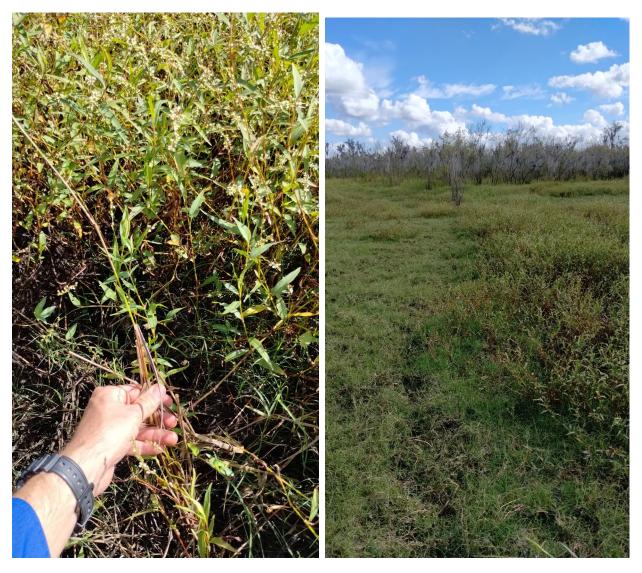
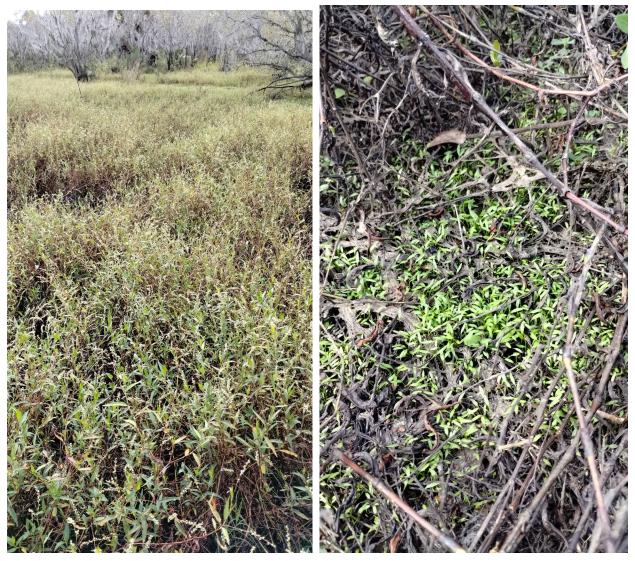
Southern Maidencane Area

Southern maidnencane planting area, dominated by smartweed. Photo right showing abundant sprouting plants below the smartweed, possibly Coreopsis that seeded from the prior planting.

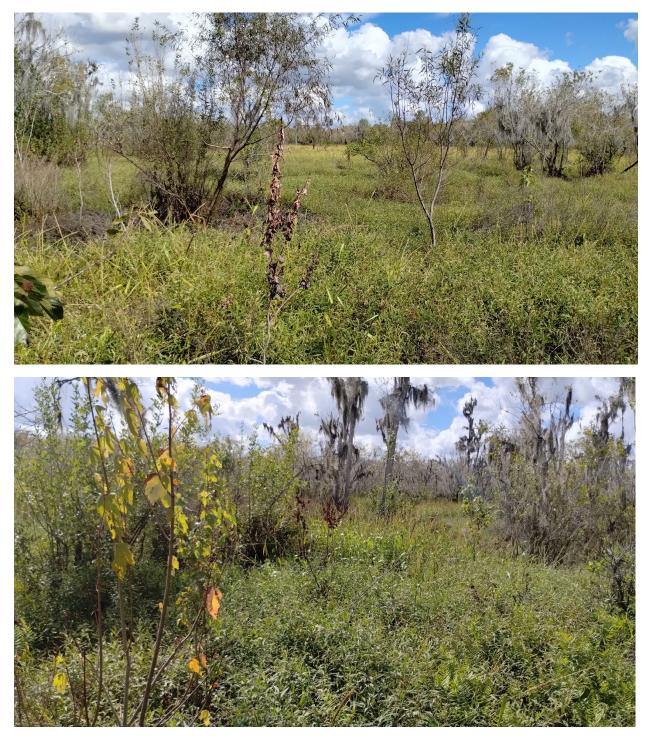
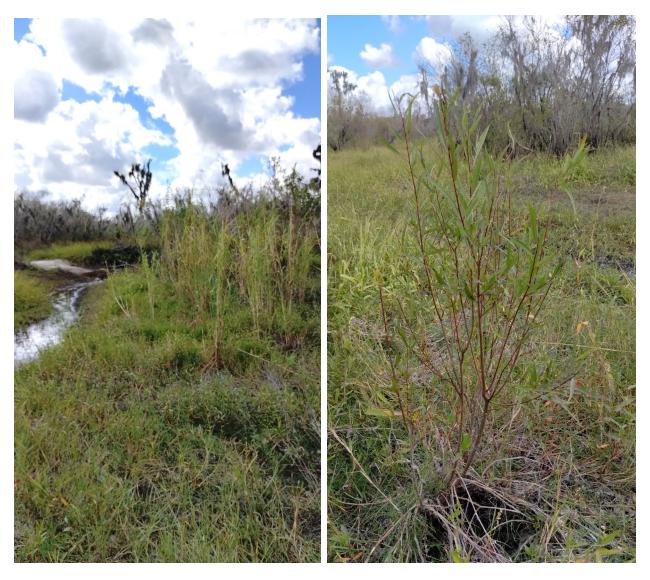
Myakka Creek Area

Myakka Creek area showing healthy Phragmites, left, and willow, right.

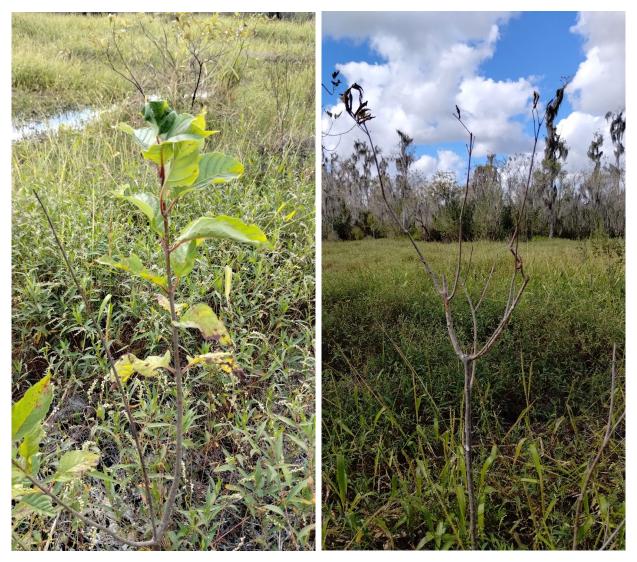
Myakka Creek area showing health buttonbush, left, and a dead tree, right.

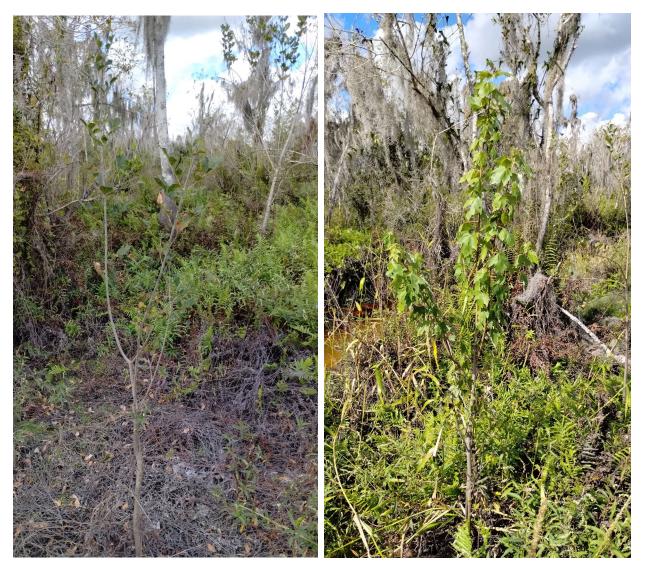
Myakka Creek area showing health pop ash, left, and red maple, right. Both were planted at a higher elevation near the riparian tree line of Ogleby Creek.
