Pine Island Sound Basin Water Quality Status Report

WATER QUALITY IMPROVEMENT

Summary

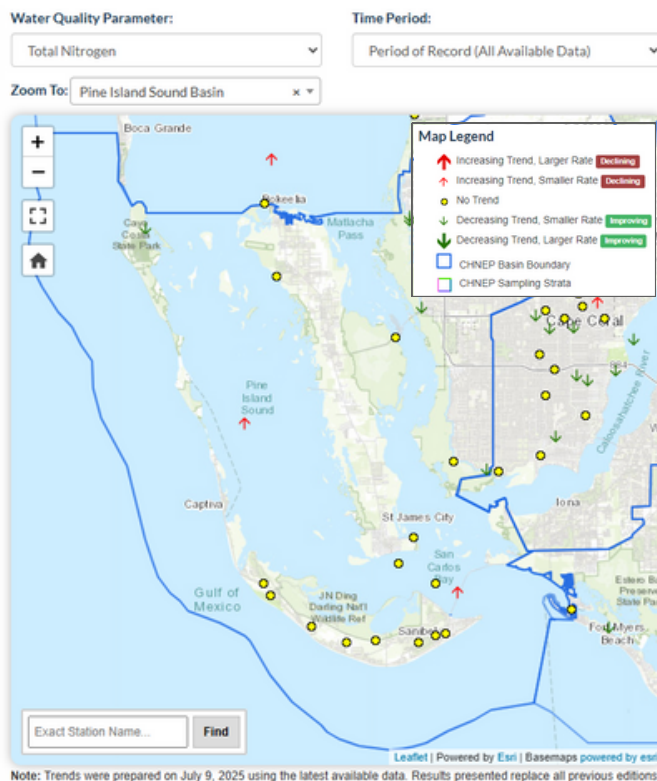
Top graphic shows the trends for Nitrogen at long-term monitoring stations spread throughout the Basin.

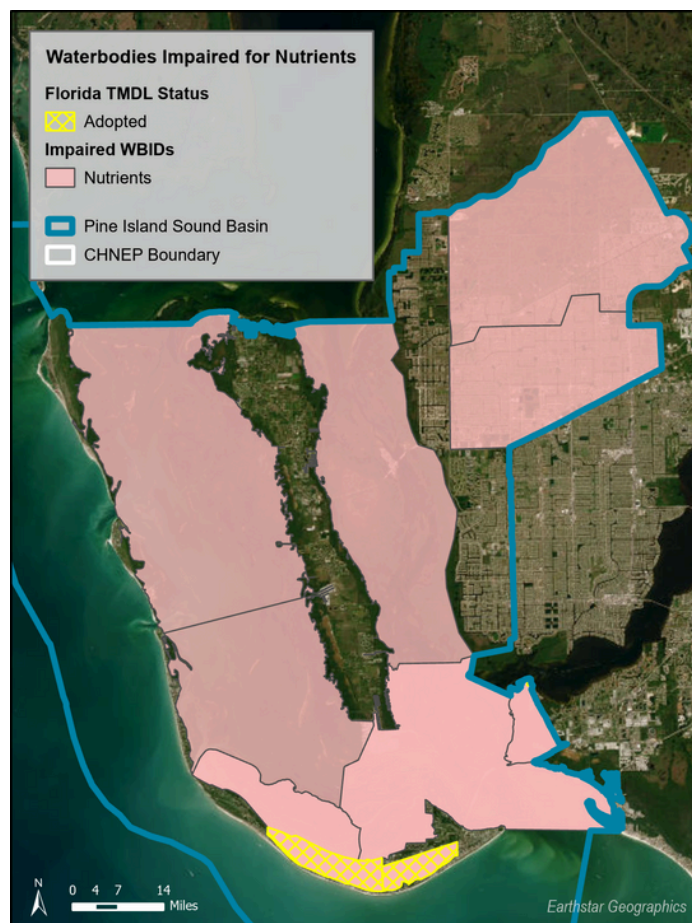
On the map to the right, pink areas are verified impaired for nutrients and yellow striped areas designate areas under TMDL or TMDL development.

The following WBIDs are currently not meeting water quality standards for nutrients:

- Gator Slough Canal
- Horseshoe Hermosa Canals
- Matlacha Pass
- Pine Island Sound (Upper and Lower Segments)
- Punta Rasa Cove
- San Carlos Bay
- Sanibel Bayous
- Sanibel Slough (East and West)

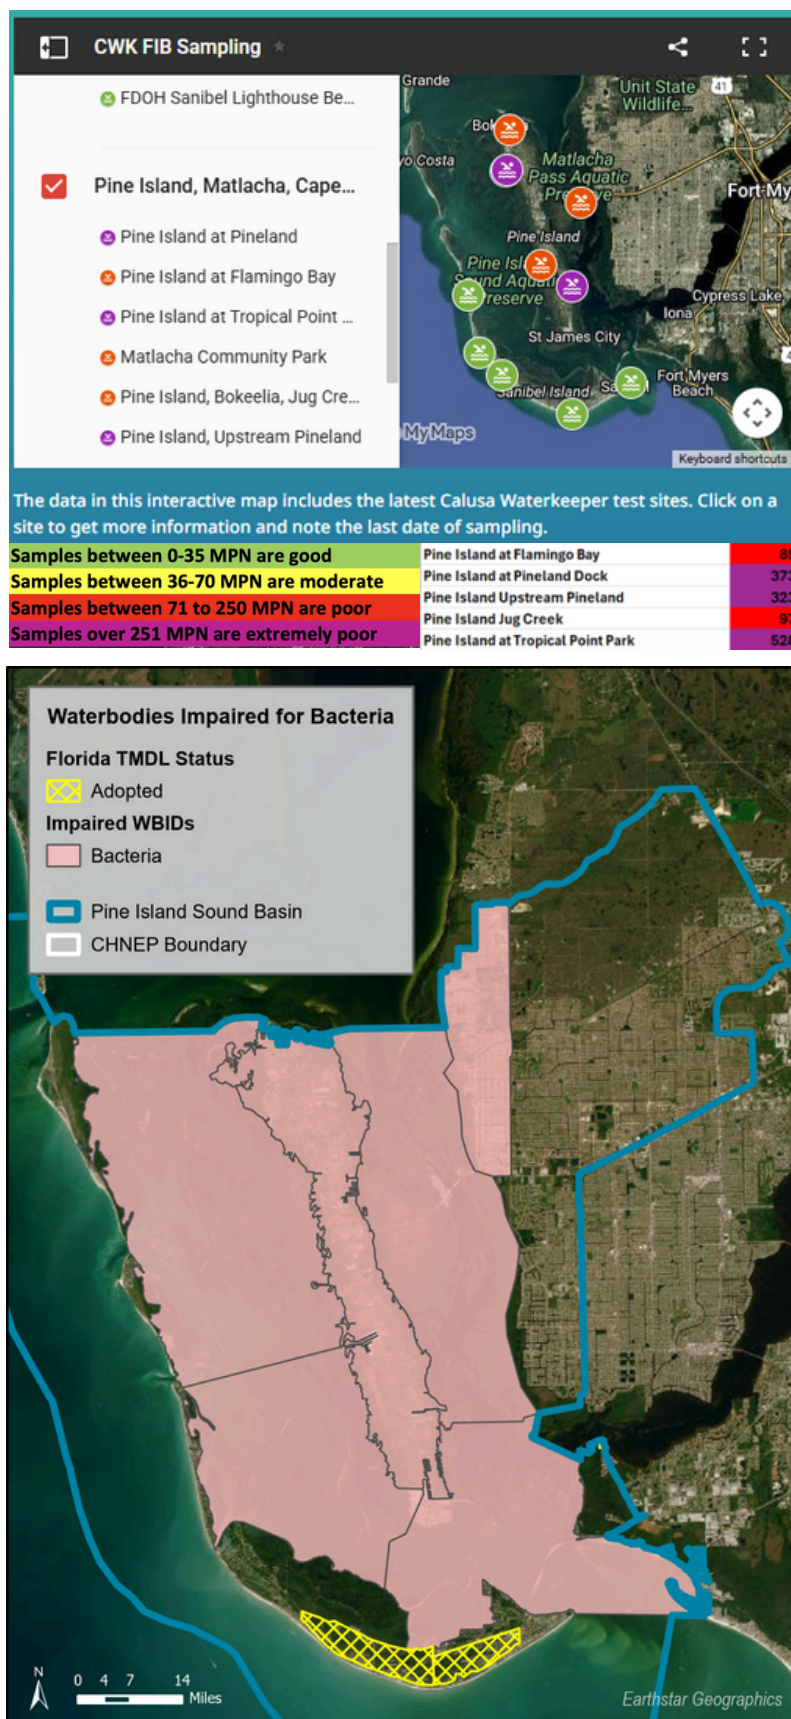
The graphic above shows recent results for Bacteria (Enterococci) at monitoring stations spread throughout the Pine Island Sound Basin.

Pink areas are verified impaired for bacteria on the map to the right. No TMDL development has yet occurred at the state level for bacteria within the Pine Island Sound Basin.

The following WBIDs are currently not meeting water quality standards for bacteria:

- Cape Coral (West Urban)
- Matlacha Pass
- San Carlos Bay
- Pine Island
- Pine Island Sound (Lower Segment)
- Pine Island Sound (Upper Segment)

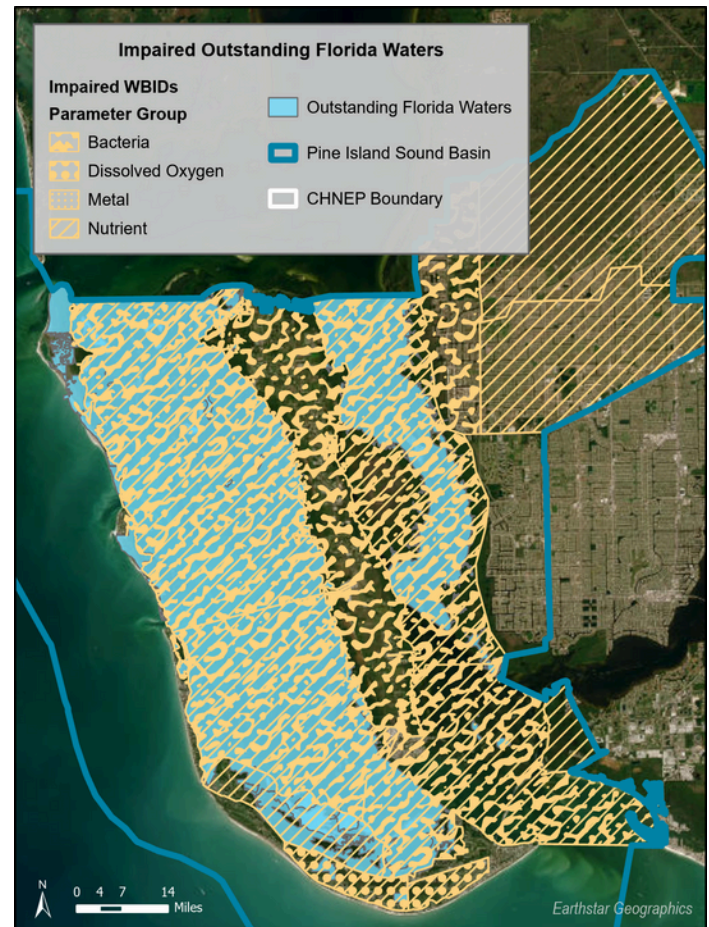
Most OFWs are areas managed by the state or federal government as parks, refuges, or preserves. However, many of these OFWs are currently impaired (as indicated by light blue with peach fill pattern on the map to the right).

The following OFWs are currently not meeting water quality standards:

- Cayo Costa State Park
- Josslyn Island
- J.N. Ding Darling National Wildlife Refuge
- Matlacha Pass Aquatic Preserve
- Matlacha Pass National Wildlife Refuge
- Pine Island Sound Aquatic Preserve
- Pine Island National Wildlife Refuge

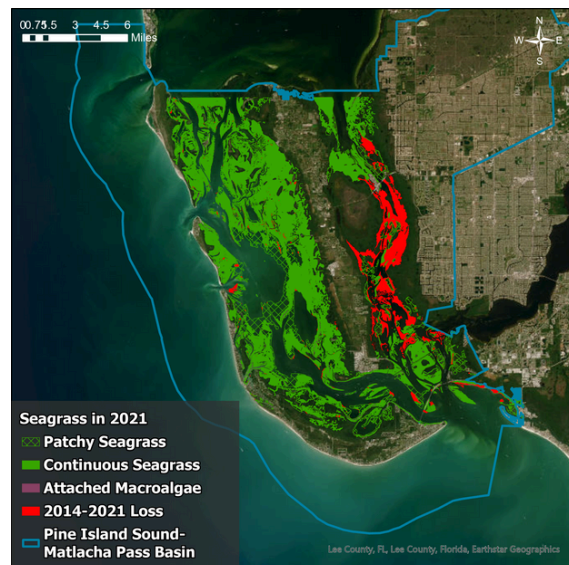
Seagrass beds provide many benefits. It is nursery habitat for fish and shellfish and it contributes to better water quality by trapping sediments, storing carbon, and filtering nutrients from stormwater runoff. Seagrass requires clean water and ample sunlight to grow, and therefore it is used by agencies and local governments as a way to measure water quality. This is documented in two ways:

- Mapping changes in seagrass acreage and location over time with aerial photography. This is valuable for estimating seagrass locations, acres and broad changes over time.
- On-the-ground monitoring of changes in species composition, estimation of bottom cover in a seagrass bed (abundance), and maximum depth in which seagrass can grow due to light availability and water clarity (deep edge). This monitoring works to characterize the density, complexity, and stability of those seagrass meadows.

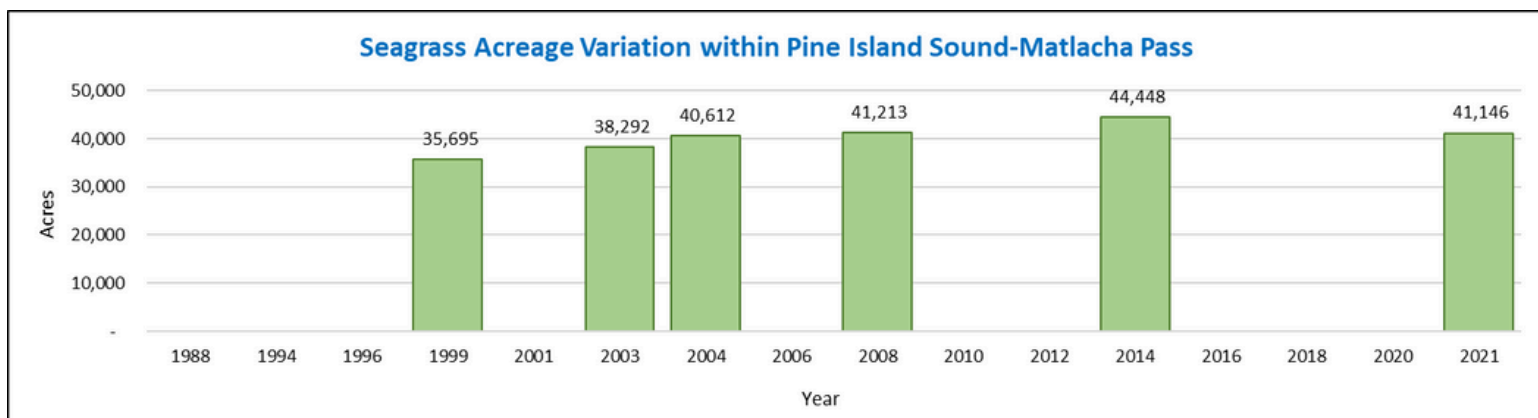
The graphs below depict results from seagrass mapping in Pine Island Sound, Matlacha Pass, and San Carlos Bay from 1999–2021. Due to tidal flushing in Pine Island Sound, which hosts the majority of the region's seagrass, acreages in this area have remained relatively stable over time. Note that consistent mapping of acreage and locations with aerial photography is needed at least every 3–4 years in order to evaluate trends in seagrass acreage. Between 2014 and 2021, Pine Island Sound/Matlacha Pass lost 3,302 acres of seagrass, representing a 7% loss overall. The reason for this decline is complex and likely involves several factors. This includes impacts from storm events such as Hurricane Irma, increased temperatures and rainfall, additional nutrient runoff from land, as well as prolonged red tide and algae blooms in the region. CHNEP continues to work with our partners to better understand causes and investigate solutions.

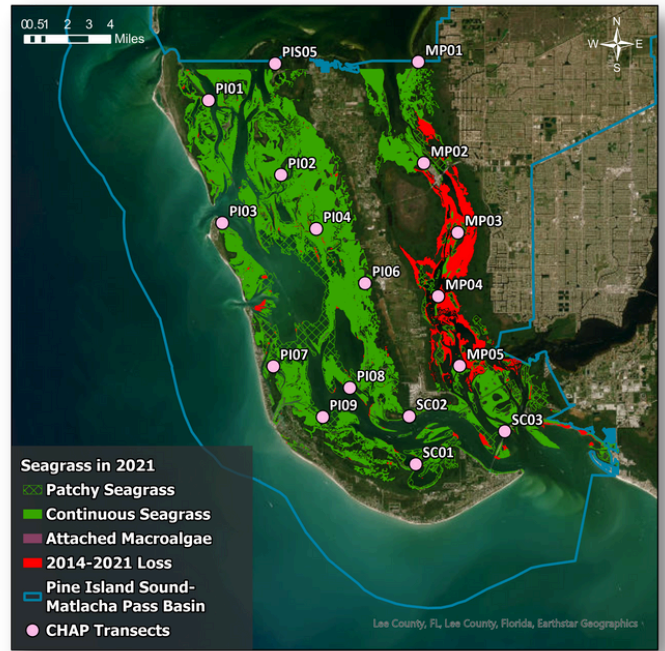
The bar graphs here depict the changes in presence of different species of seagrass found at monitored locations in the region. Since this region is so large, data shared in the graphs below are divided by two seagrass species at different monitoring locations in Pine Island Sound and Matlacha Pass for the years 2004-2024. Other types of seagrass are only found infrequently at these locations; there are not enough data to be graphed here.

Although both types of seagrass species experienced some declines at multiple monitoring locations starting as far back as 2016, numbers are relatively more stable in Pine Island Sound, which is mostly influenced by seawater from the nearby passes. Matlacha Pass (which receives freshwater flows from the Caloosahatchee River) has experienced more notable declines in seagrass in recent years due to a macroalgae issue (*Caulerpa fastigiata*).
