# 2019 Habitat Restoration Needs Plan

## PINE ISLAND/MATLATCHA PASS BASIN

### Section 4: Results, Recommendations, and Conclusions

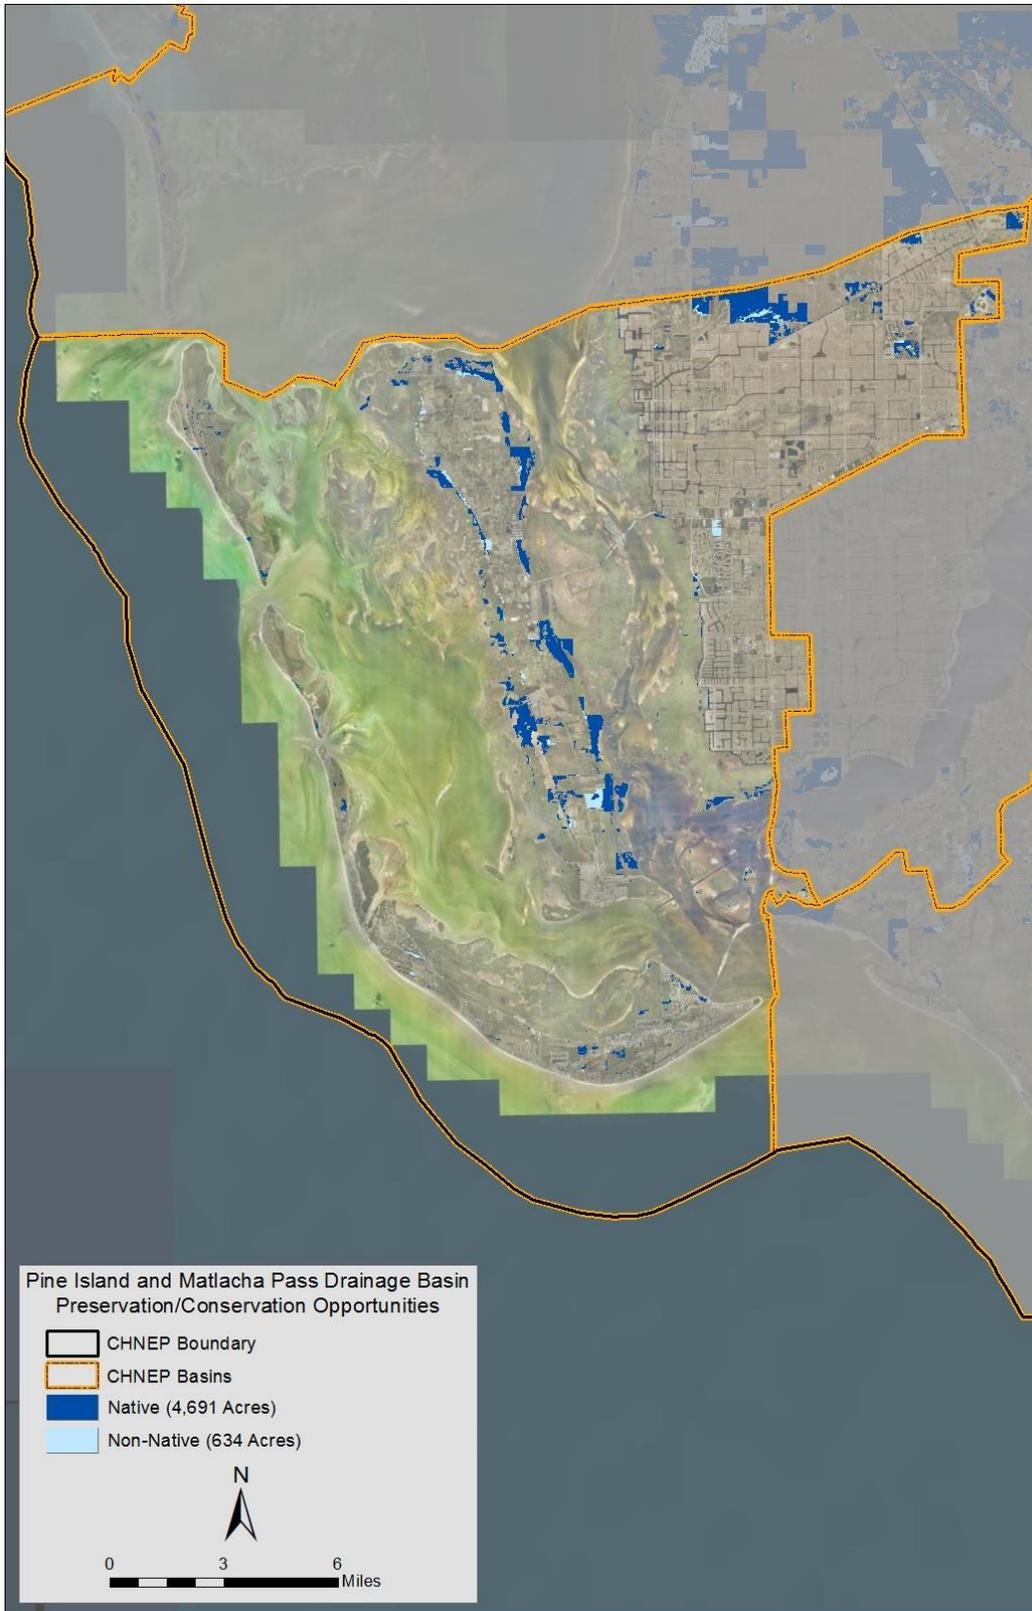
Figure 33. Pine Island/Matlacha Pass Basin PCO.

A total of 5,326 acres was identified for potential PCO within this basin. Twelve percent (634 acres) were categorized as non-native and 88 percent (4,691 acres) as native habitat (Table 19; Figure 33). Overall, the acreages identified constitute 2 percent of the total lands within the Pine Island/Matlacha Pass basin. The dominant native habitat community was classified as mangrove swamp which comprised 46 percent (2,435 acres) of all potential PCO acreages. Exotic species (285 acres; 5%) was identified as the major non-native habitat classification within the overall basin (Appendix E). Overall, the potential PCO were distributed around Pine Island for this basin (Figure 33).

\*See narrative for note on mapping classifications.

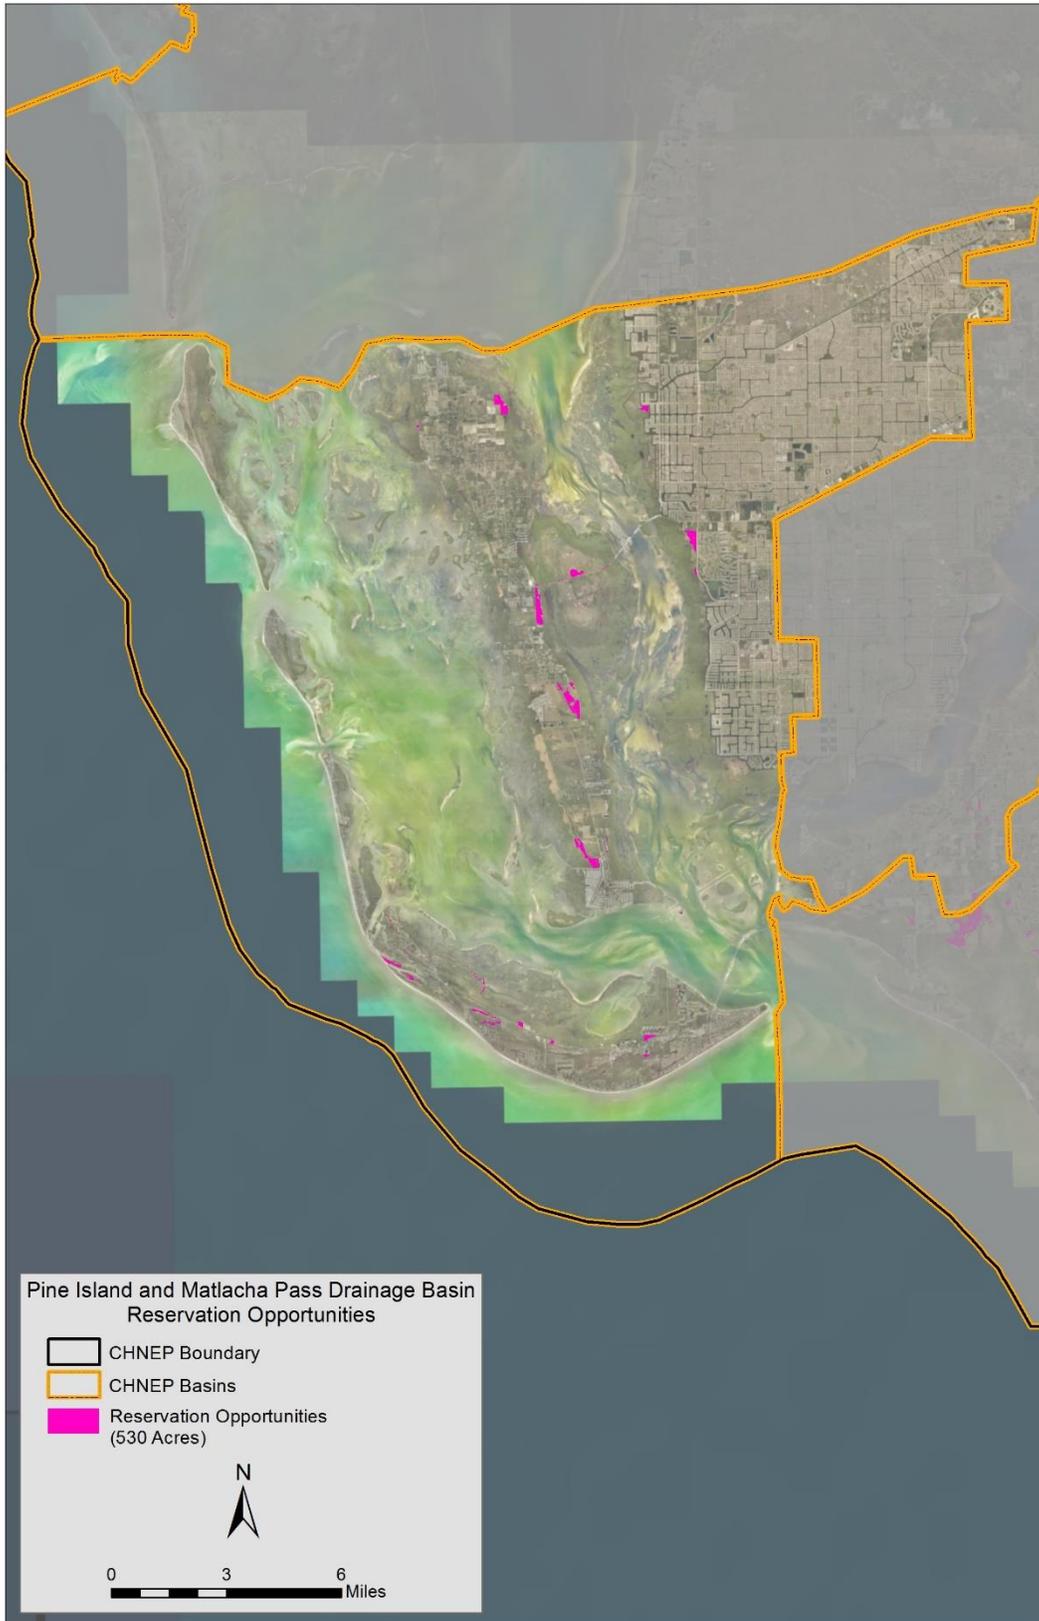
Figure 34. Pine Island/Matlacha Pass Basin RO.

A total of 530 acres was identified for potential RO (Table 19; Figure 34) within this basin. Overall, the acreages identified constitute less than one percent of the total lands within this basin. The dominant habitat community was classified as exotic species (416 acres; 79%) which consists of Brazilian pepper, Australian pine, and melaleuca; which could be recommended for invasive exotic removal programs (Appendix E). Potential RO were identified on Pine and Sanibel Islands (Figure 34).

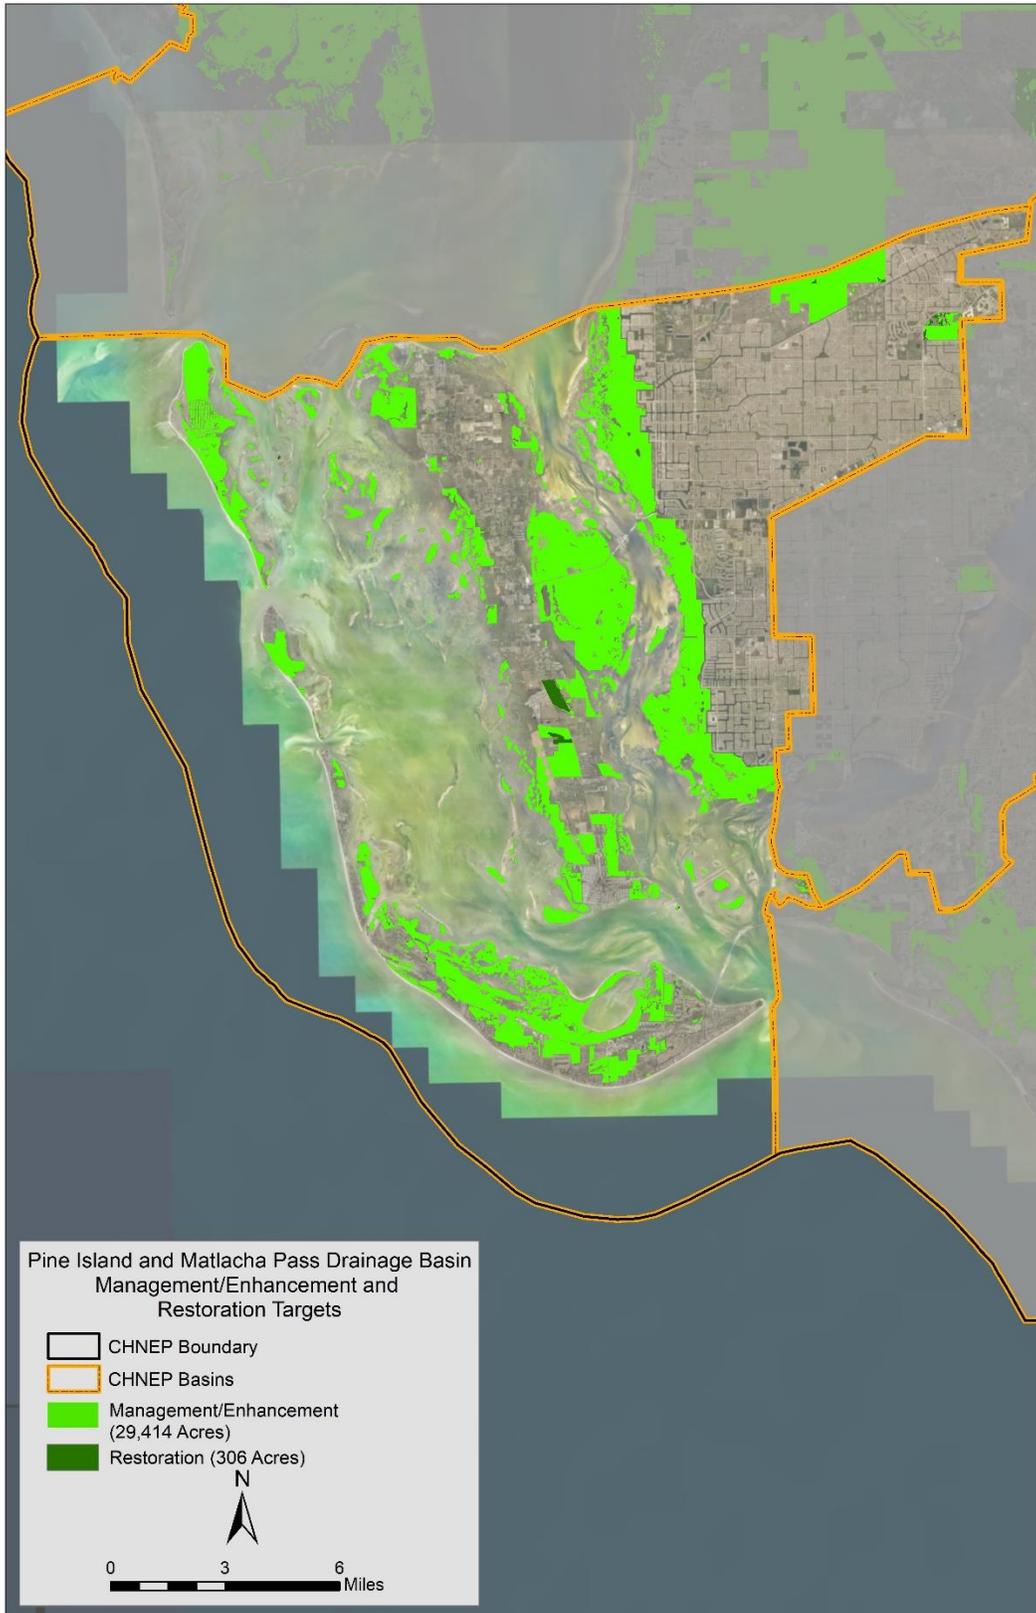
**Figure 35. Pine Island/Matlacha Pass Basin MET and RT.**

A total of 29,720 acres was identified as MET and RT within the Pine Island/Matlacha Pass basin. This includes 29,414 acres categorized for MET (99%) (Table 19; Figure 35). Overall, the acreages identified for MET and RT constitutes 12 percent of the total lands within the Pine Island/Matlacha Pass basin (Appendix E). MET were developed for the three major native habitat types: tidal wetlands, freshwater wetlands, and uplands, to distinguish the types of overall habitats that could be managed or enhanced (Table 19). The vast majority of MET within this basin are associated

with the Charlotte Harbor Preserve State Park and Ding Darling Wildlife Management Area (Figure 35).

A total of 29,720 acres was identified as RT and MET within the Pine Island/Matlacha Pass basin. This includes 306 acres (1%) identified as RT (Table 19; Figure 35). Overall, the acreages identified for RT and MET constitutes 12 percent of the total lands within the Pine Island/Matlacha Pass basin (Appendix E). RT were developed for the three major native habitat types: tidal wetlands, freshwater wetlands, and uplands, to distinguish the types of overall habitats that could be restored (Table 19). There are areas on Pine Island identified as non-native (RT) that are directly adjacent to native habitats. Identifying areas for strategic restoration could result in the further expansion of restored native habitat communities.

**\*See narrative for note on mapping classifications.**

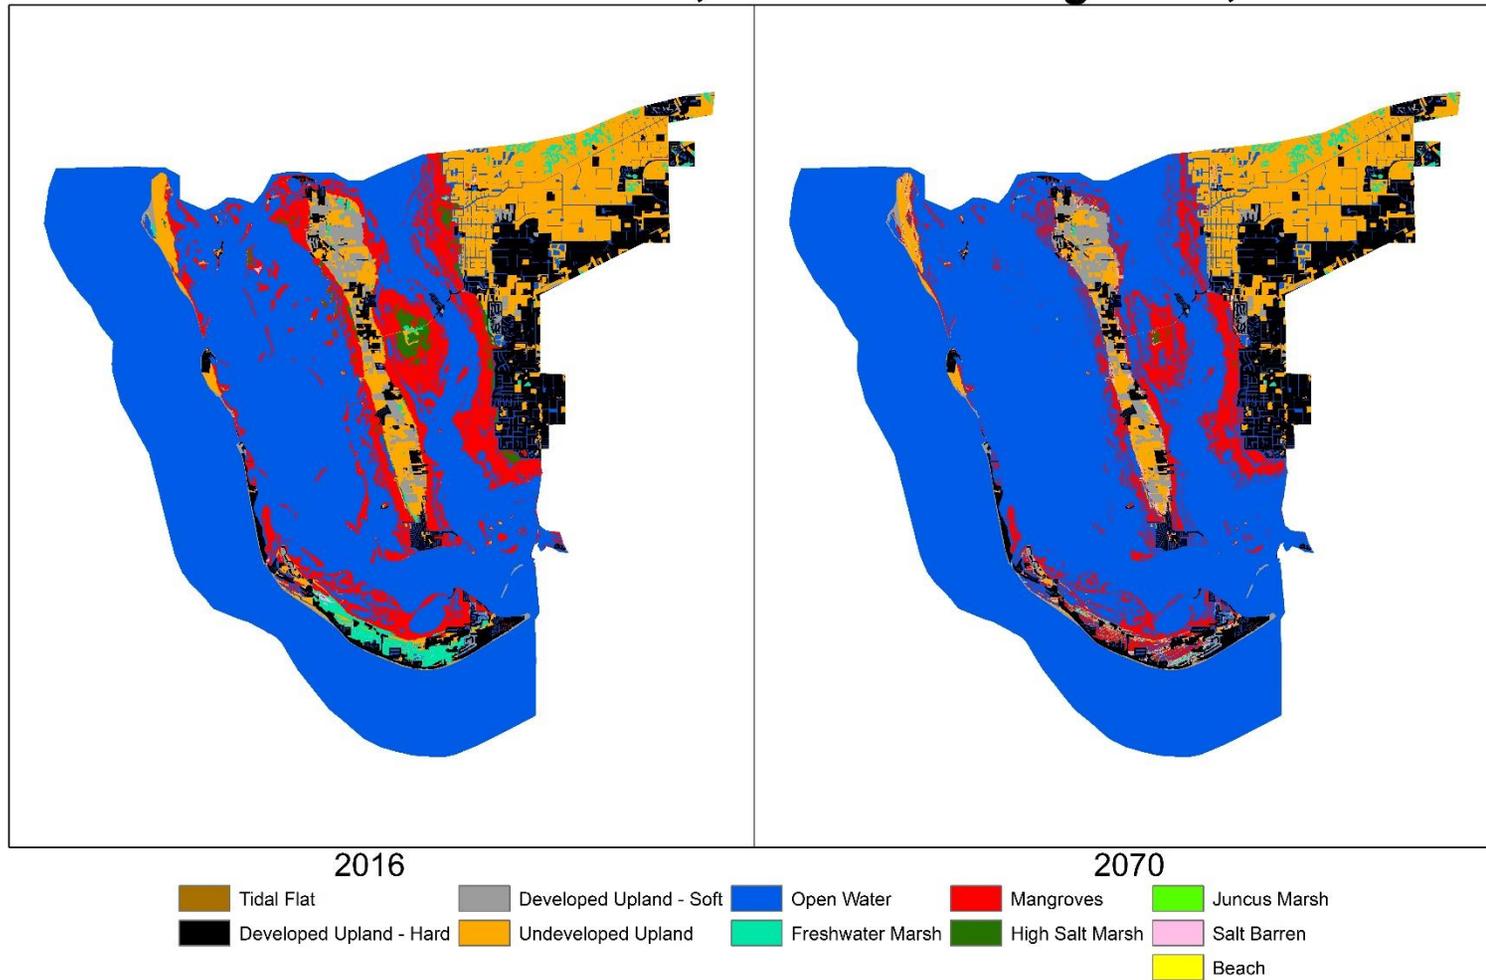
Figure 36. HEM Model Results for the Pine Island/Matlacha Pass basin.

The concept of reservation areas is to support potential tidal habitat migration caused by increased tidal flooding and inundation from projected sea level rise. As presented in Section 3 and Appendix B, a model was developed to project potential habitat migration in tidally influenced areas. The Pine Island/Matlacha Pass basin HEM map (Figure 36) illustrates model Run 3 (Intermediate-High Sea Level Rise, Low Accretion) for Years 2016 and 2070. The results illustrate an expansion of open water created by sea level rise, as well as the loss of mangroves and their migration higher in the landscape. Additionally, nearly all freshwater marsh predicted to be lost by 2070.

### Pine Island/Matlacha Pass - Run 3, Intermediate-High SLR, Low Accretion

PCO are generally limited in this basin due to existing development, the extent of MET and RT lands, and the extent of open water within this basin. The bulk of the identified PCO occur on Pine Island, and are predominantly tidal wetlands. RO are largely focused around Pine Island. The HEM shows dramatic migration and losses resulting from projected sea level rise including the loss of freshwater marsh areas within Ding Darling Wildlife Management Area, and open water areas expanded throughout Pine Island Sounds and Matlacha Pass. This basin supports relative large Restoration/Management lands relative to its size. The MET and RT include Little Pine Island, the southern limits of Charlotte Harbor Preserve State Park, and Ding Darling Wildlife Management Area. In total, there is 29,414 acres of MET, and a relatively small 305 acres of RT that are predominantly uplands.
