2013 Volunteer Tidal Shoreline Survey

Charlotte Harbor National Estuary Program

Technical Report 13-2

August 19, 2013

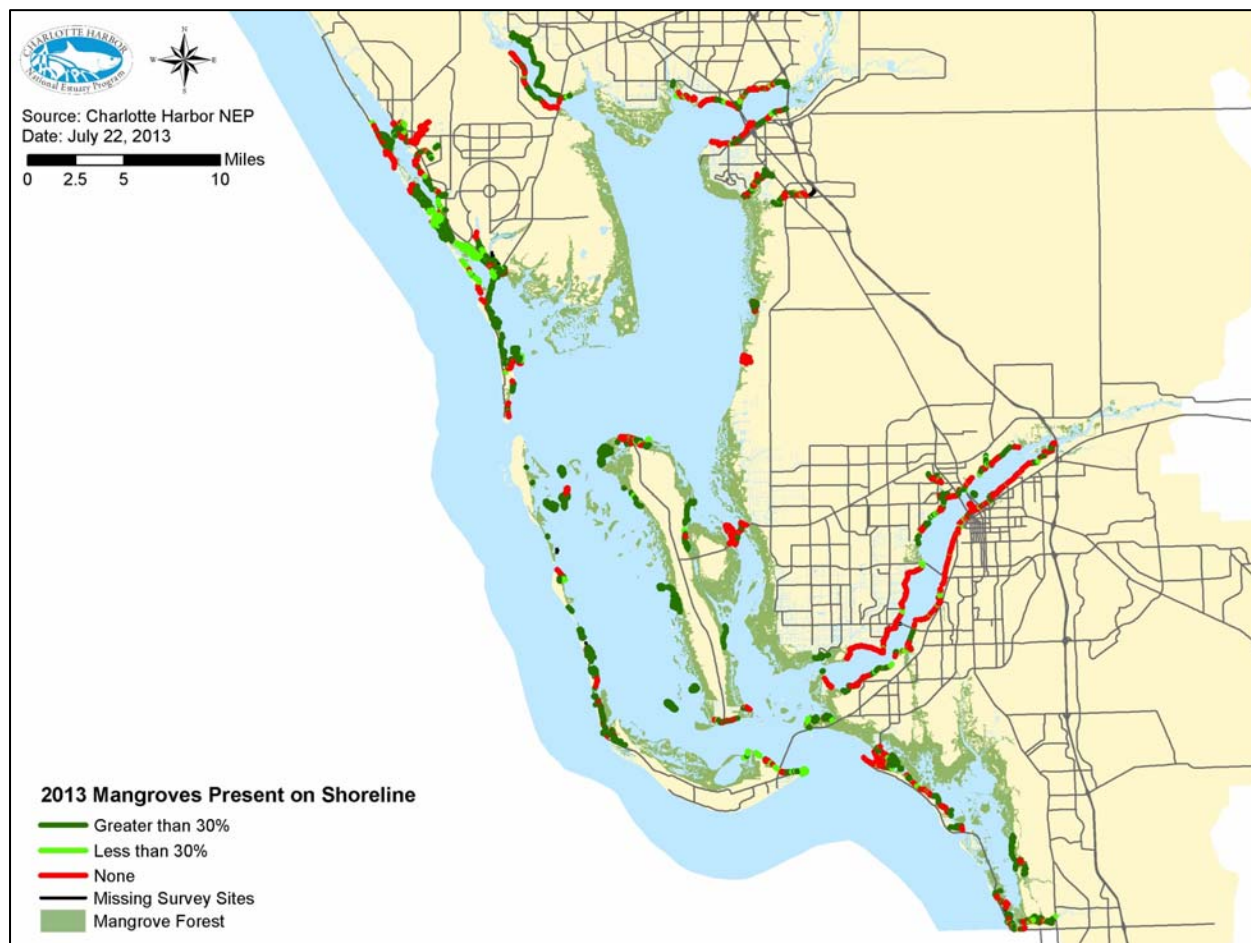
In 2013, 238 of 246 miles of shoreline were surveyed for mangrove presence. One-hundred twenty-four miles (52%) of urban shoreline had a greater than 30% mangrove extent. Since only 34% of parcels had greater than 30% mangrove, larger parcels continued to be more likely to have greater than 30% mangrove extent than smaller parcels. Conversely, 85 miles of urban shoreline (36%) had no mangroves present while 52% of parcels had no mangrove present.

2013 Mangroves	Sum of Miles	Percent of Miles	Number of Parcels	Percent of Parcels
Greater than 30%	124	52.0%	1,812	33.5%
Less than 30%	29	12.1%	786	14.5%
None	85	35.8%	2,817	52.0%
Total	238		5,415

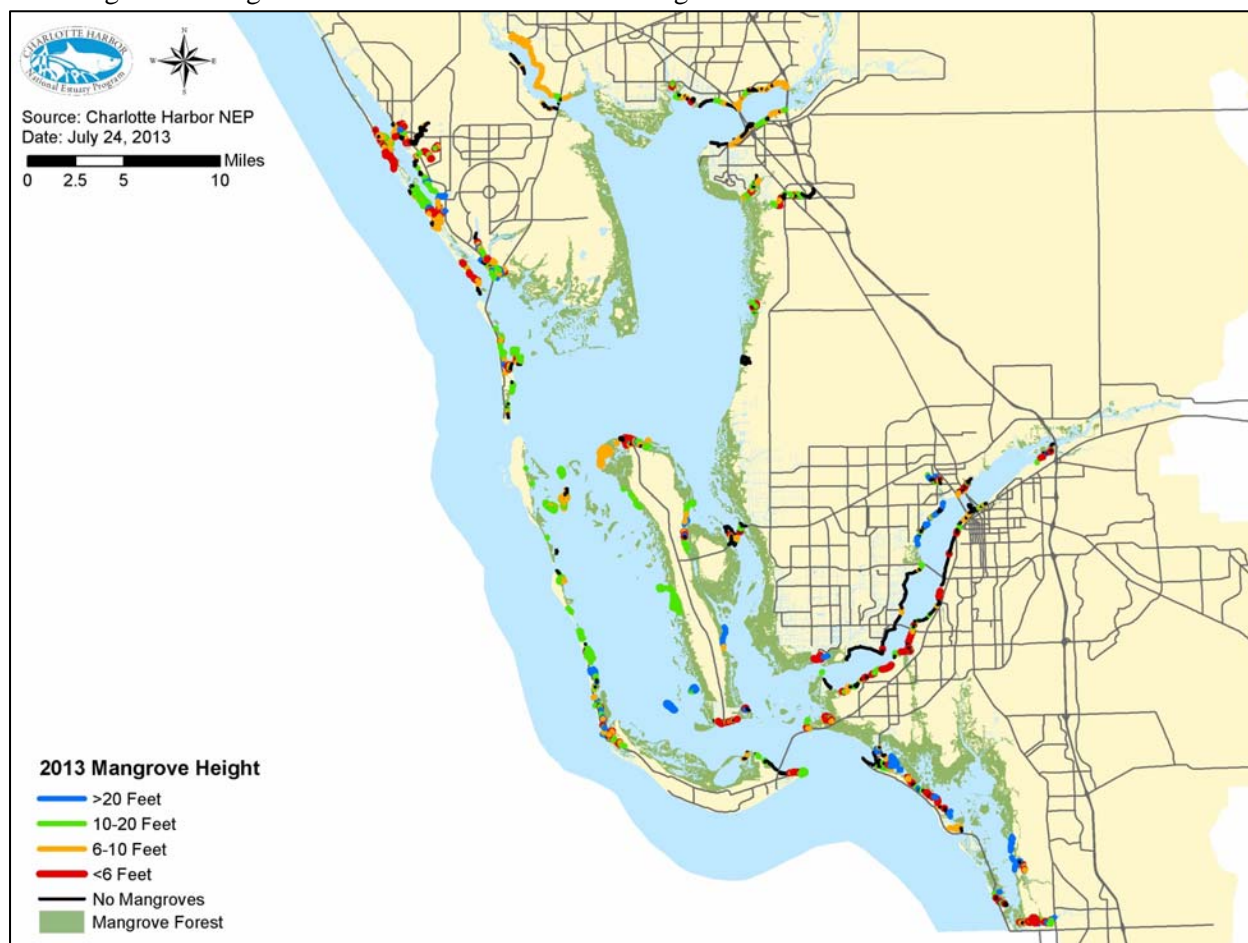
In 2013, 198 miles were assessed for mangrove height of the 238 miles surveyed for mangrove presence. Lack of mangrove presence was identified for 85 miles of shoreline compacted to no mangroves for 77 miles for trimming assessments. Differences are consistent between mangrove presence which gained for the Google Earth augmentation and the field verified height information.

Seventy miles (35%) of urban shoreline had mangroves of 10 feet or greater in height. Since only 17% of parcels had mangroves of 10 feet or greater in height, larger parcels were more likely to have taller mangrove than smaller parcels. A similar percentage between miles (26%) and parcels (28%) had mangroves of 10 feet or less in height.

2013 Mangrove Height	Sum of Miles	Percent of Miles	Number of Parcels	Percent of Parcels
>20 Feet	21	10.4%	194	4.5%
10-20 Feet	49	24.8%	546	12.6%
6-10 Feet	38	19.0%	752	17.4%
<6 Feet	14	7.0%	440	10.2%
No Mangroves	77	38.8%	2401	55.4%
Total	198		4,333

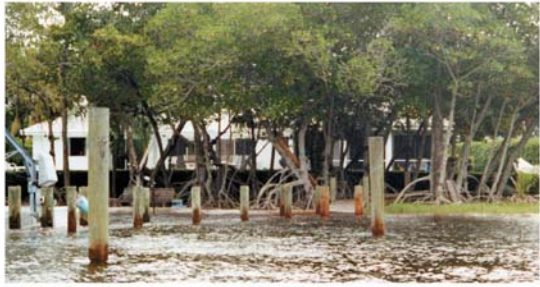
Undercutting: This is the trimming of the lower portion of a tree. Undercutting as it is sometimes called, may provide a view lower than 6 feet through a taller tree but young plants that grow up through that viewing area can not be trimmed until they exceed 6 feet. The results will be similar to window trims with a lower view at 6 feet. Recruiting young plants (those colonizing under established trees) also should not be pulled out of the ground. This activity technically is a form of alteration and requires a permit.

Whatever style of trimming you choose, consider a style that can be maintained with the least loss of leaves resulting from the trimming activity. Mangrove leaves are an important source of nutrients for the smaller animals of the marine food chain, including sea grass and coral reef communities. Leaves that die naturally on the tree and then fall into the water are much more quickly biodegraded and available as a food source than healthy leaves cut from the tree. Fresh cut green leaves will stay mostly intact lying on the substrate for months before total leaf breakdown.

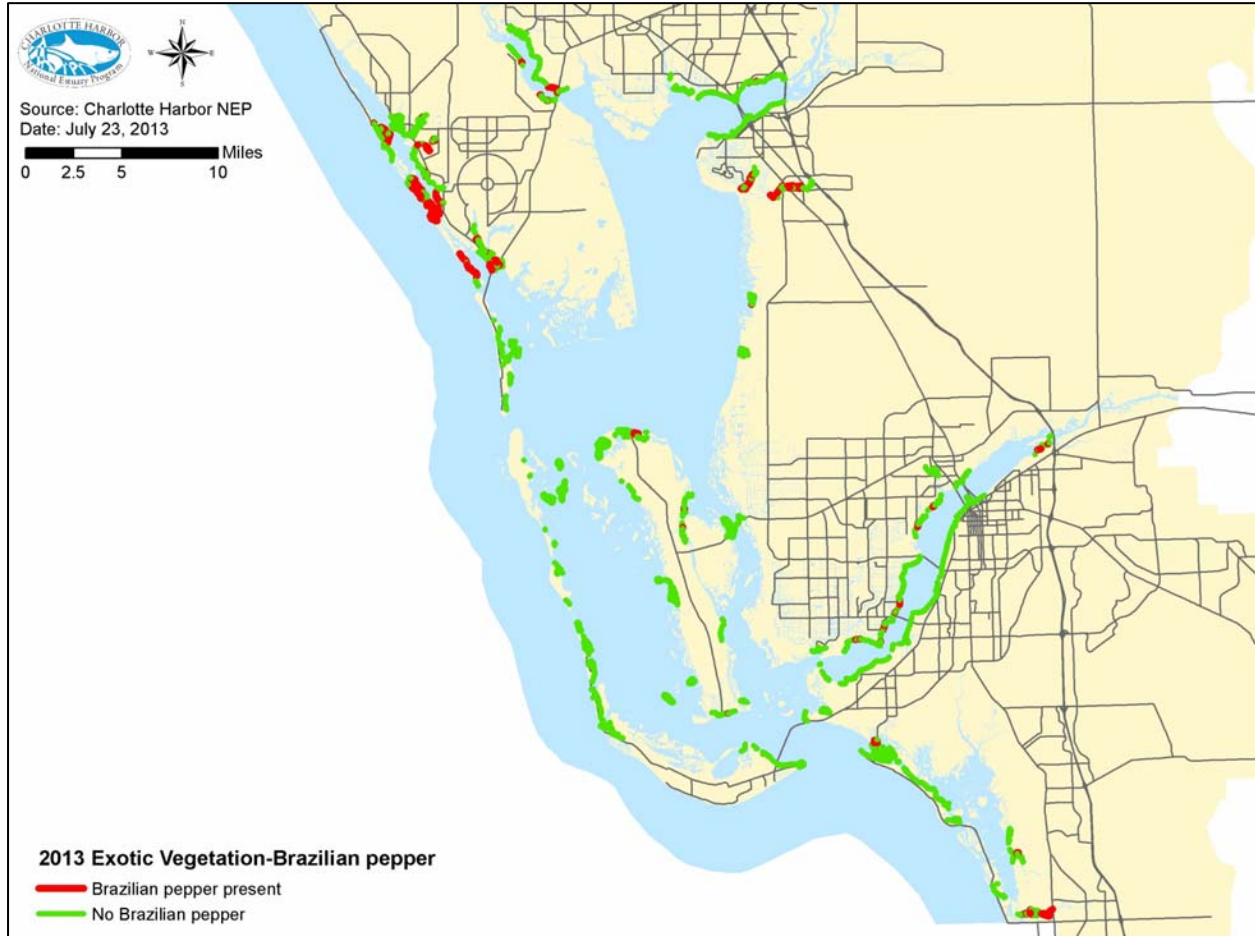
Maps of exotic vegetation presence were prepared for 2013 only. Brazilian pepper has the greatest extent of all species of invasive exotic vegetation on urban shorelines. It is particularly problematic on Lemon Bay, Alligator Creek and Imperial River.

2013 Brazilian Pepper	Sum of Miles	Percent of Miles	Number of Parcels	Percent of Parcels
Yes	24	12.4%	479	11.1%
No	173	87.6%	3,854	88.9%
Total	198		4,333

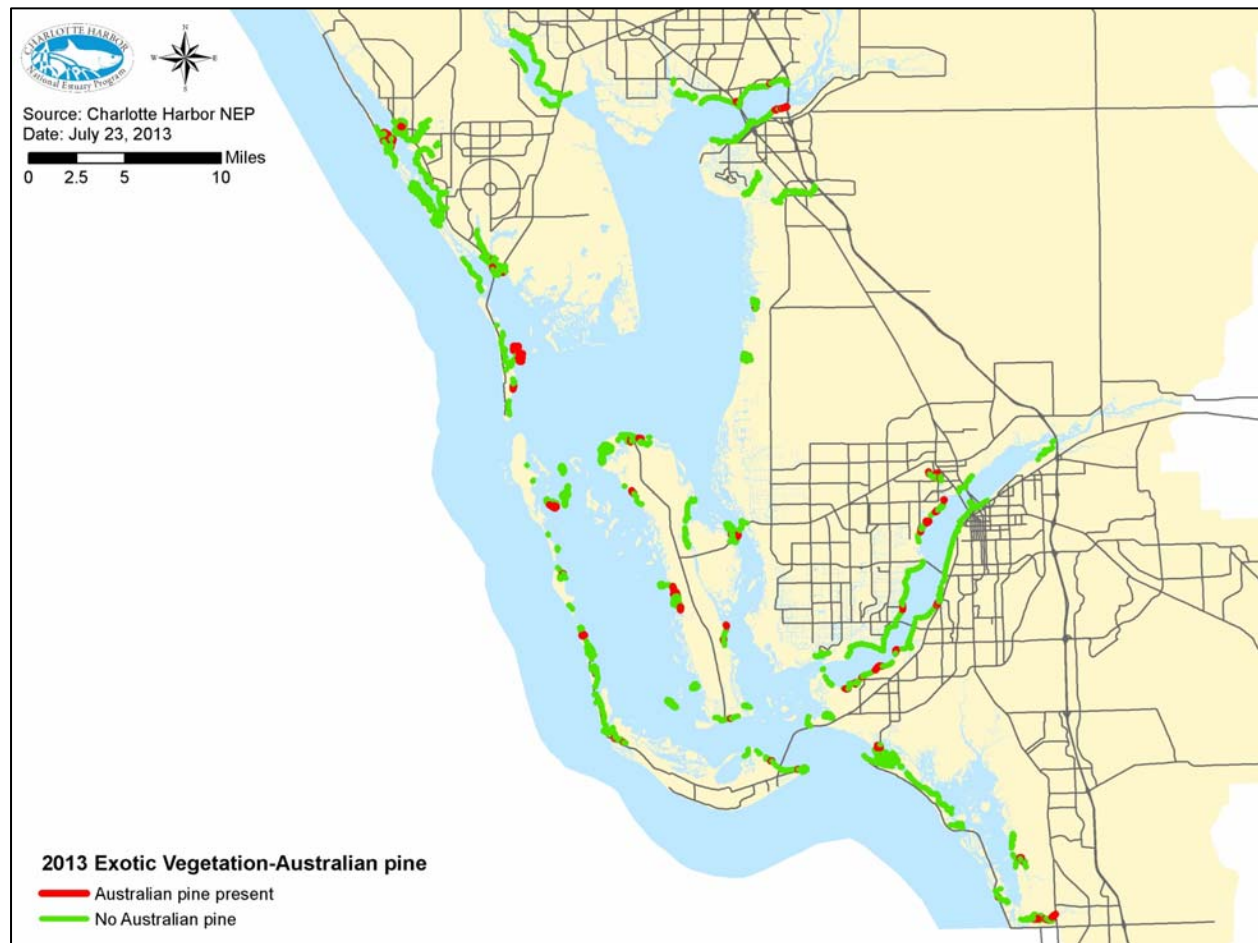
Australian pine has the second greatest extent on urban shorelines throughout the estuarine areas of the CHNEP study area.

2013 Australian Pine	Sum of Miles	Percent of Miles	Number of Parcels	Percent of Parcels
Yes	15	7.7%	125	2.9%
No	183	92.3%	4,208	97.1%
Total	198		4,333

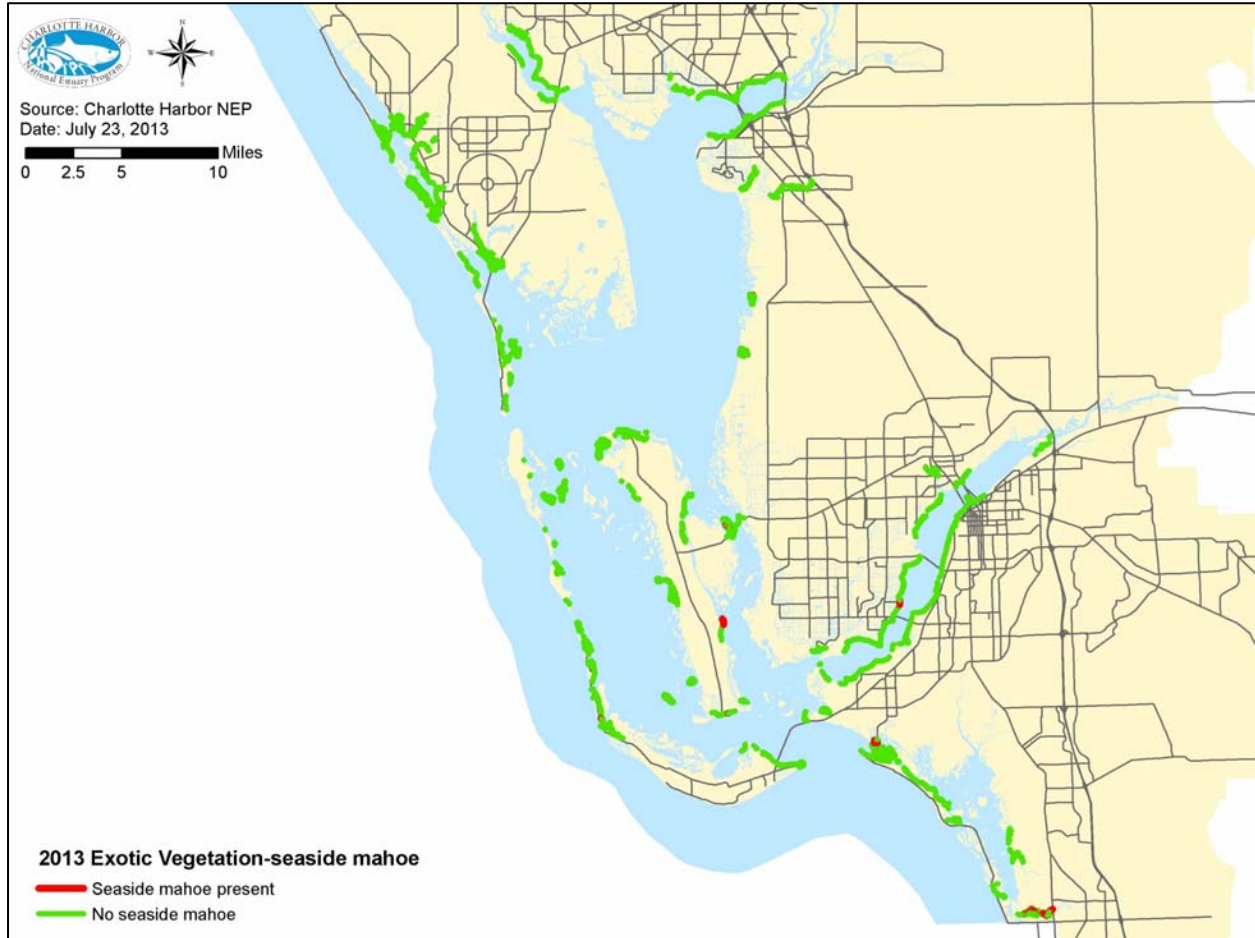
Seaside mahoe is present within the southern portion of the CHNEP study area.

2013 Seaside Mahoe	Sum of Miles	Percent of Miles	Number of Parcels	Percent of Parcels
Yes	2	1.2%	29	0.7%
No	196	98.8%	4,304	99.3%
Total	198		4,333

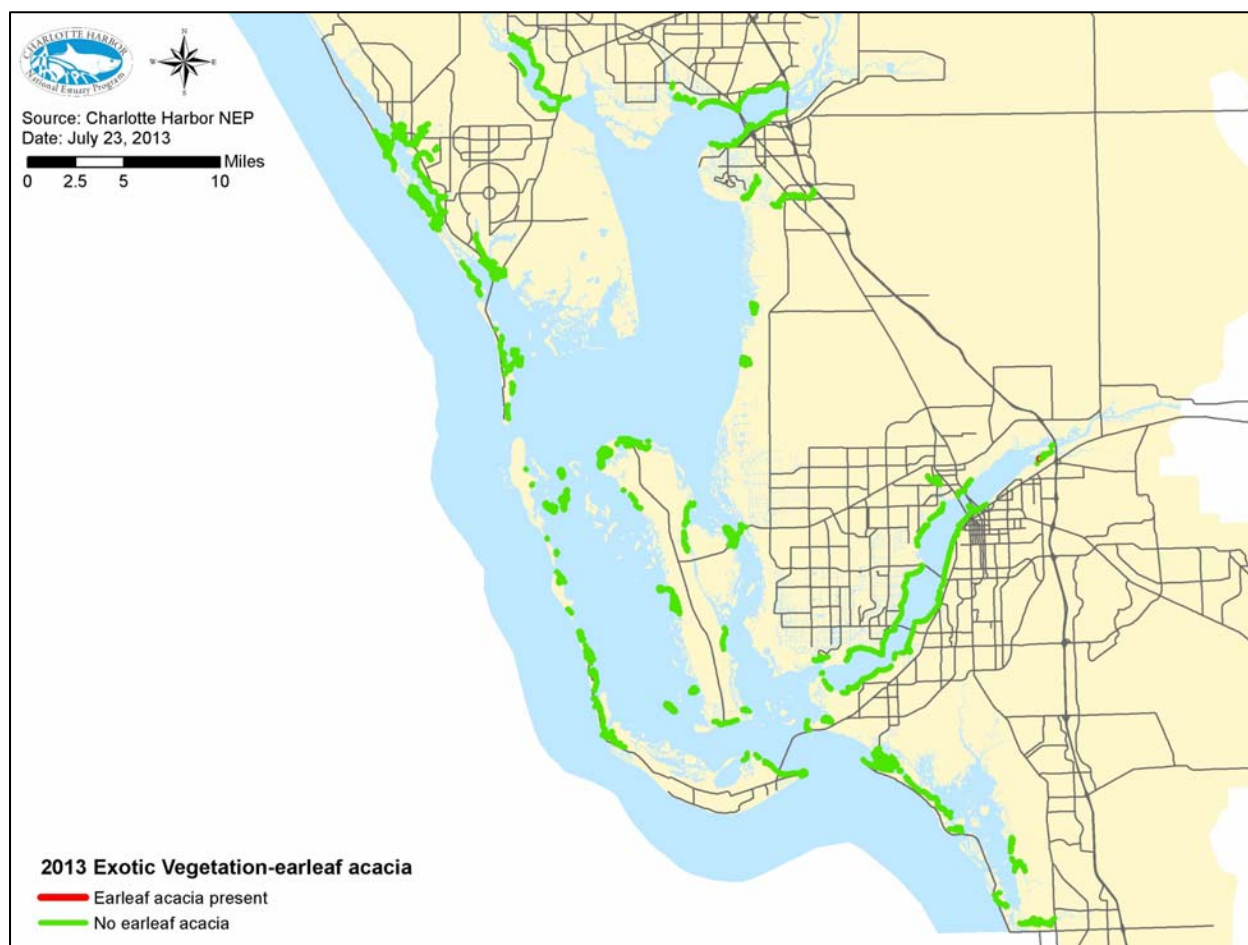
Earleaf acacia was found on only one parcel and does not appear problematic on tidal shorelines in the CHNEP study area.

2013 Earleaf Acacia	Sum of Miles	Percent of Miles	Number of Parcels	Percent of Parcels
Yes	0	0.0%	1	0.0%
No	198	100.0%	4,332	100.0%
Total	198		4,333
