Lower Charlotte Harbor Flatwoods Strategic Hydrologic
Restoration Plan

Lower Charlotte Harbor Flatwoods Hydrologic Modeling/Planning Project

Technical Memorandum – Task 3c Mapping Historic Hydropatterns

To: Jennifer Hecker, Nicole Iadevaia, CHNEP
From: Roger Copp and Kirk Martin, P.G., Water Science Associates
Date: August 30, 2021
Re: Mapping Historic Hydropatterns

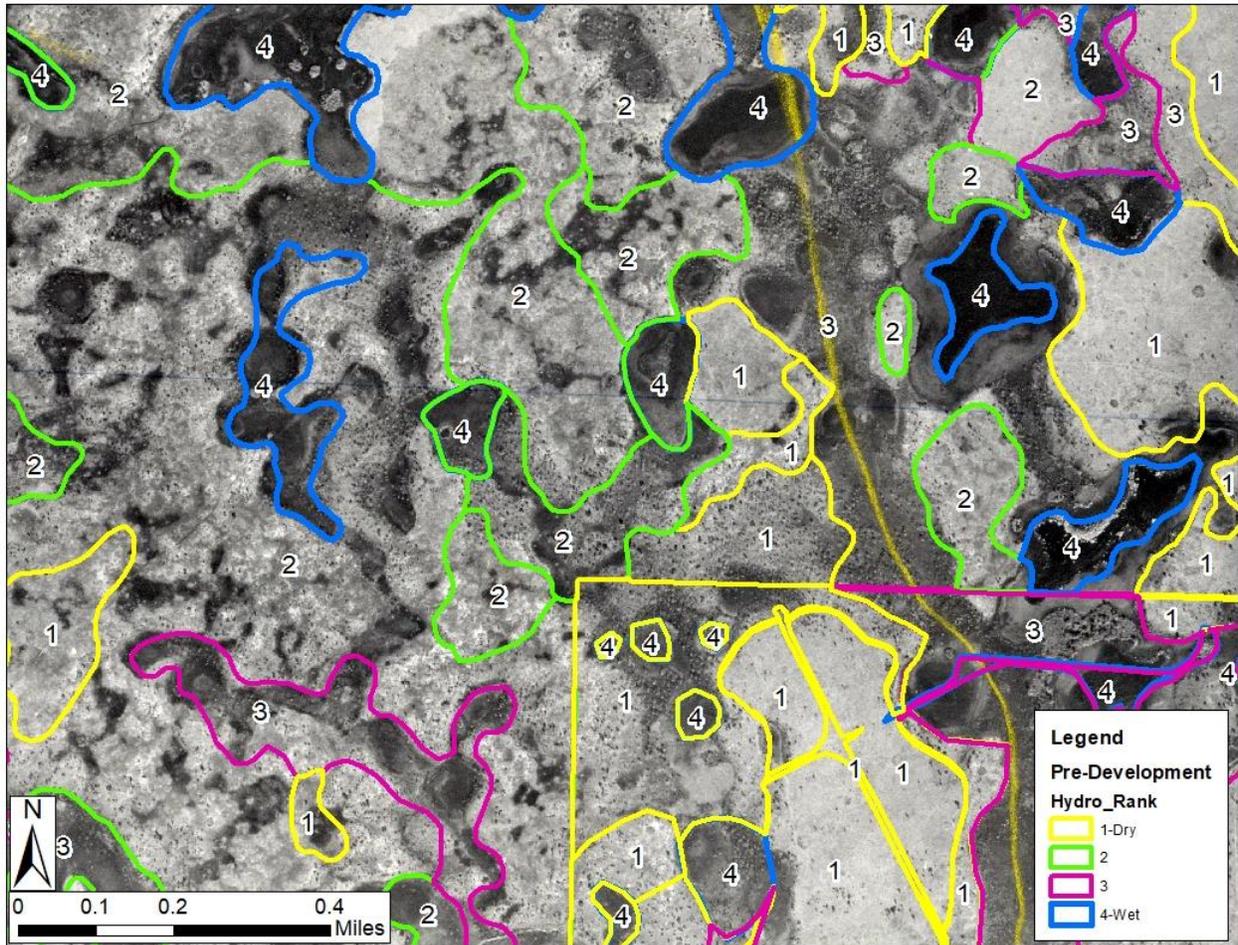
Figure 1 – Geo-referenced 1950's Aerial Photographs of South Yucca Pens and Hydrologic Rank Assignments

Hydrologic rank was also based on visual signatures evident in the historic aerial photographs, such as grayscale. Dark areas were frequently observed along known creeks or flow-ways. Areas assigned Hydrologic Rank 3 based on information in the SSURGO database were typically slightly less dark. Areas assigned Hydrologic Rank 2 typically had a mix of light and dark colored areas, and areas assigned Hydrologic Rank 1 typically had light grey shading. **Figure 1** illustrates geo-referenced aerial photographs and hydrologic rank for a portion of southern Yucca Pens.

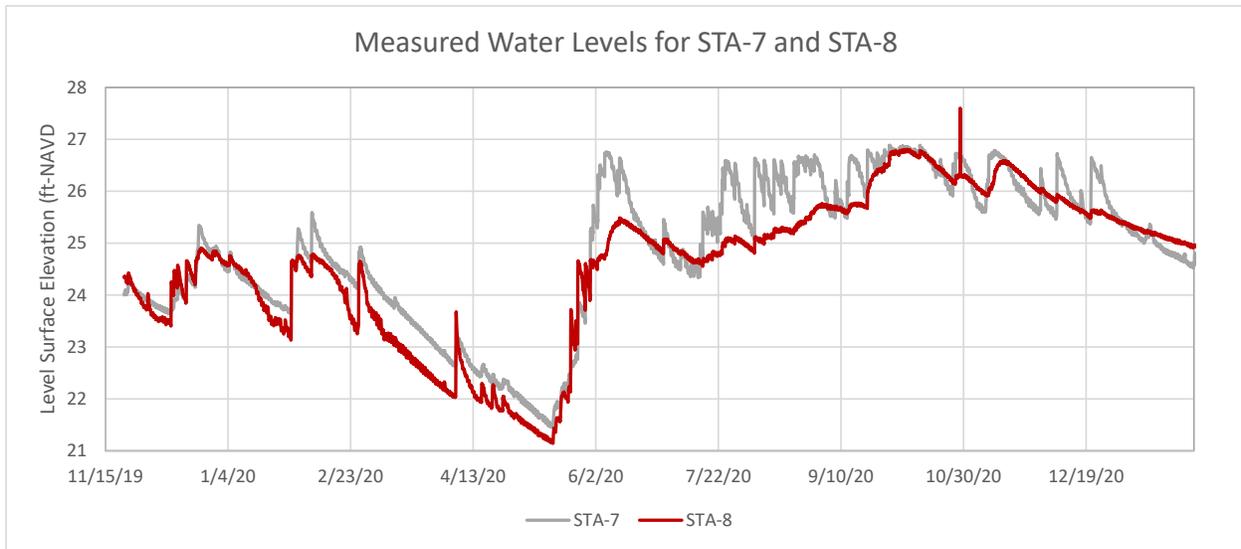
Figure 2 – Measured Water Elevations for Monitoring Stations STA-7 and STA-8

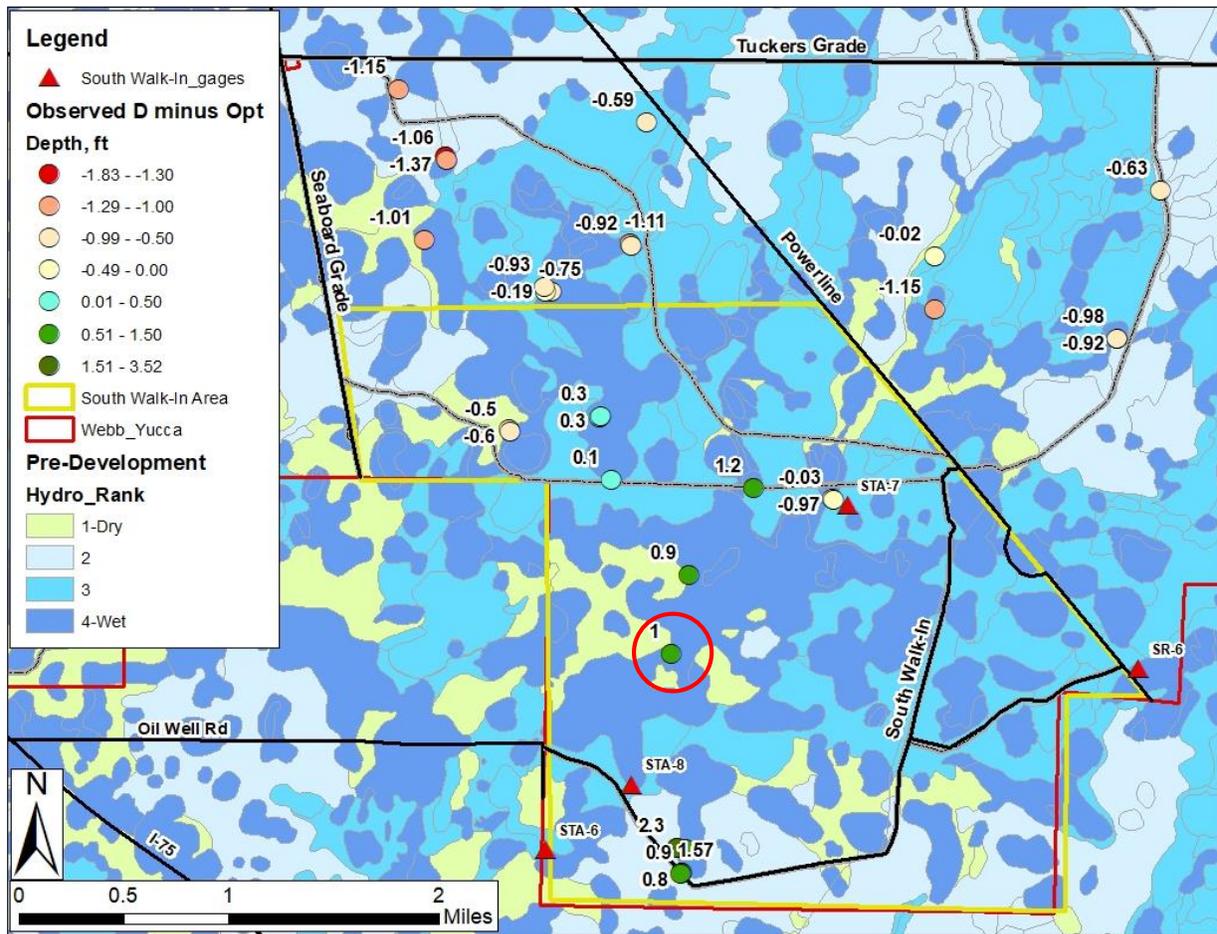
Figure 3 – Comparison of Predevelopment Hydrologic Rank and 2020 Observed Average Wet Season Water Depths for Southwestern Portion of Babcock Webb. (In the legend, dots ranging from green to light blue indicate existing depths (ft) exceed optimum depths)

Note: In the Figure 3 Legend, “Observed D minus Opt Depth” is Observed Depth minus Optimum Depth, which is equal to Average 2020 Wet Season Water Depth minus Optimum Depth. For example, see point in red circle above in **Figure 3**. Avg 2020 Wet Season Depth = 2.5 ft. Hydro Rank is 4, so optimum depth is 1.5 feet. Therefore, Observed Depth minus Optimum Depth = 1 ft

Babcock Webb. Vegetation indicator points in Babcock Webb located within the South Walk-In Area presented in **Figure 2** generally had higher water depths than optimum water depths. Of the 14 points within the South Walk-In Area, 10 locations had observed water depths higher than optimum with exceedances ranging from 0.3 to 1.6 feet (mean = 0.6 feet). The four locations with 2020 observed water depths less than optimum were in the northern portion of the South Walk-In Area, and those points were evaluated in September 2020, when it was drier than typical wet season conditions. As referenced above, since drier than average wet season conditions were encountered in 2020, data from STA-7 and 8 were used to determine for the South Walk-In Area rather the water depths measured at each vegetation indicator location because of varying hydrologic conditions in the South Walk-In Area during 2020.

Babcock Webb. The southwest portion of Babcock Webb WMA has water depths deeper than optimum conditions. Restrictions to historic flow-ways west of Babcock Webb are the primary cause for the flooding of southwest Babcock Webb. Areas north of the South Walk-In Area (identified in **Figure 3**) do not show water depths above optimum conditions, however this area could be evaluated further to confirm they do not warrant restoration measures, during a typical wet season.

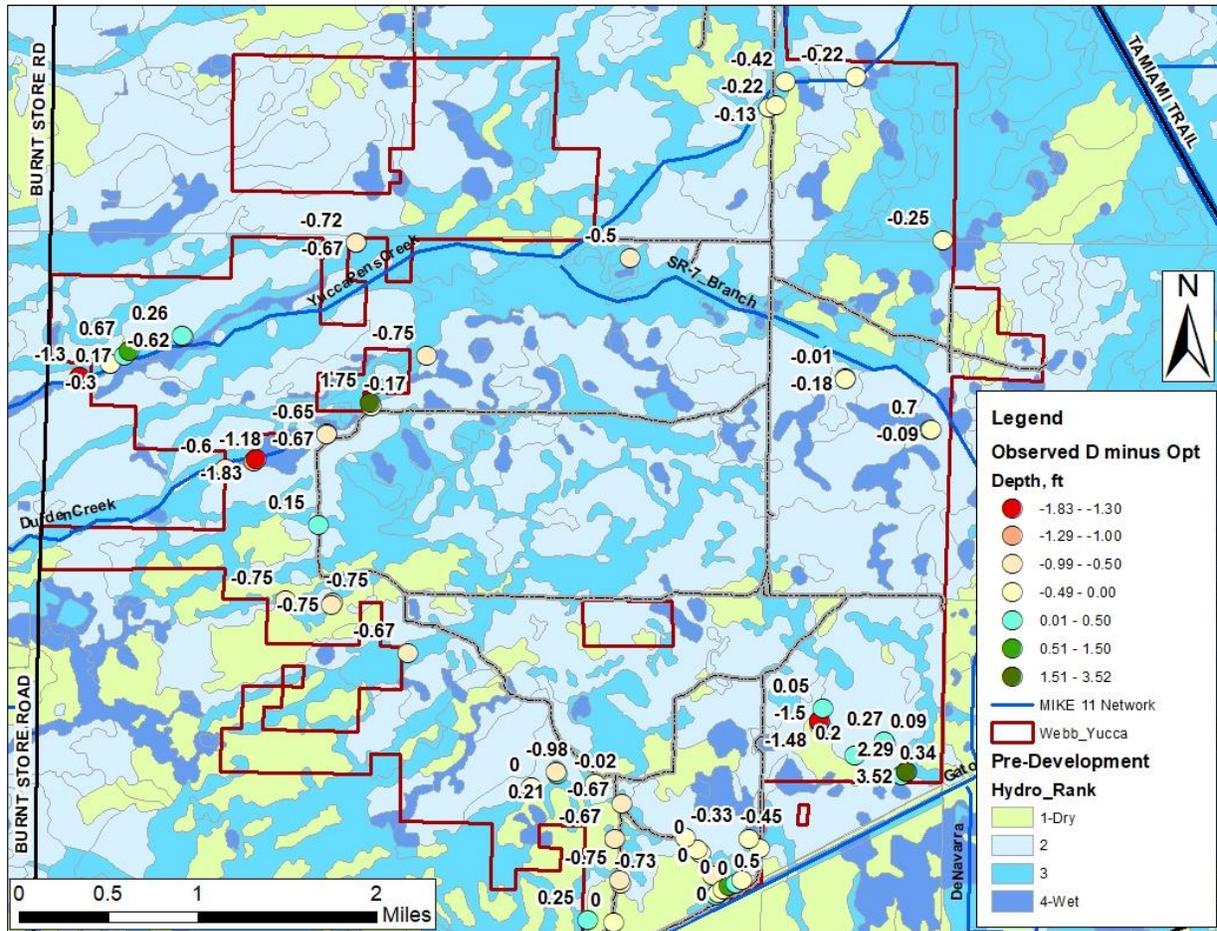
Figure 34– Comparison of Predevelopment Hydrologic Rank and 2020 Observed Average Wet Season Water Depths for Yucca Pens (yellow to red dots indicate existing depths are less than optimum depths)

Yucca Pens. Yucca Pens 2020 observed wet season average water depths more representative of a typical wet season due to different rainfall patterns. Yucca Pens 2020 observed wet season average water depths were drier than optimum conditions at 60% of the vegetation stations and the average difference was -0.62 feet (observed depth was 0.62 feet lower than optimum average wet season water depths) (see **Figure 4**). The locations where water depths were higher than optimum were found in areas where roads have impounded outflows, such as the southeastern portion of Yucca Pens and Yucca Pens north of Zemel Road (see **Figure 5**). The greatest negative deviations from optimum wet season water depth (areas that were drier than optimum) were located on the southern and western areas of Yucca Pens most pronounced in proximity to the boundaries, suggesting that drainage has a significant impact on wetland hydrology in Yucca Pens. The predominance of negative values (indicating observed 2020 average wet season water levels were less than optimum levels) shown in **Figure 6** supports this conclusion.

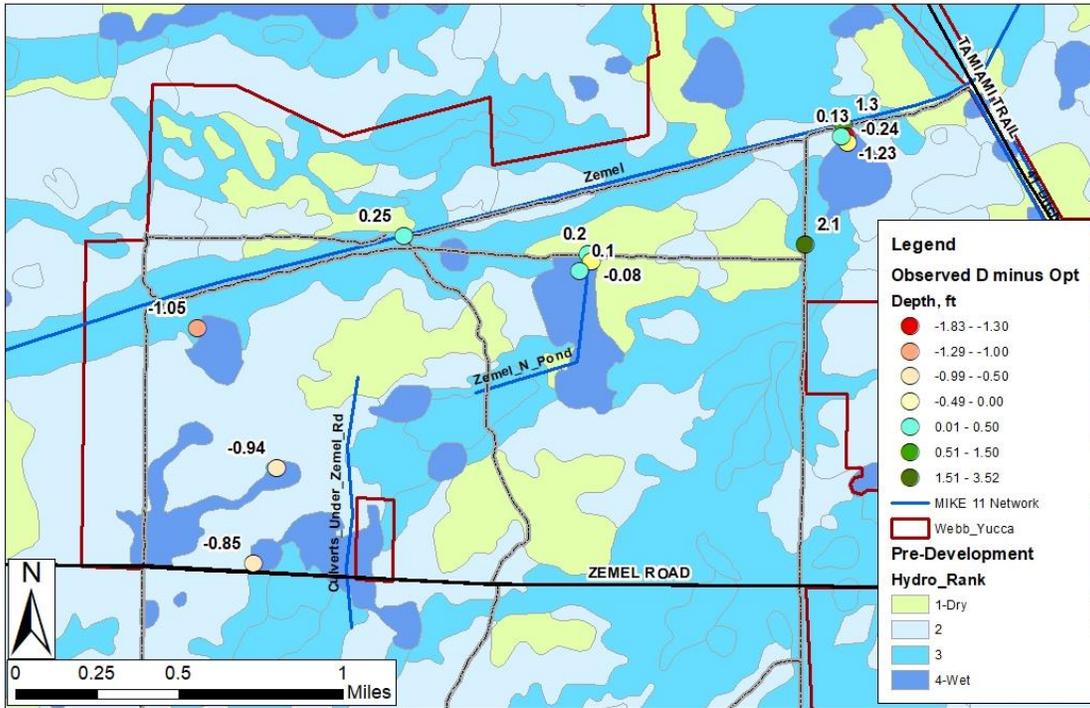
Figure 5 – Comparison of Predevelopment Hydrologic Rank and 2020 Observed Average Wet Season Water Depths for Northern Portion of Yucca Pens (yellow to red dots indicate existing depths are less than optimum depths)

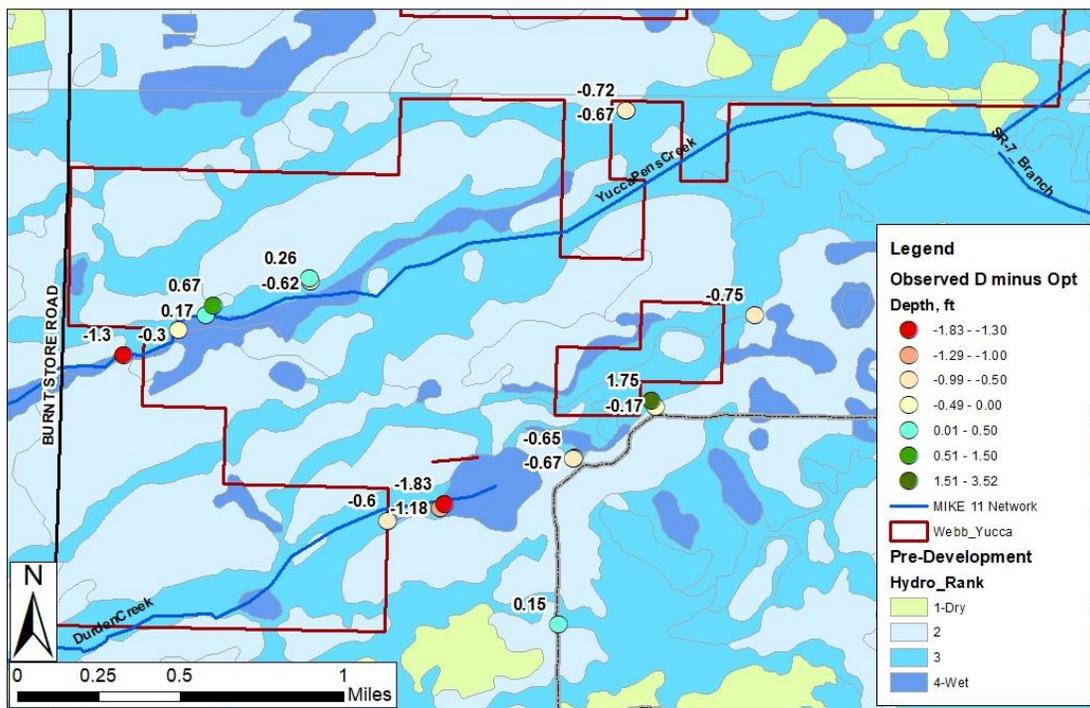
Figure 6 – Comparison of Predevelopment Hydrologic Rank and 2020 Observed Average Wet Season Water Depths for the Yucca Pens and Durden Creek portion of Yucca Pens (yellow to red dots indicate existing depths are less than optimum depths)

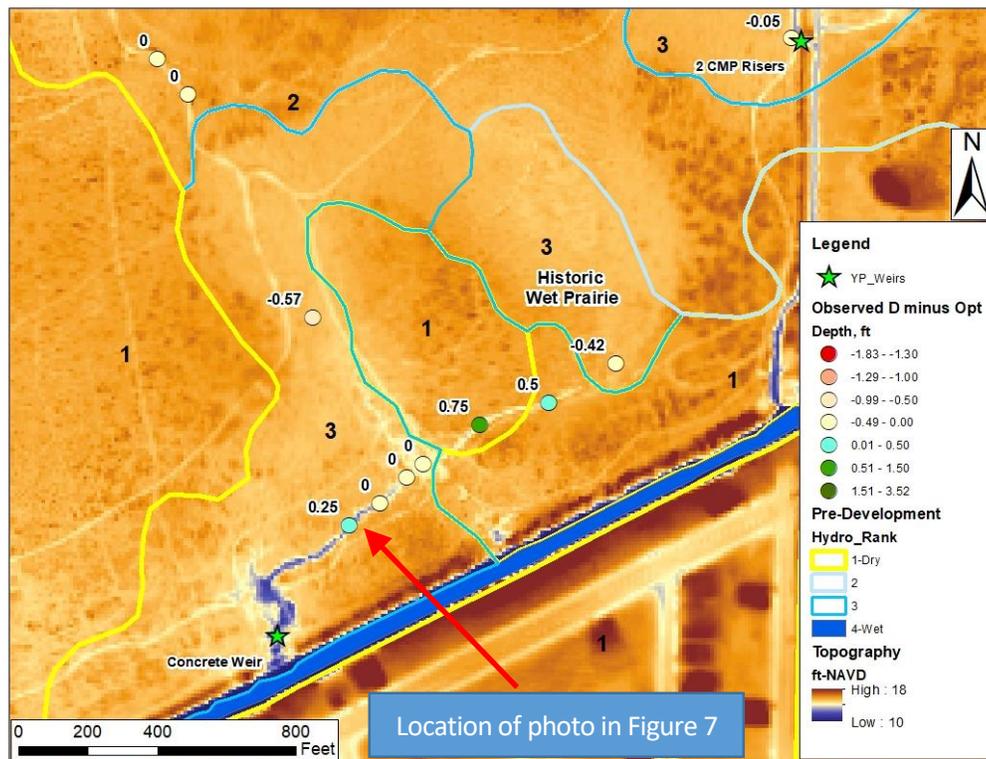
Figure 7a – Topography, Hydrologic Rank Coverage, and Deviations from Optimum Water Depth for South Yucca Pens

A detailed view of the portion of Yucca Pens immediately north of Gator Slough is presented in **Figures 7a and 7b**. Existing topography with current aerial photograph in **Figure 7a** illustrates a channel (blue band) draining west from a shallow depression classified as a **historic wet prairie**. **Figure 7b** illustrates the same area with 1950's-era aerial photograph that clearly suggests the historic presence of wetland conditions in the area identified as a historic wet prairie. The vegetation assessment point (yellow dot, value -0.42 feet) within the historic wet prairie indicated existing water depths at less than optimum conditions. Other points along the channel were either similar to or higher than optimum conditions because they were located within the channel (concentrated flows within the erosion feature). **Figures 8a and 8b** present dry and wet season photographs of this erosion feature. It is located upstream of an existing concrete weir constructed by FWC in 2014-2015. This channel currently is draining the historic wet prairie, and along with other eroded ATV trails, contributes to the low water levels throughout the southern portion of Yucca Pens.

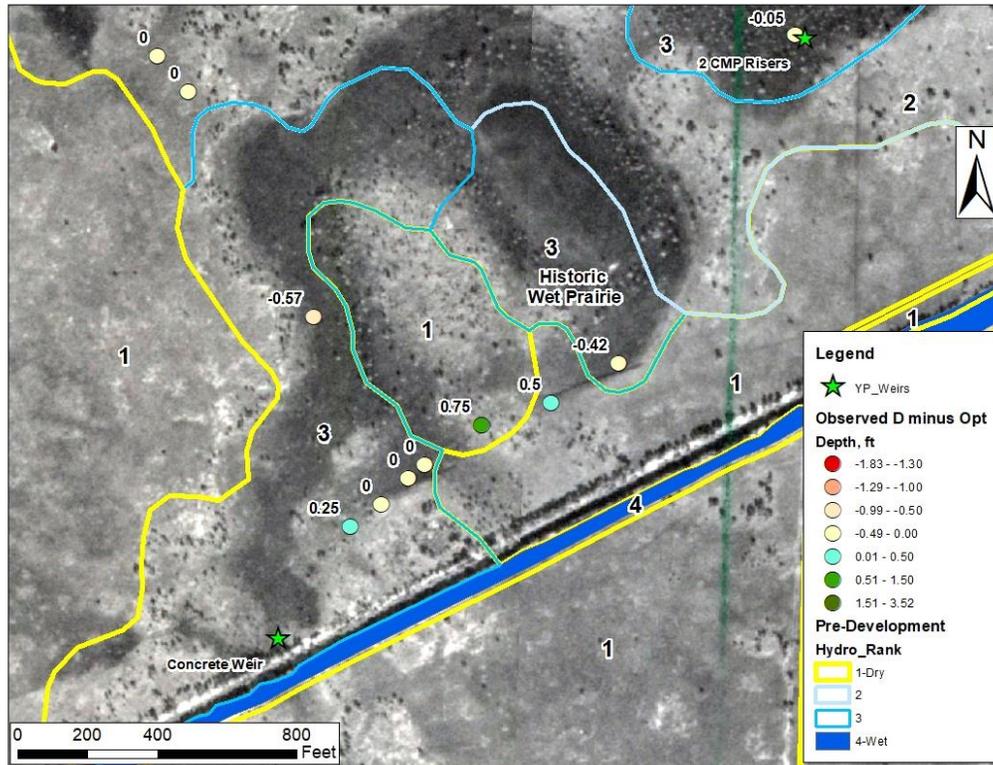
Figure 7b – Historic Aerial Photography, Hydrologic Rank Coverage, and Deviations from Optimum Water Depth for South Yucca Pens

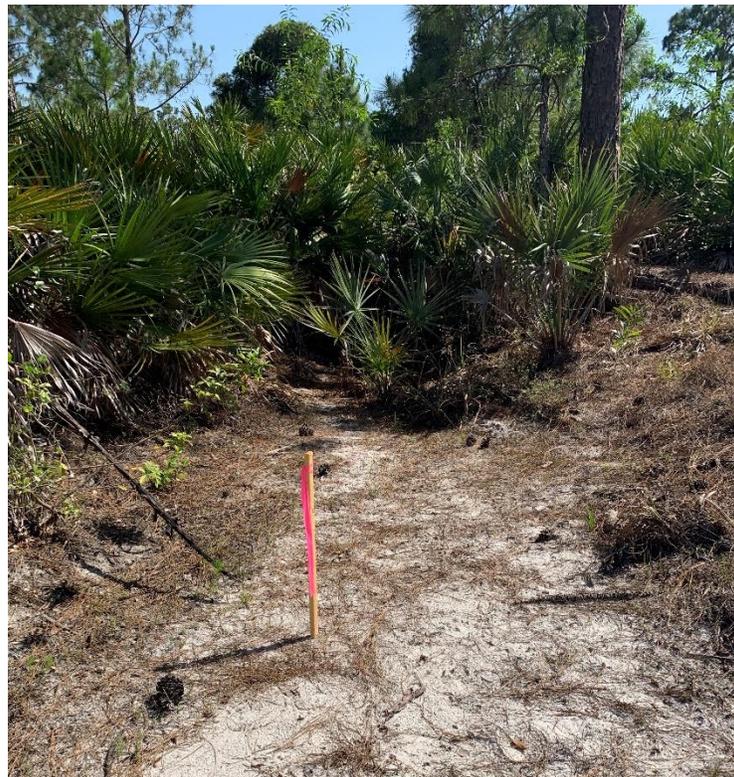
Figure 8a – Dry Season Photograph of Eroded Channel in South Yucca Pens, 5-20-20, Looking South

Yucca Pens. The southern and western portions of Yucca Pens have water depths less than optimum conditions. Drainage via eroded ATV trails has been observed at numerous locations in Yucca Pens, and construction of additional ATV channel blocks will be evaluated as part of Task 6 – Modeling Natural (Pre-development) and Future Conditions.

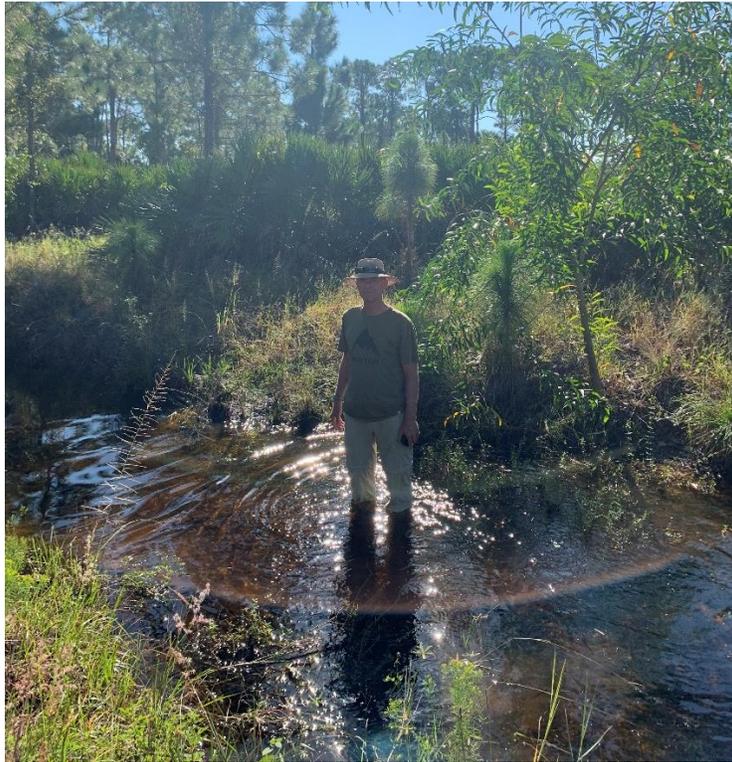
Figure 8b – Wet Season Photograph of Eroded Channel in South Yucca Pens, 10-15-20, Looking North

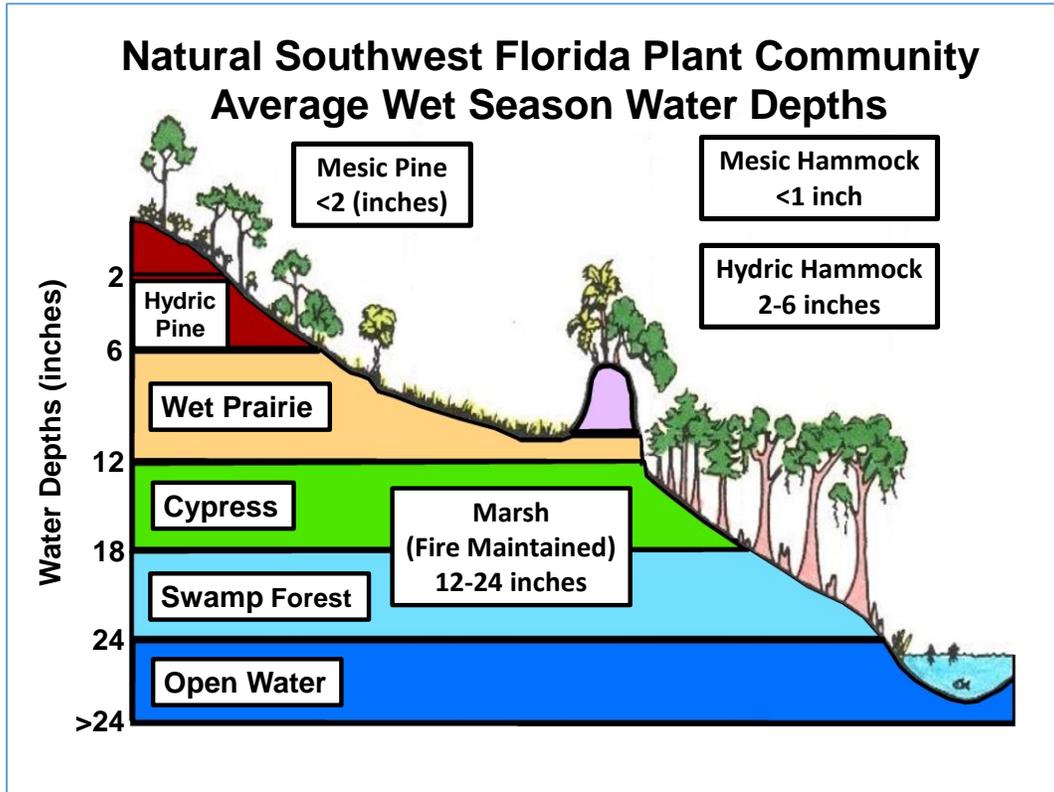
Attachment 1 – Average Wet Season Water Depths for Natural Southwest Florida Plant Communities

Source: Duever and Roberts, 2013

Hydrologic Rank was also an indication of average wet season water depth. Average wet season water depths were assigned to each Hydrologic Rank based on ecologic work conducted across Southwest Florida by Mike Duever (See **Attachment 1**) and is presented in **Table 1**. Water Science Associates modified the GIS files created by Liebermann and Kemmerer to add the average wet season water depths presented in **Table 1**.
