# **Ecological Report Summary Density Reduction Groundwater Resource (DRGR) Area for The Bonita Springs City Council**

**A Presentation to the Bonita Springs City Council  
Bonita Springs City Hall  
November 19, 2014**

**The City of Bonita Springs retained Kevin Erwin Consulting Ecologist, Inc. to provide an updated evaluation of the historic and existing land use and cover conditions within the City and make recommendations regarding opportunities for water storage, and wetland and hydropatterns restoration within the study area.**

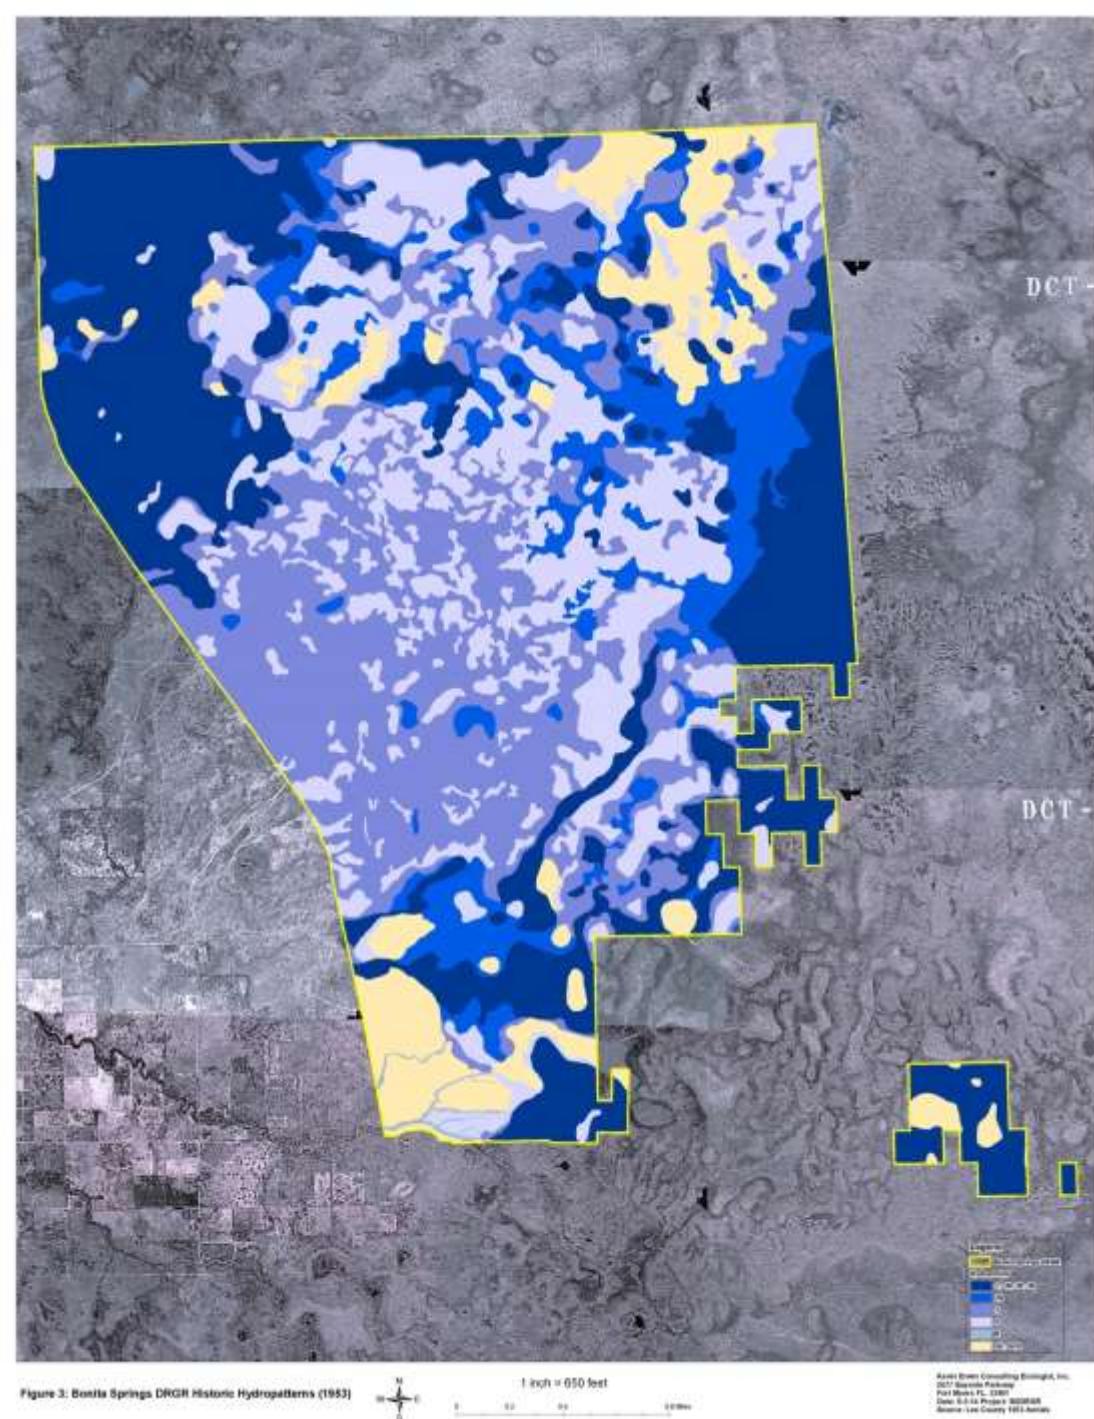
The deeper ponds, cypress swamps, and marshes have been assigned dark blue on Figure 1 with progressively shallower, shorter hydroperiod wetlands being assigned lighter shades of blue. This representation illustrates the location of **historic flow ways, deep pools and sheet flow areas**, provides an opportunity in the future to calculate the **historic capacity for water storage in the study area** during an annual cycle and also allows us to link the area with the Lee County DRGR evaluation (KECE 2008) and 2009 DHI report.

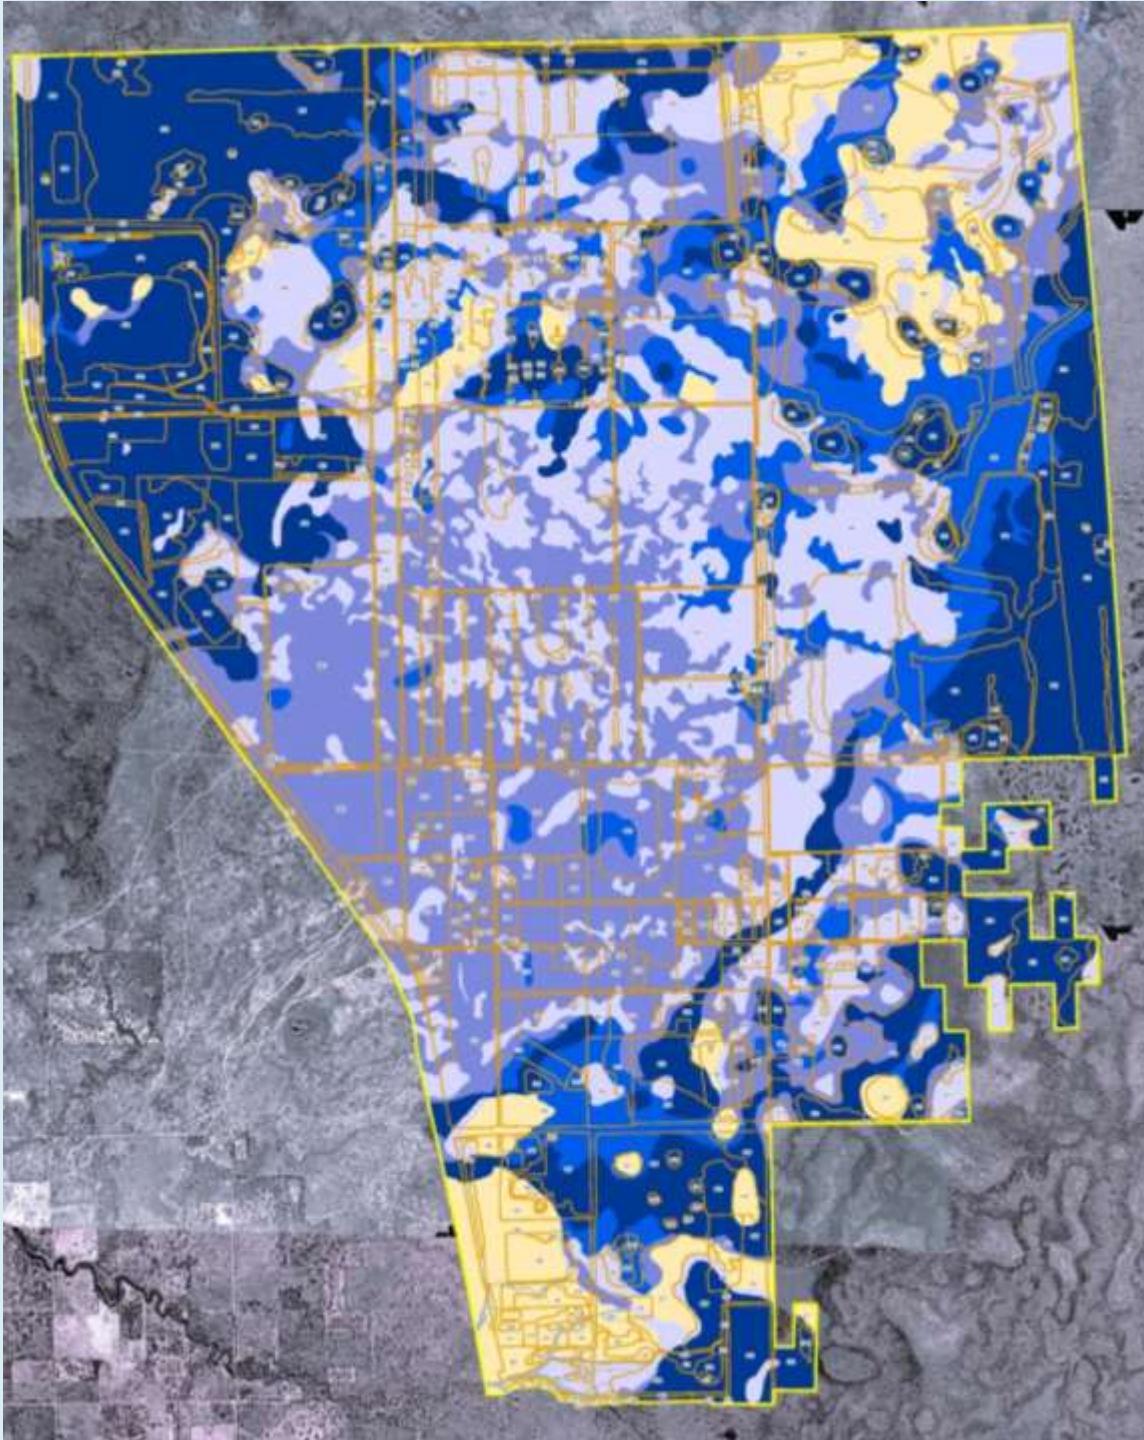
## Existing Land Use and Historic Hydropatterns 1953

# Bonita Springs DRGR

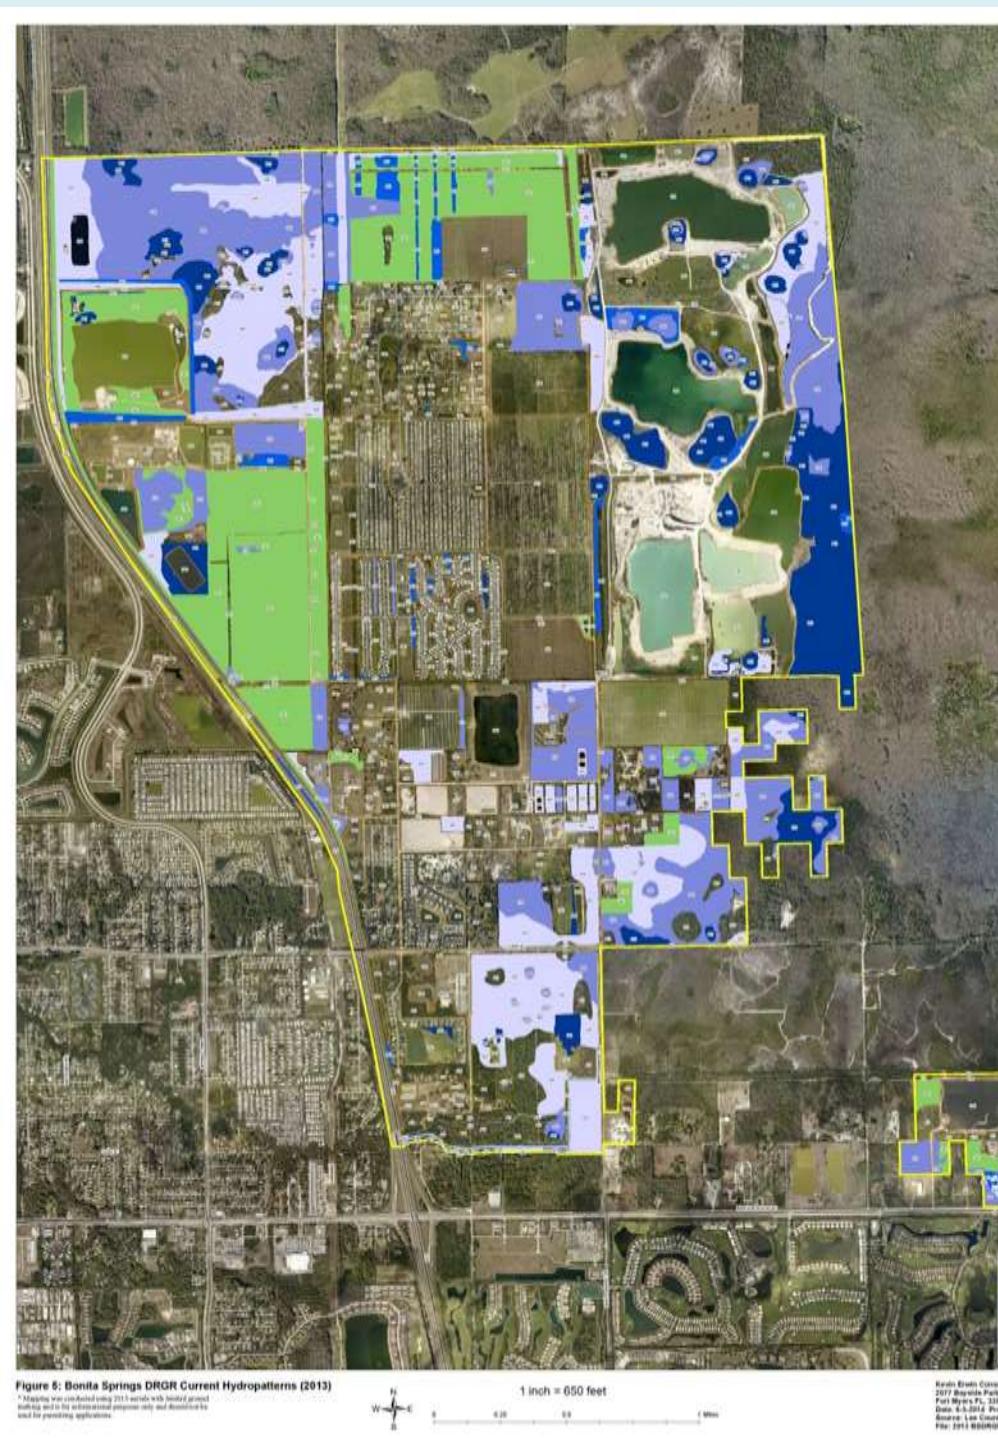
Figure 5: Bonita Springs DRGR Current Hydropatterns (2013)

**Physical alterations within the study area, including the conversion of native habitat to agriculture, construction of roads and drainage canals, the development of subdivisions, utilities and mining has redirected flows of surface water from their historical pathways.**

\*This map is intended for 2013 wetlands with hydrologic patterns resulting from physical alterations to the hydrological system and does not reflect pre-existing conditions or future projections.

Without appropriate **water level monitoring data**, there is no precise way to estimate the existing hydrological conditions within wetlands remaining in the DRGR. Therefore, one should assume that the hydrological conditions in the existing landscape are **drier** than that reflected in this analysis.

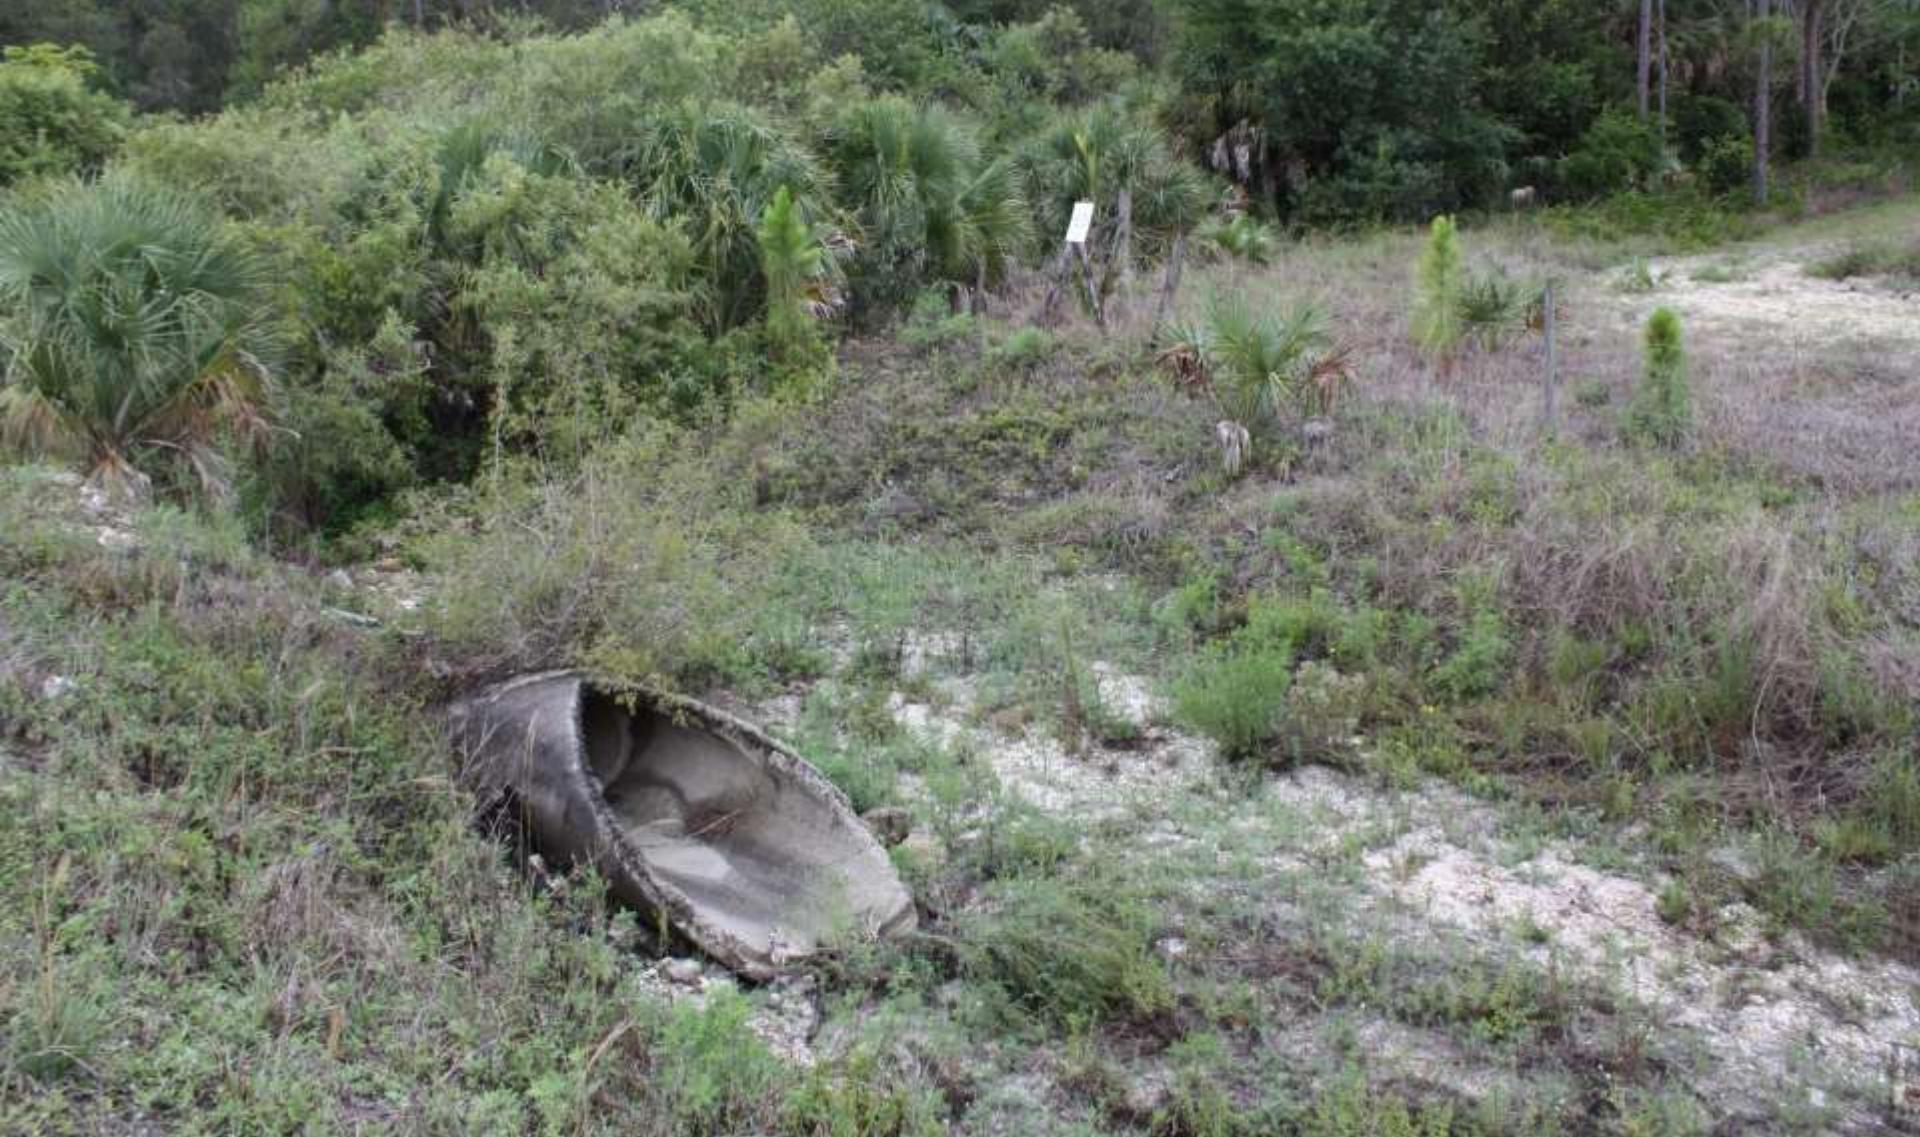
We estimate that drainage within the study area has resulted in significant lowering of the water table during both wet and dry seasons and a shortening of wetland hydroperiods.

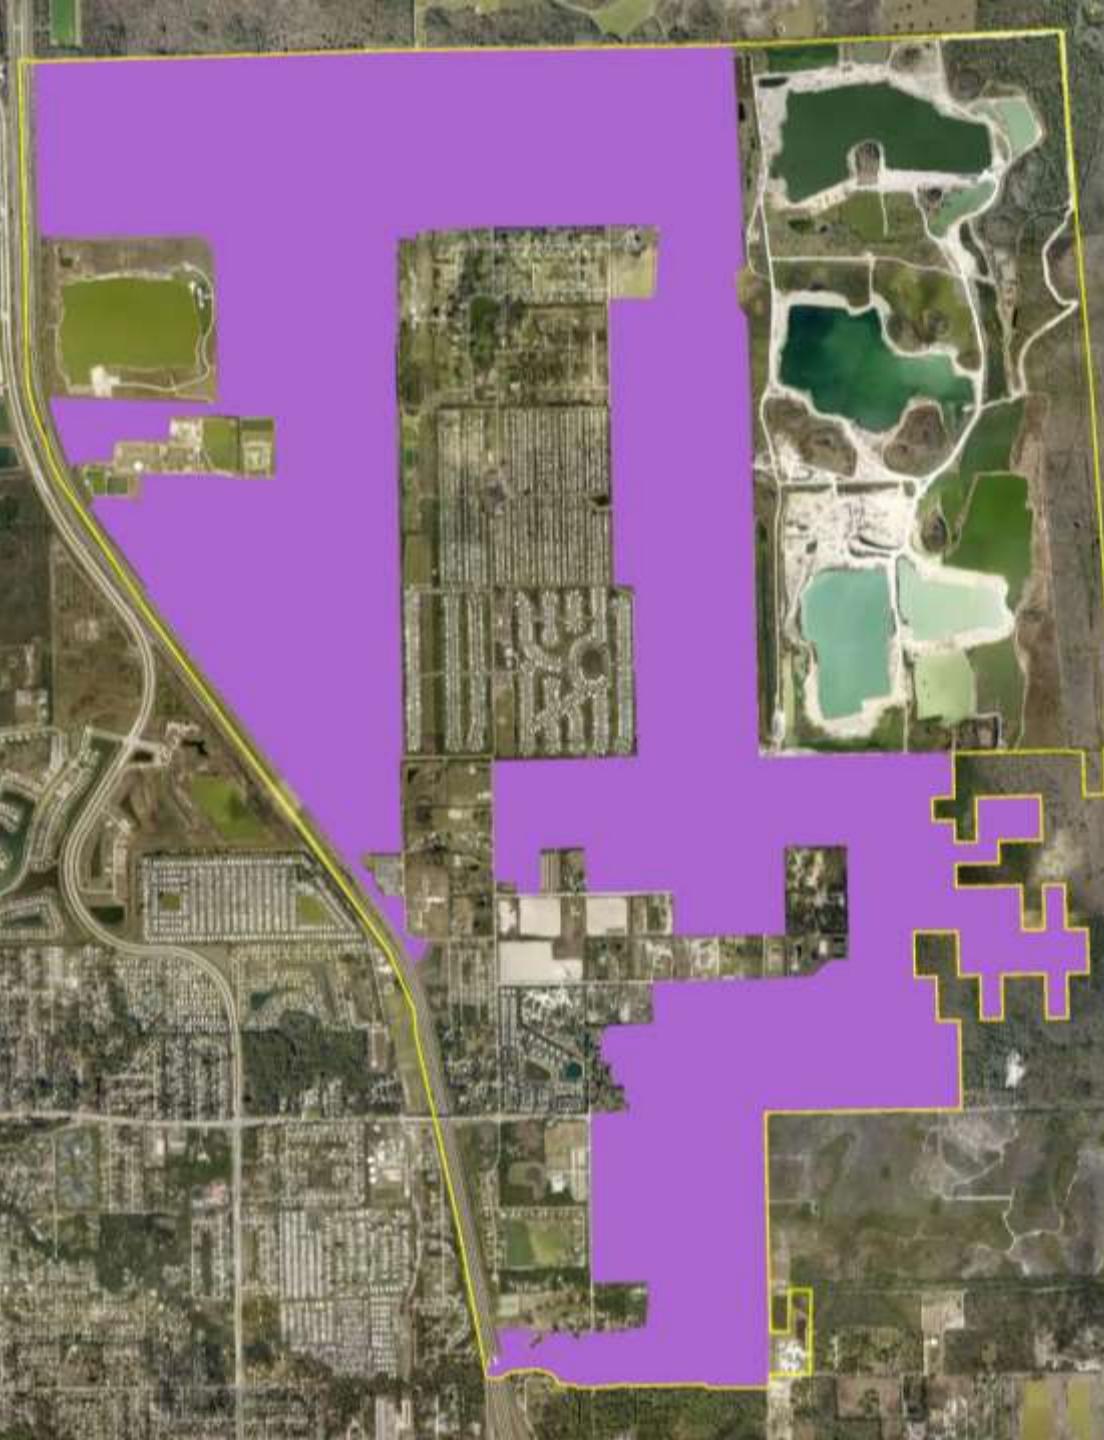
This proposed Conservation Overlay, shows **all contiguous lands with potential for applying conservation practices**, including restoration, parks and sustainable agriculture.

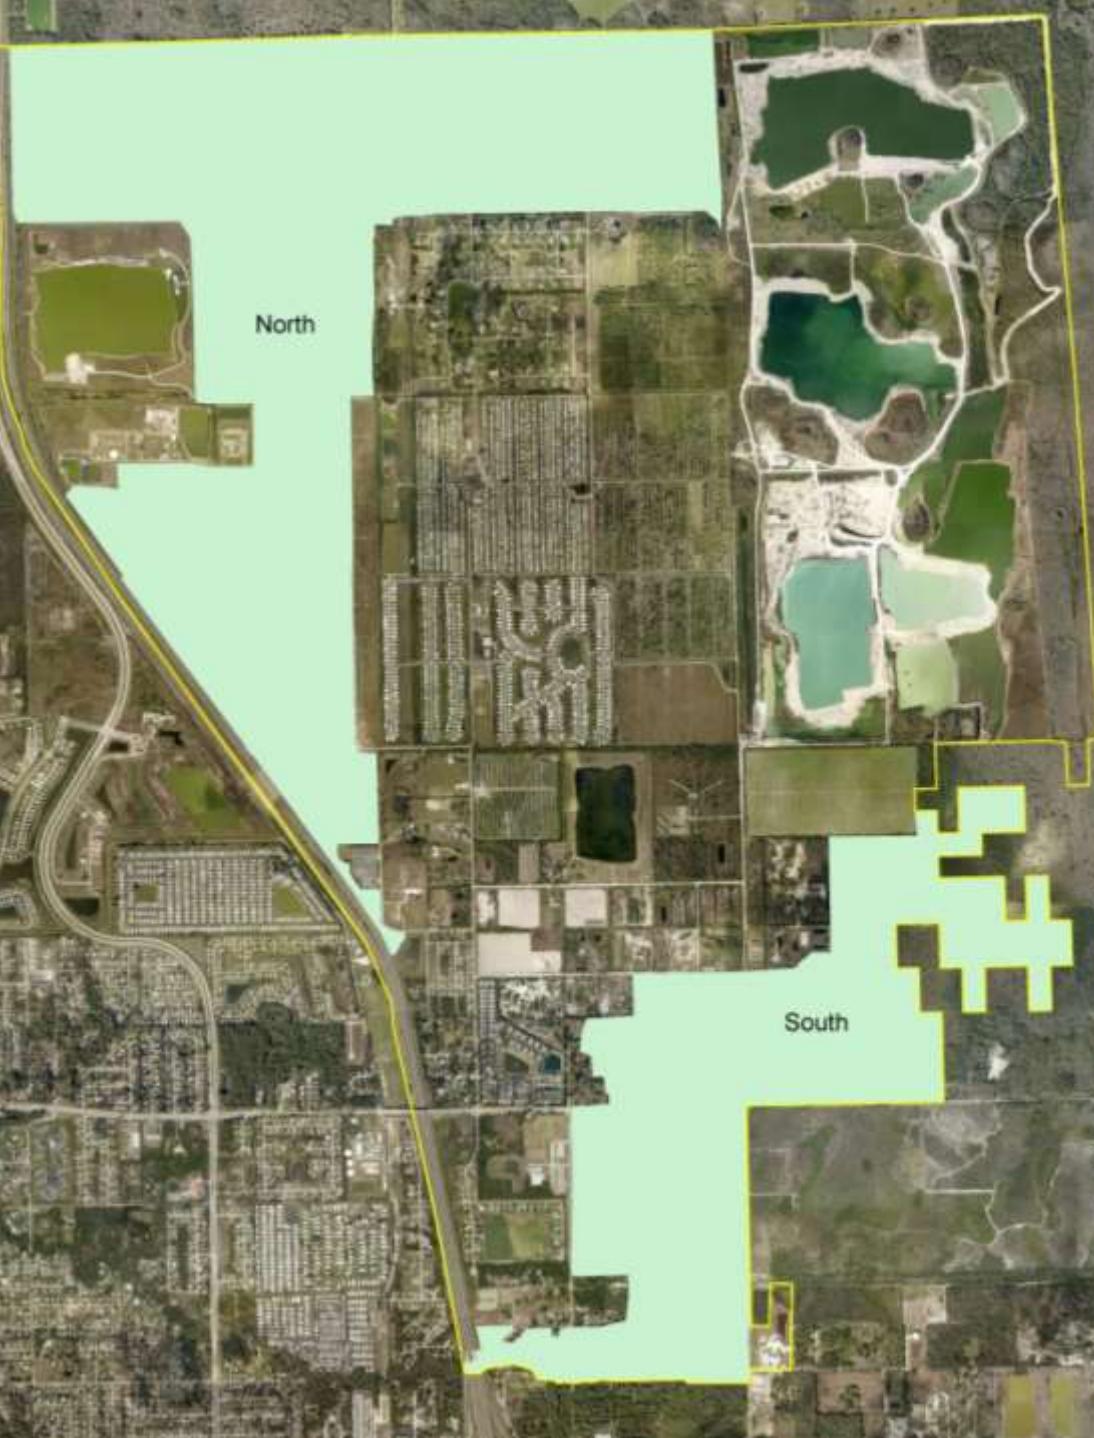
This proposed Restoration Overlay focuses on a combination hydrological restoration, wetland restoration and management, and flow way creation. **Phased wetland restoration** is possible and recommended within two regions of the study area.

**Each proposed restoration scenario attempts to avoid water management conflicts** with adjacent land uses such as mining, residential development and farming. All detailed proposals for restoration will require further evaluation including: appropriate data collection; detailed planning and engineering; and modeling and permitting as necessary precautions in the project's design and implementation. The basic elements of these restoration plans will include developing a water budget for each restoration area, monitoring ground and surface water levels, designing structures to increase water levels and extend hydroperiods, controlling exotic plant species, and replanting some specific areas with native species.

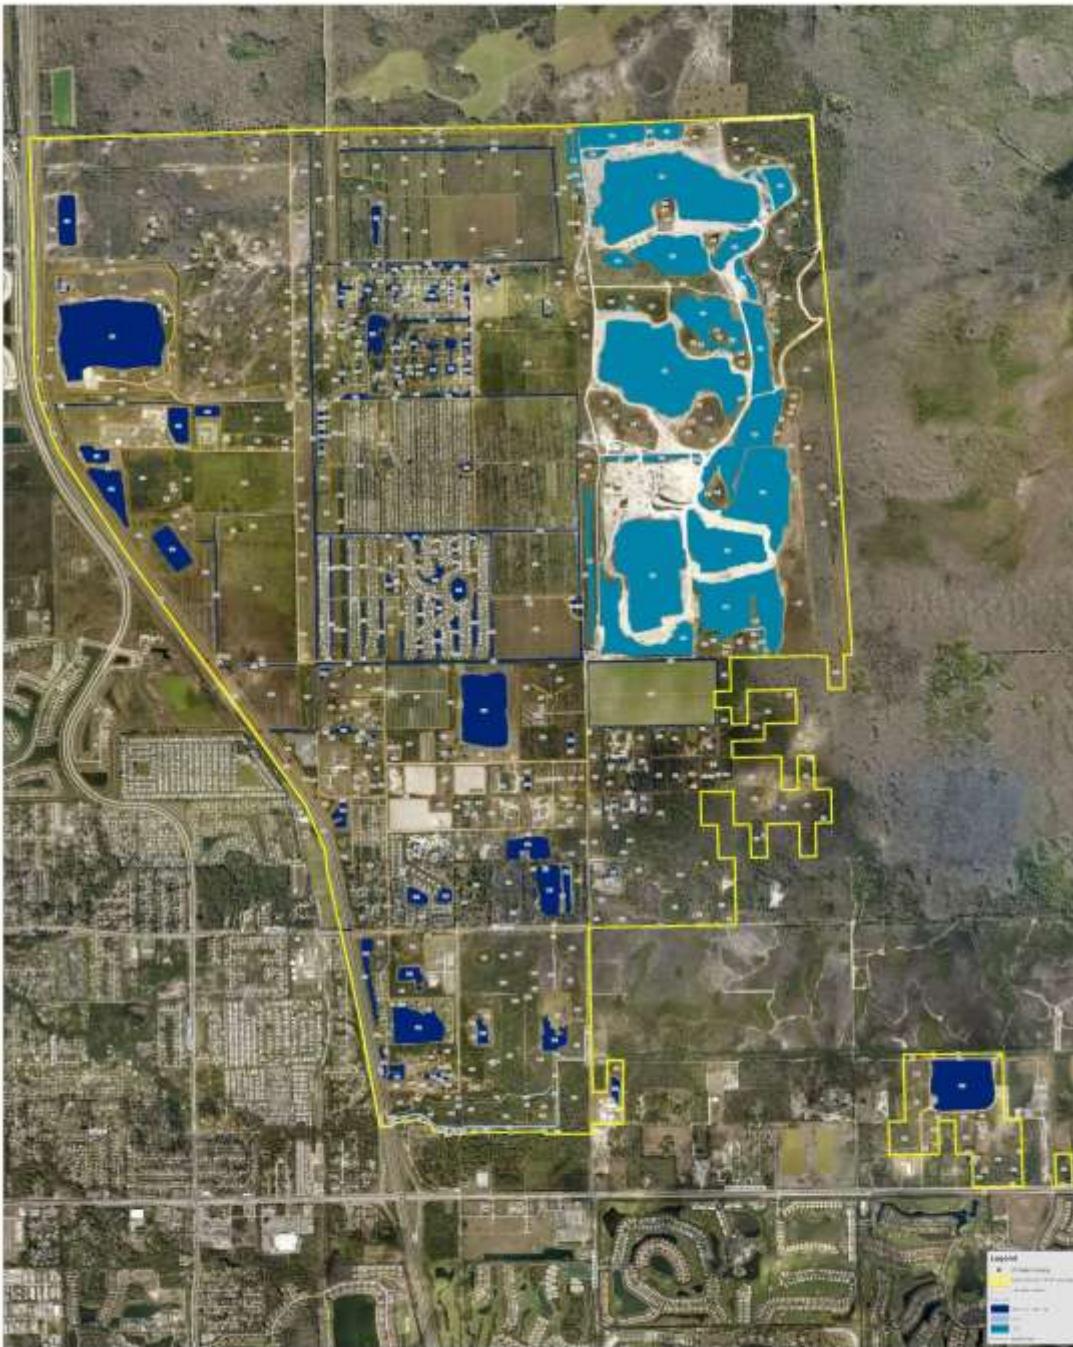
Bonita Springs DRGR - Other Water Bodies

\* Delineations were developed using 2013 aerials with limited visual verification and are subject to change.  
\*\* Includes undeveloped land parcels.

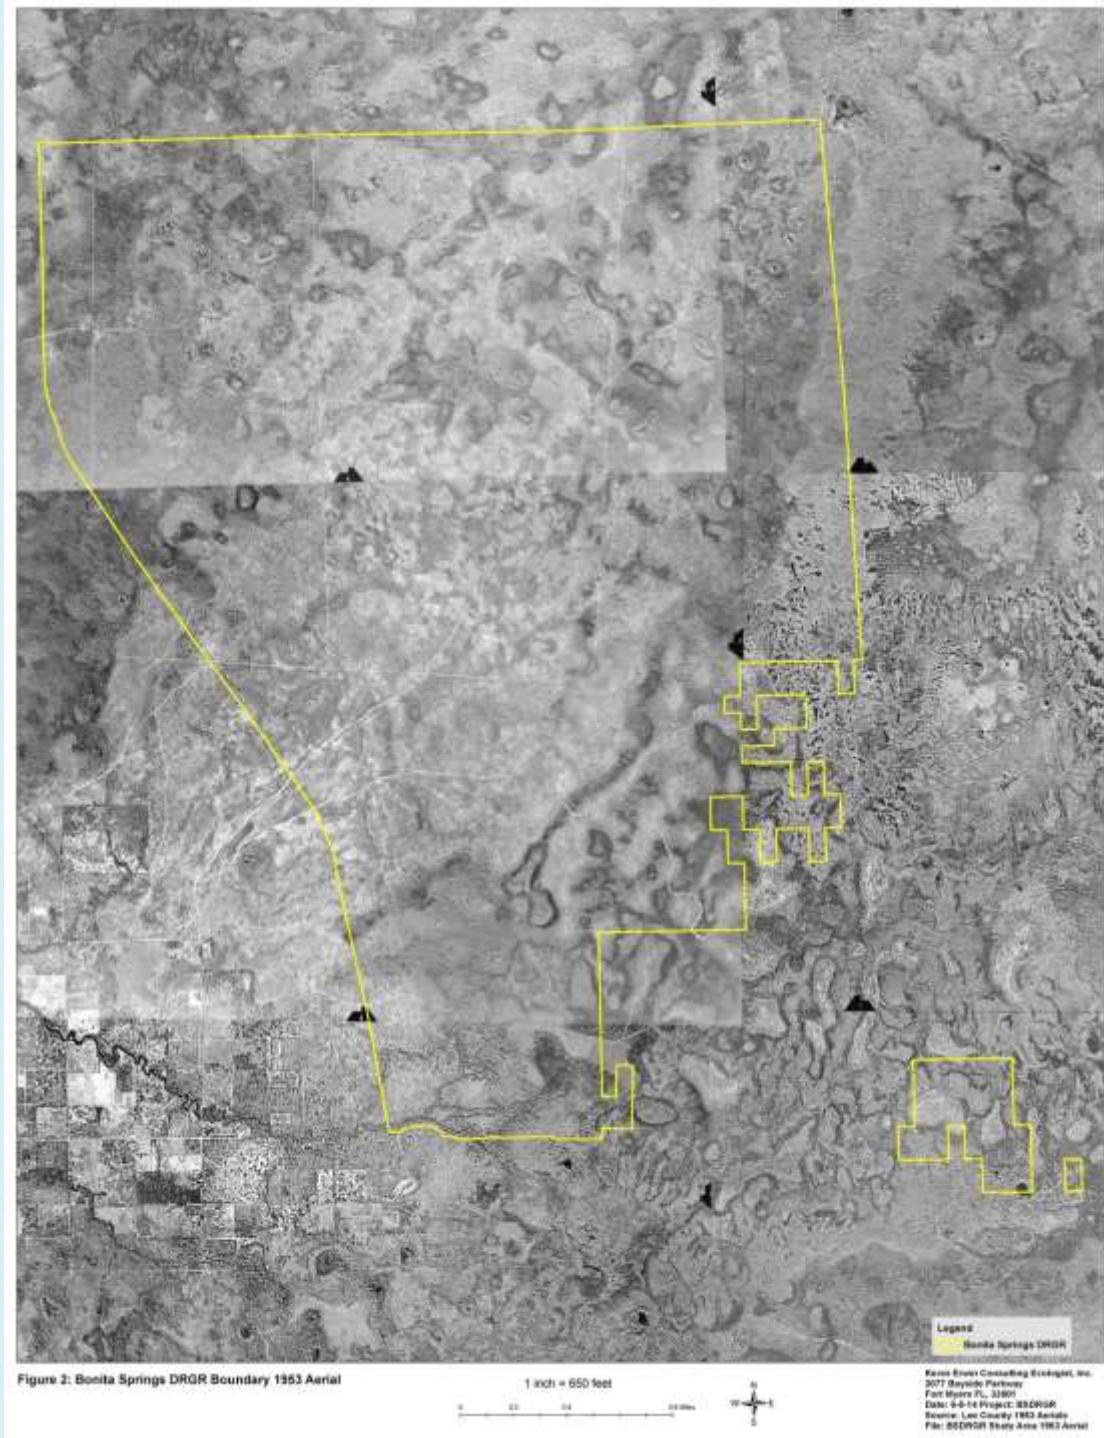
## Bonita Springs DRGR Boundary 1953

These high resolution 1953 photos of the study area were scanned, georectified, then plotted for mapping by experienced ecologists to determine the approximate historic hydrological conditions for the entire study area.
