Alligator Creek Addition Restoration Structural Monitoring Report

Charlotte Harbor National Estuary Program Technical Report 14-2 Approved: 8/26/2014

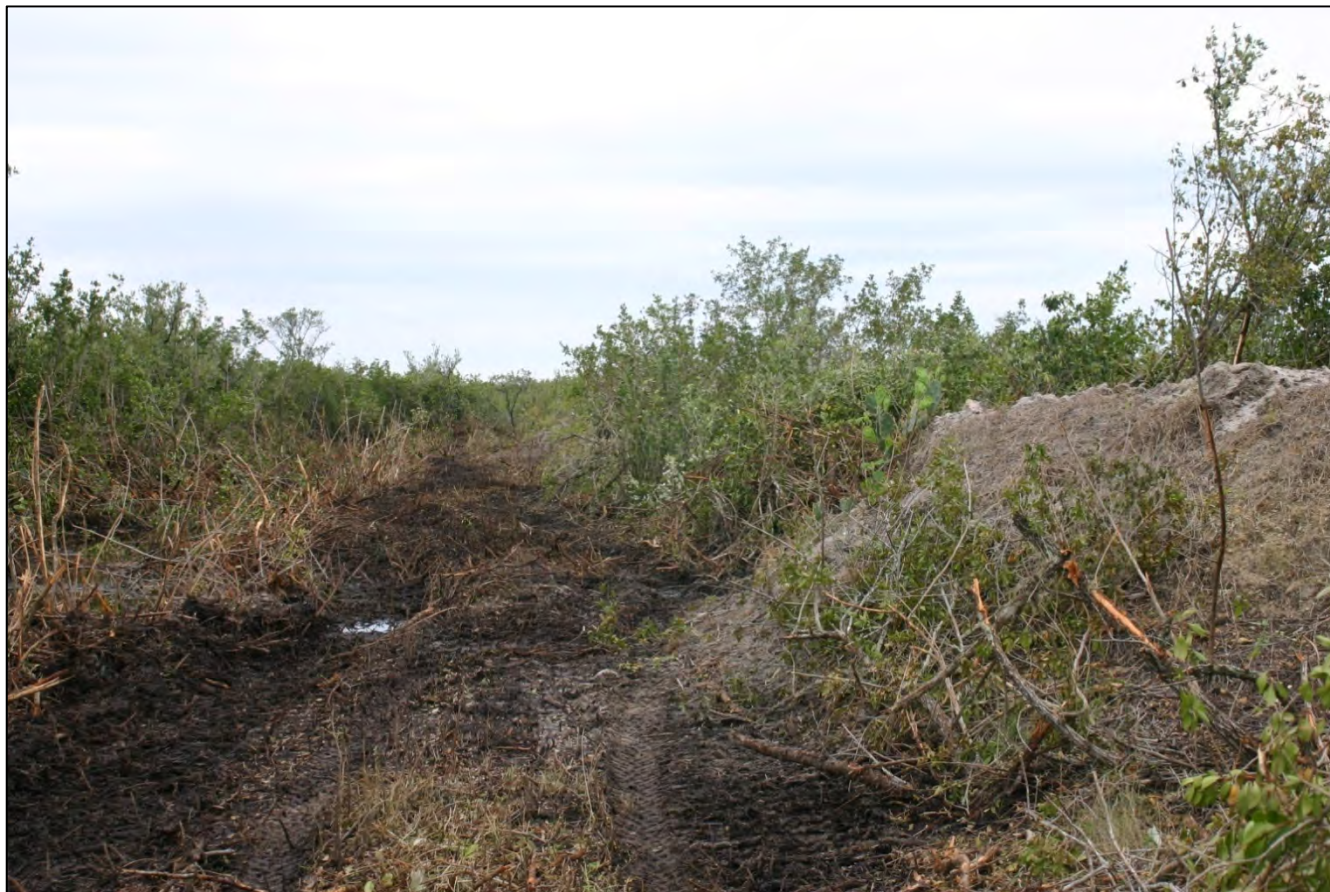
On March 11, 2008, shallower ditches were cleared and adjacent spoil was used to bring the grade to adjacent levels. According to baseline monitoring, various mangrove species the ditches while Brazilian pepper grew on the spoil piles.

Figure 4: March 11, 2008 Ditch Restoration

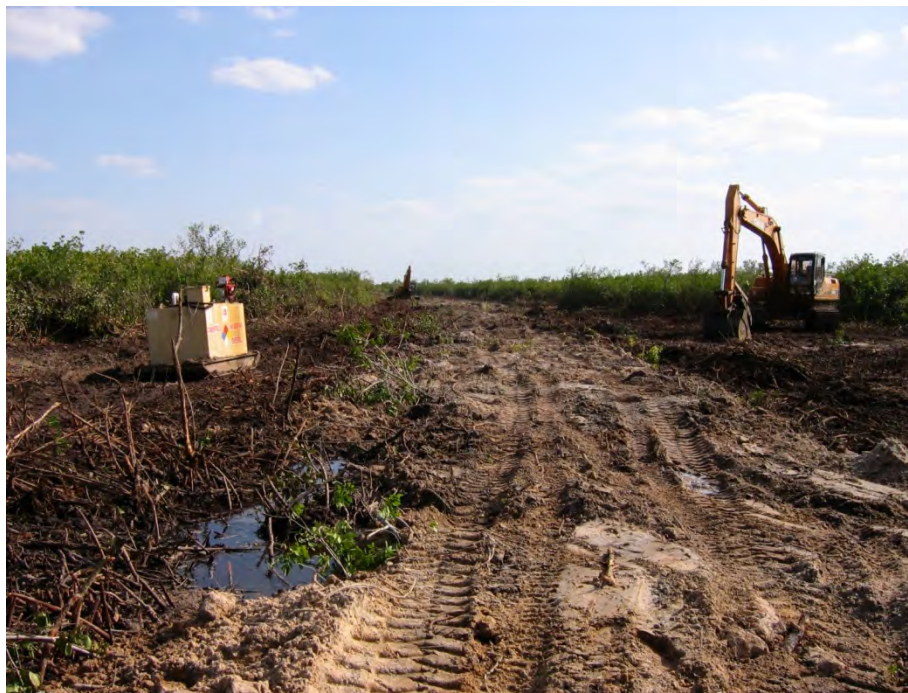
As construction progressed, larger ditches were filled to bring them up to adjacent grade. Note that fill includes a variable level of organics.

Figure 6: March 18, 2008 Restoration of Larger Ditches

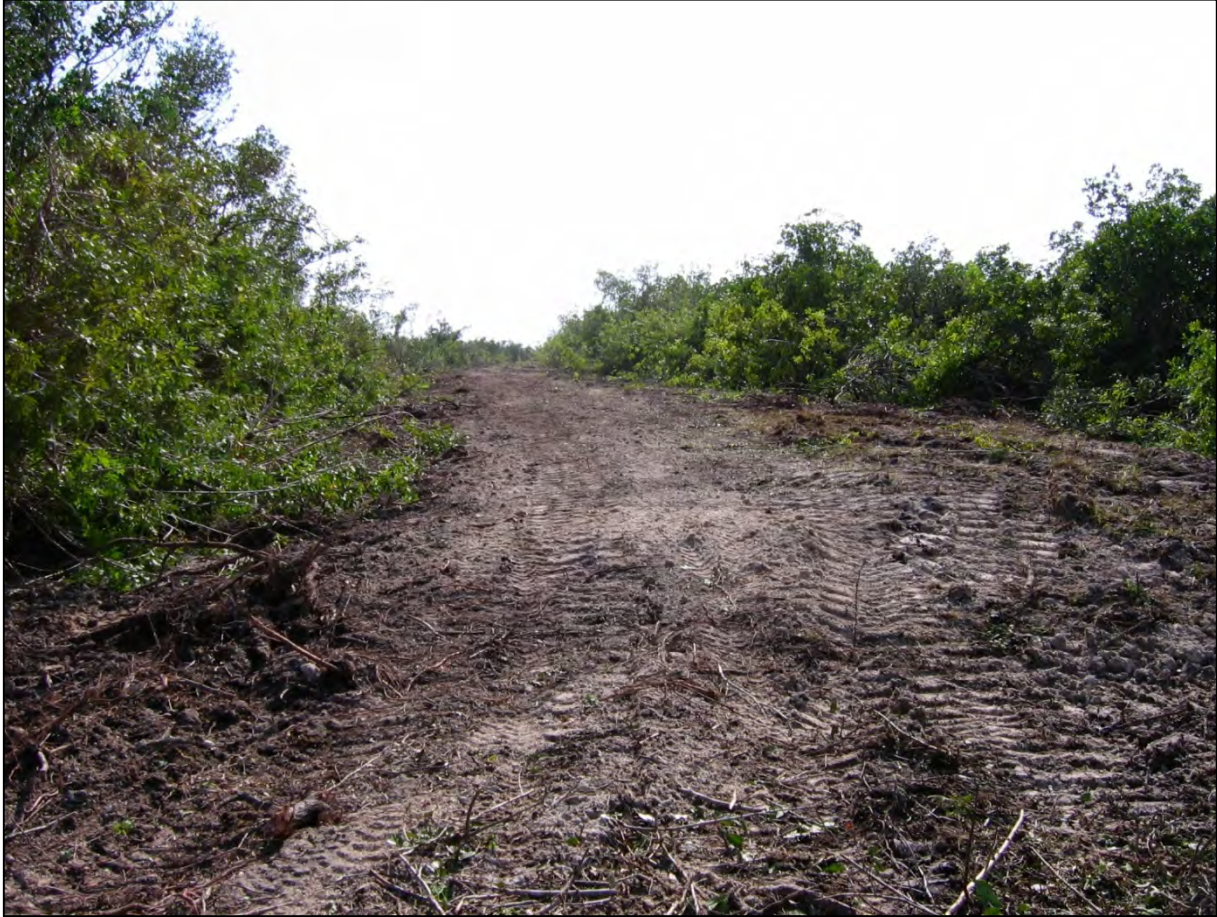
Figure 7: March 18, 2008 Completed fill of Large Ditch

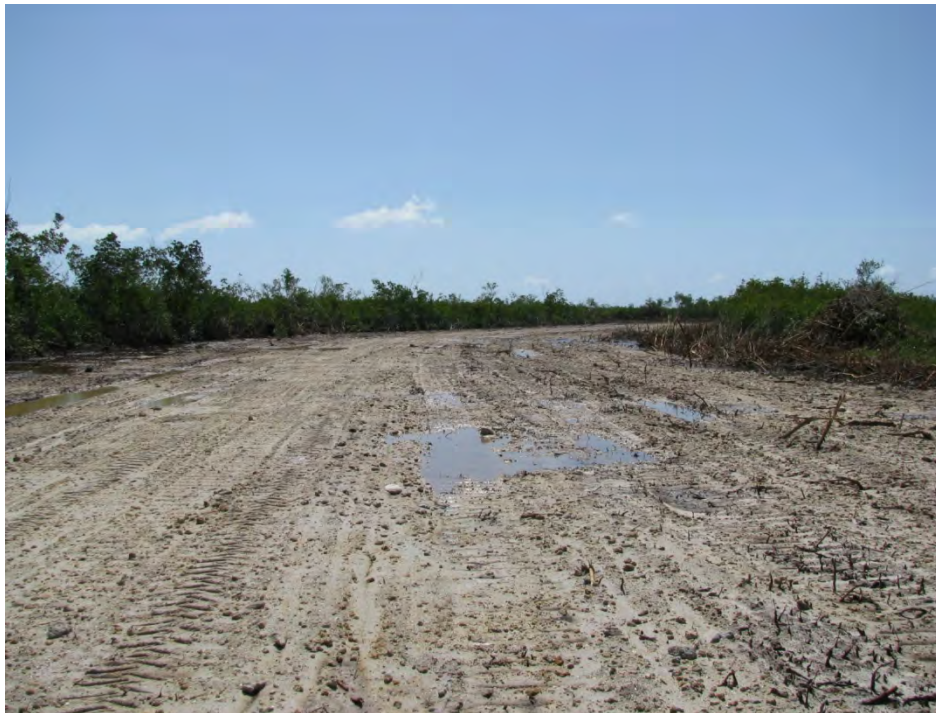
Figure 8: April 4, 2008 Completed Fill of Large Ditch

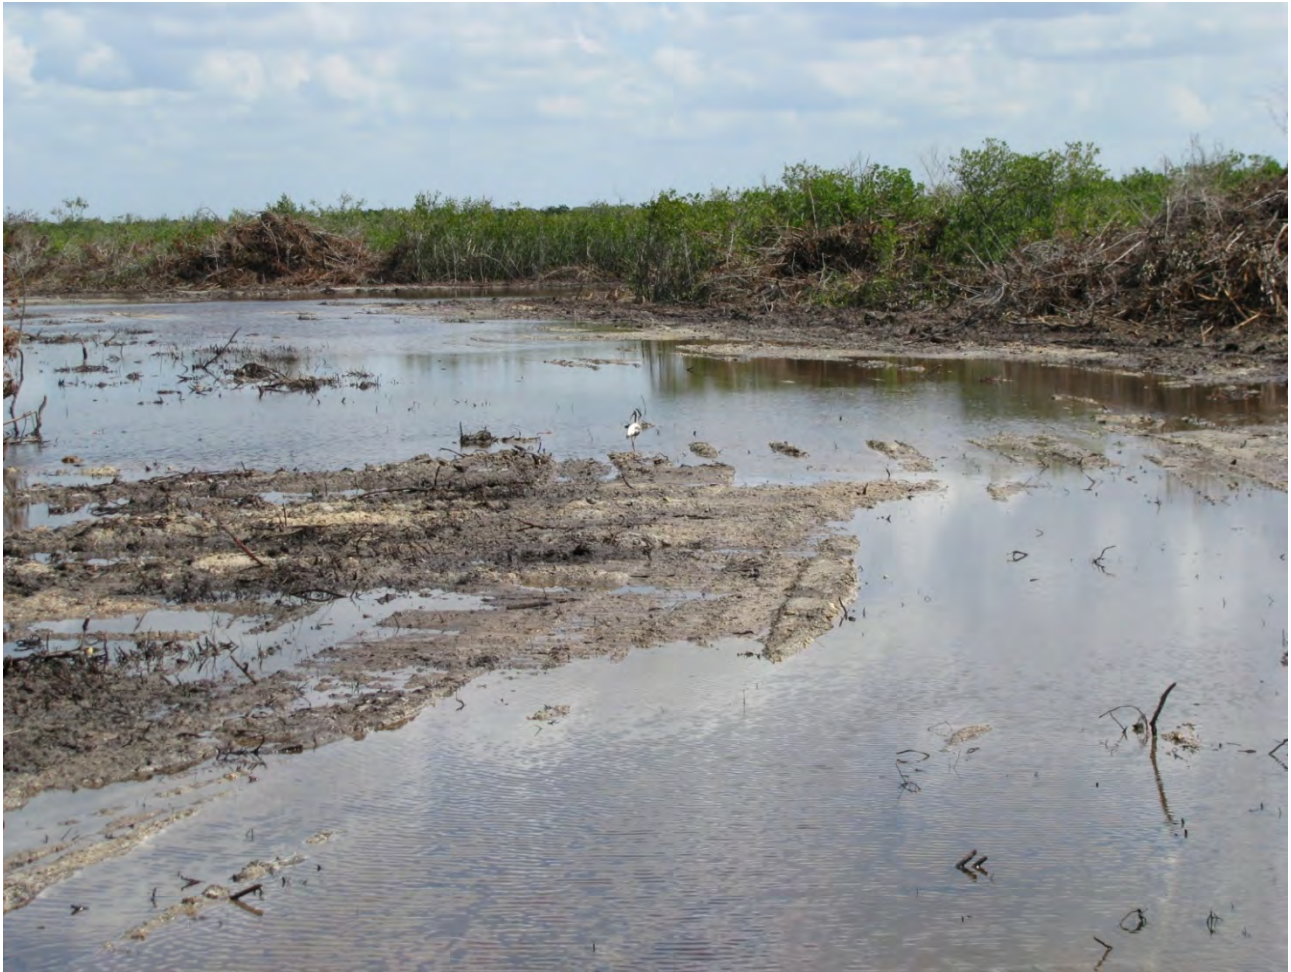
Figure 9: April 23, 2008 Flooded Works site for Heron.

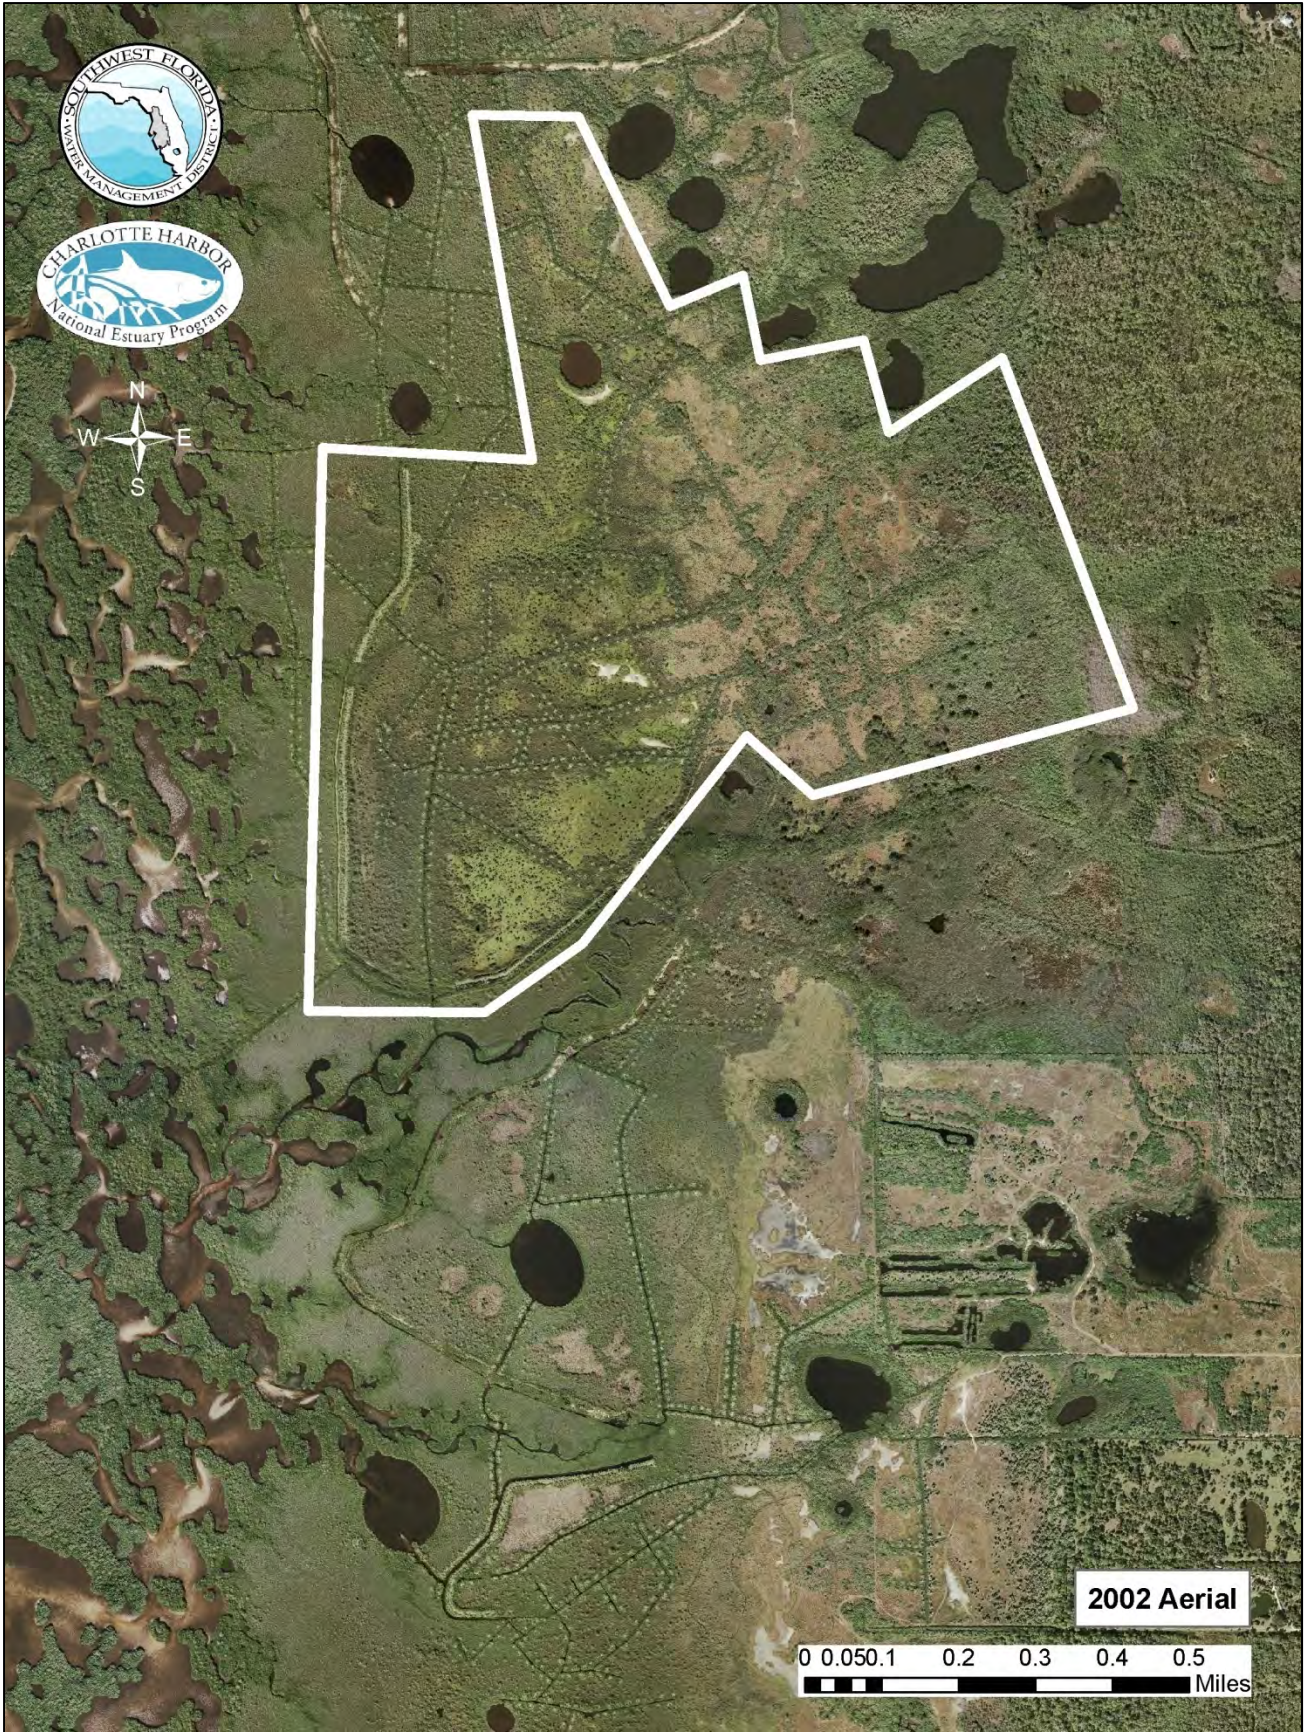
By 2002, when the Alligator Creek Restoration Project was in design, mosquito ditches crisscrossed the site. From the aerial photos, it is apparent that the open water mosquito ditches were lined with spoil piles. The invasive exotic plant, Brazilian pepper (*Schinus terebinthifolius*), was the predominant plant on the spoil piles.

Figure 13: 2002 Aerial Photograph, year of project development

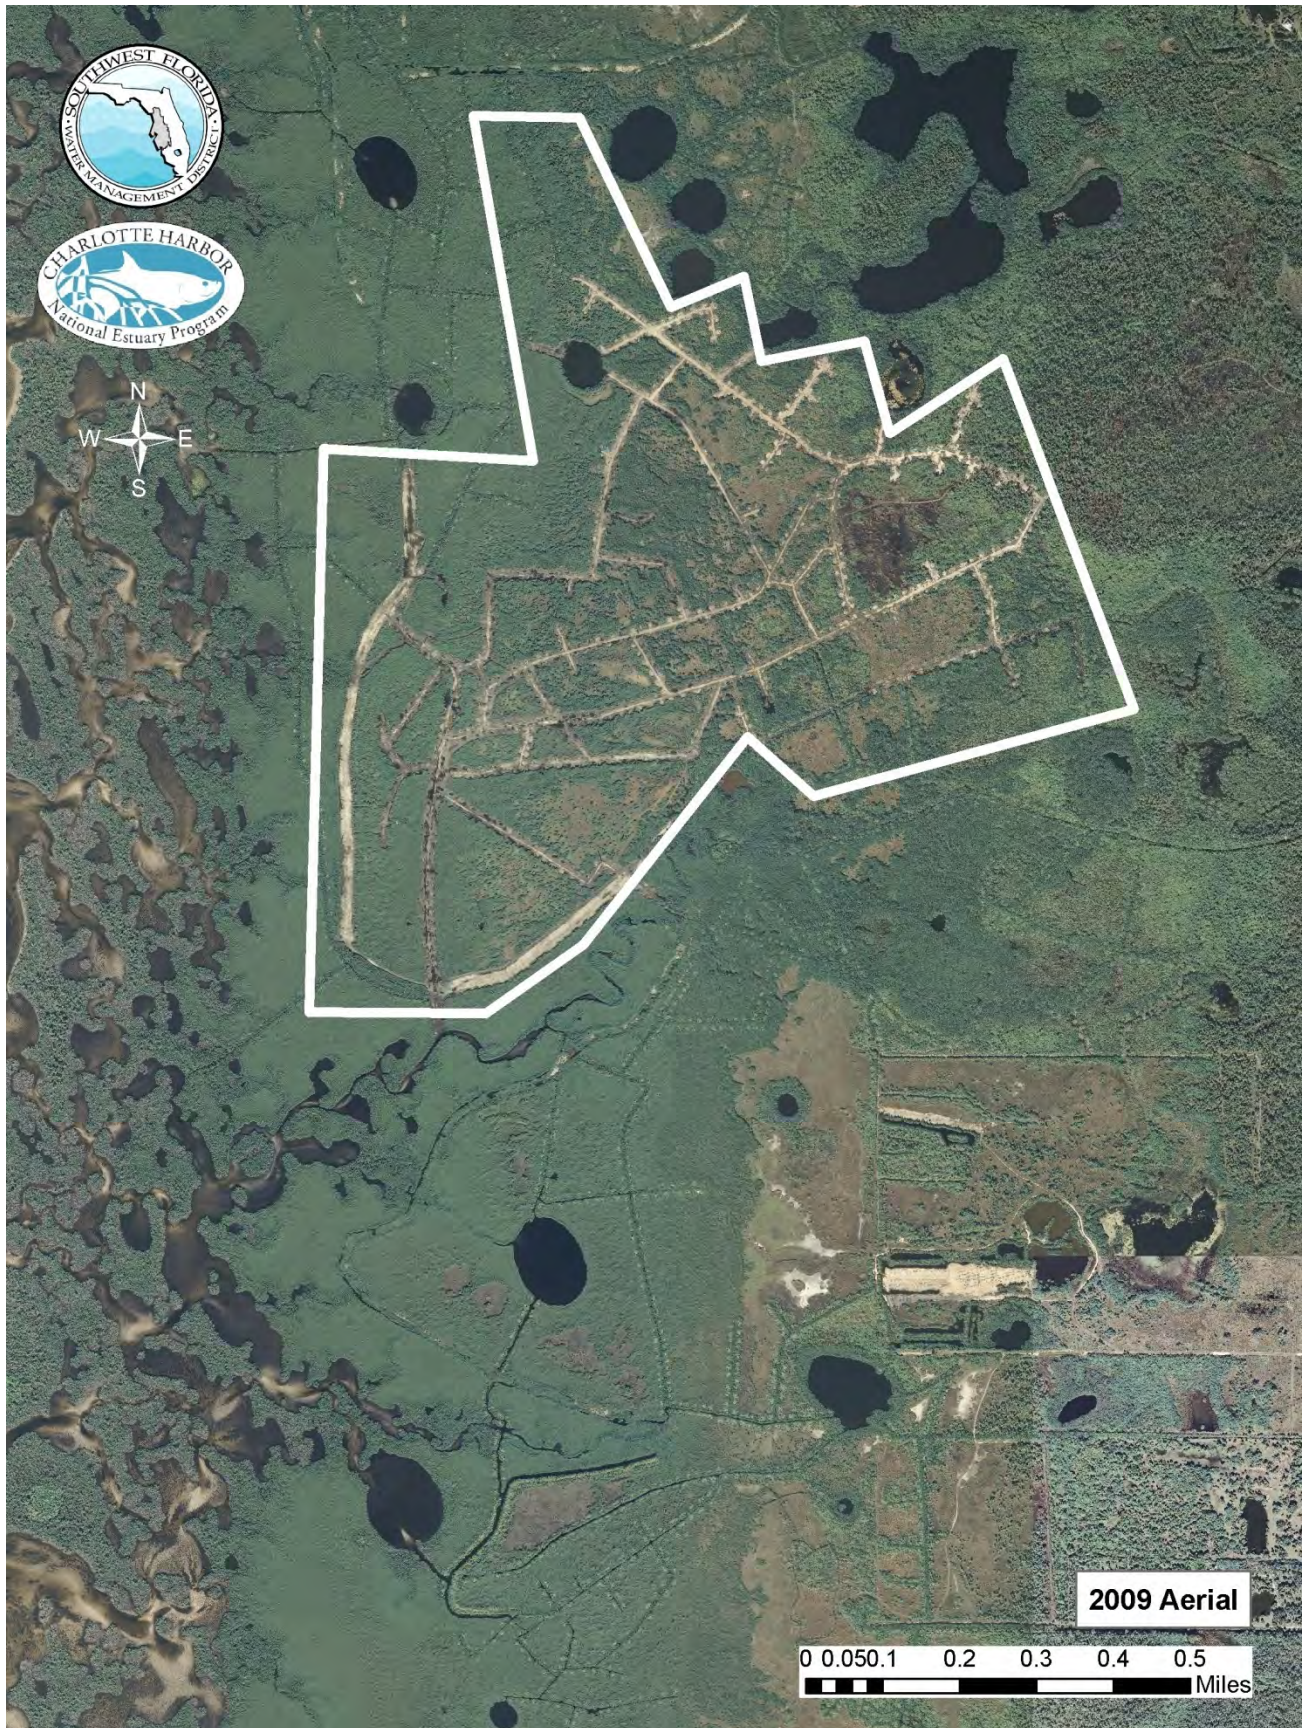
Construction of the Alligator Creek Restoration Project 16 took place soon before the 2009 aeriels were acquired. Open earth is evident where both the mosquito ditches were filled and the spoil piles were leveled.

Figure 15: 2009 Aerial Photograph, after restoration construction completed
