Lemon Bay Basin Water Quality Status Report

WATER QUALITY IMPROVEMENT

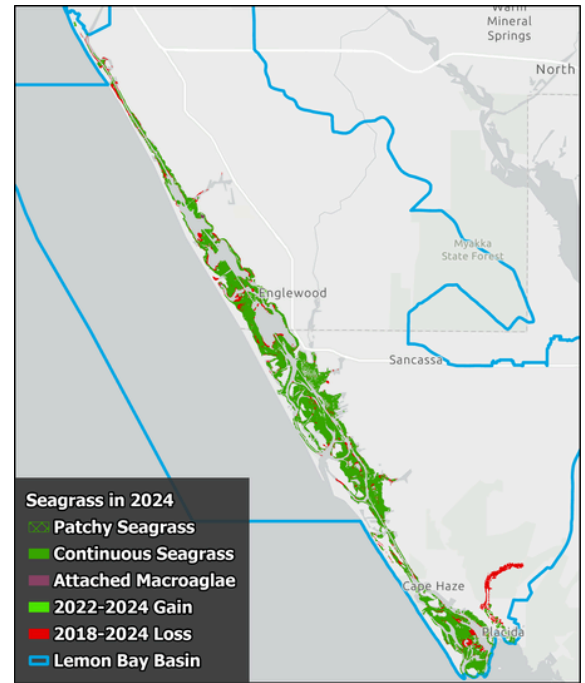
Seagrass Acreage

The table below shows results from seagrass mapping, done once every two years, in Lemon Bay from 1988-2024. Seagrass in this area has increased since the 1990's and since then remained relatively stable over time. However, acreages began to decline in 2018 and have continued to decline each year since then, reaching an all-time historic low in 2024. Between 2018 and 2024, Lemon Bay lost 679 acres of seagrass, representing a 18% loss overall. The reason for this decline is complex and likely involves several factors. This includes impacts from recent storm events such as Hurricane Irma, increased temperatures and rainfall, additional nutrient runoff from land, as well as prolonged red tide and algae blooms in the region. The CHNEP continues to work with our partners to better understand causes and investigate solutions.
