D.3.6 FUNCTIONAL GROUP 34 – ESTERO CREEKS AND HEADWATERS FLOW-WAYS

D.3.6.4 Original Components and Associated Management Measures in Functional Group 34 (*Table D-9*)

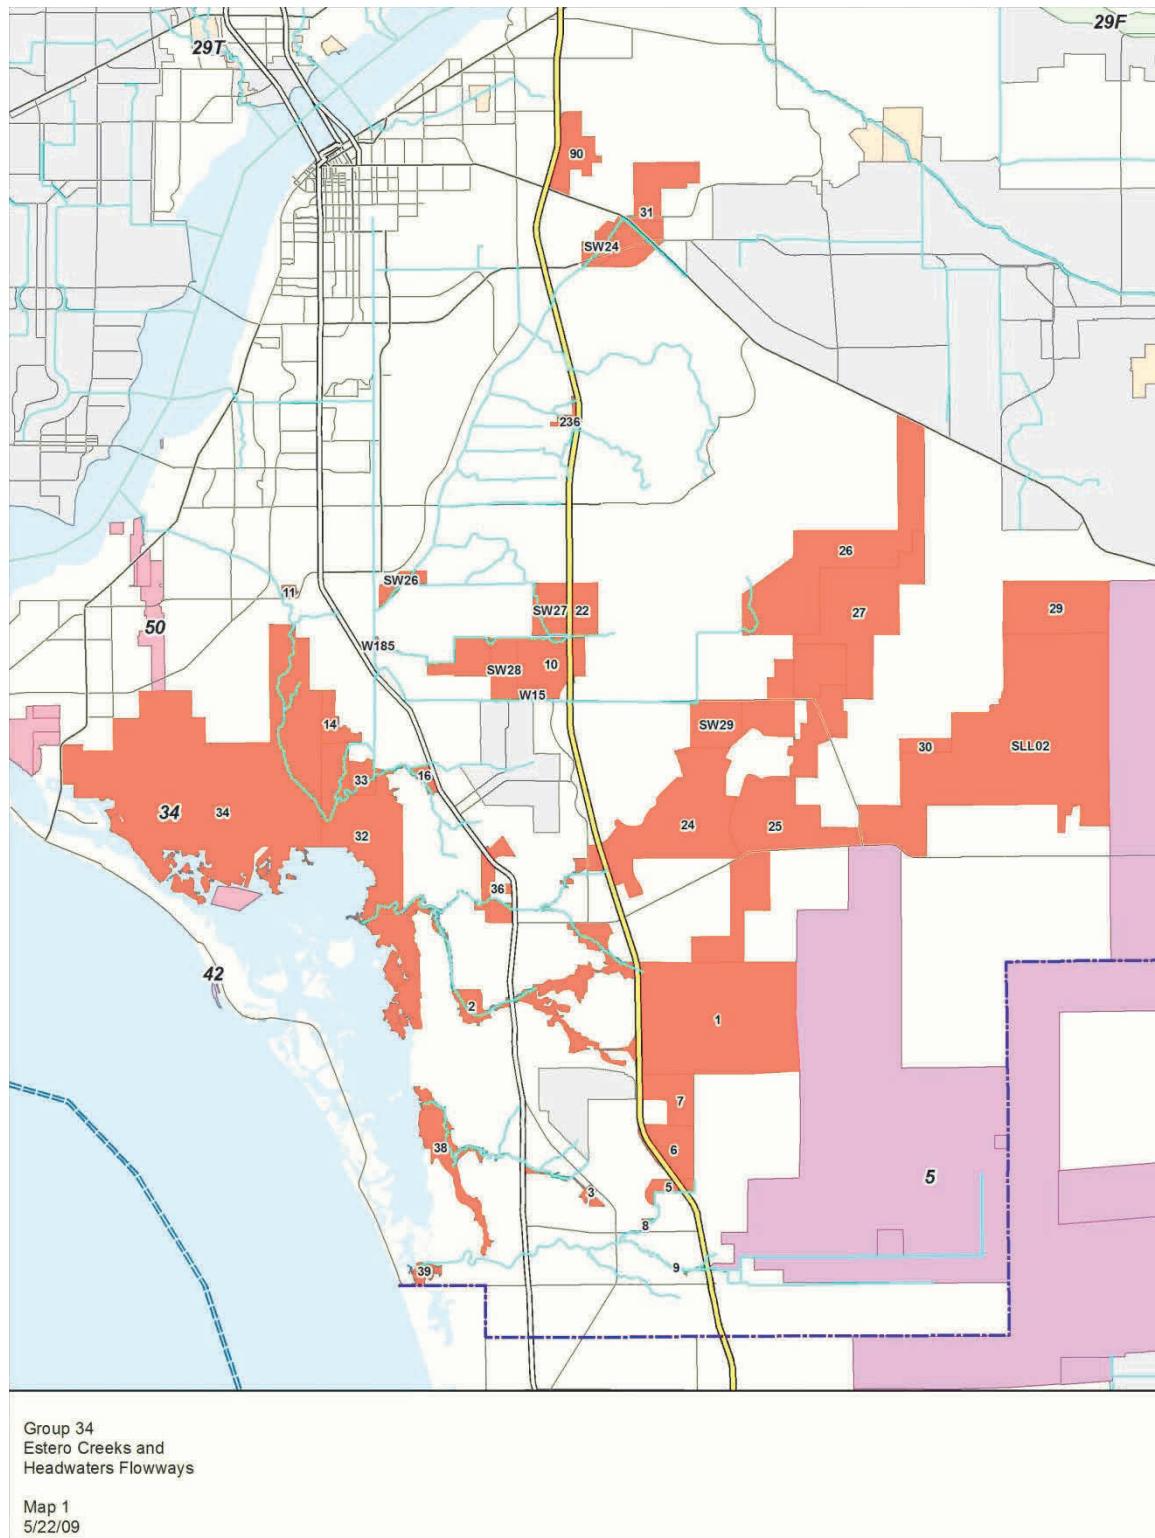
FIGURE D-12: FUNCTIONAL GROUP 34 ESTERO CREEKS AND HEADWATERS FLOW-WAYS COMPONENT BOUNDARIES
