Dona & Roberts Bays Basin Water Quality Status Report

WATER QUALITY IMPROVEMENT

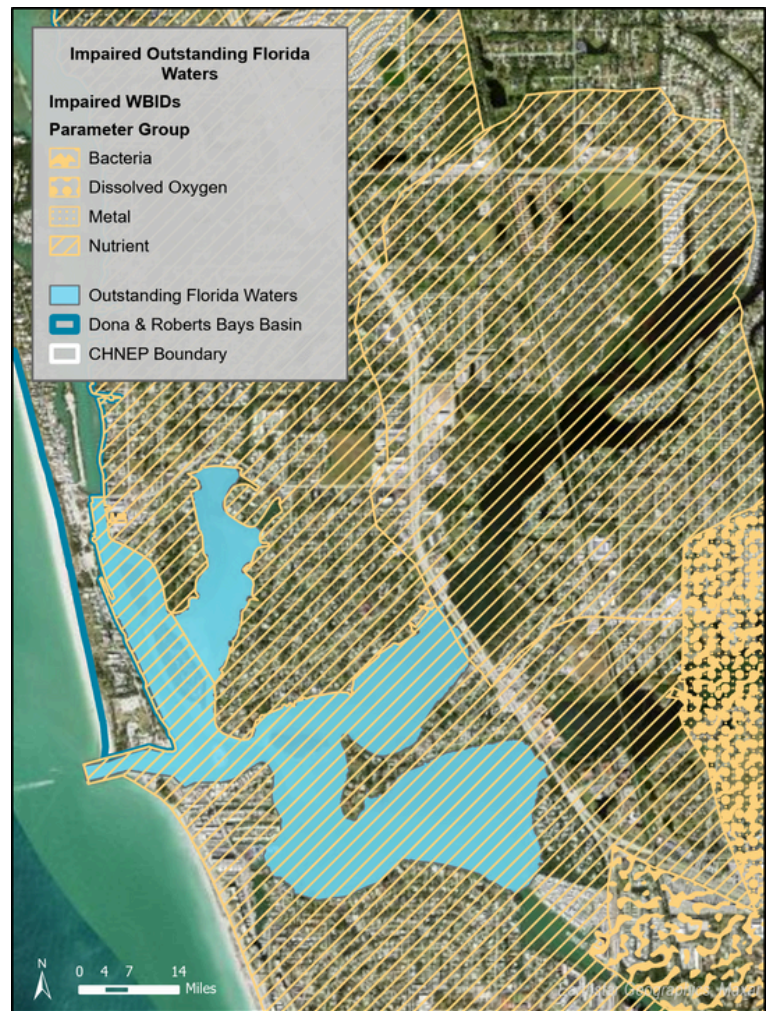
However, some of these OFWs are now impaired (as indicated by light blue with peach fill pattern on the map). The following OFWs are currently not meeting water quality standards:

- Sarasota Bay Estuarine System

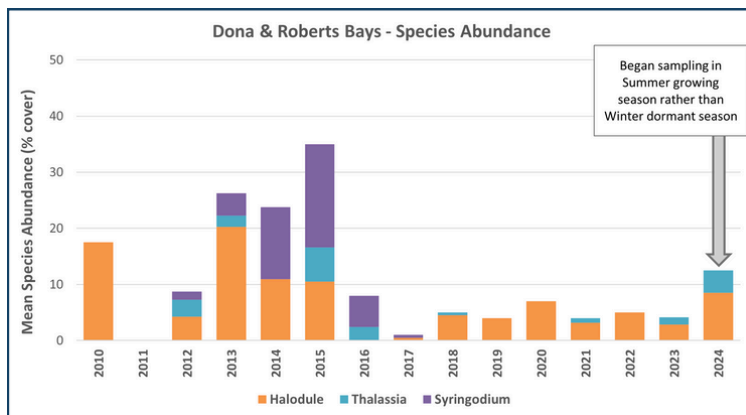
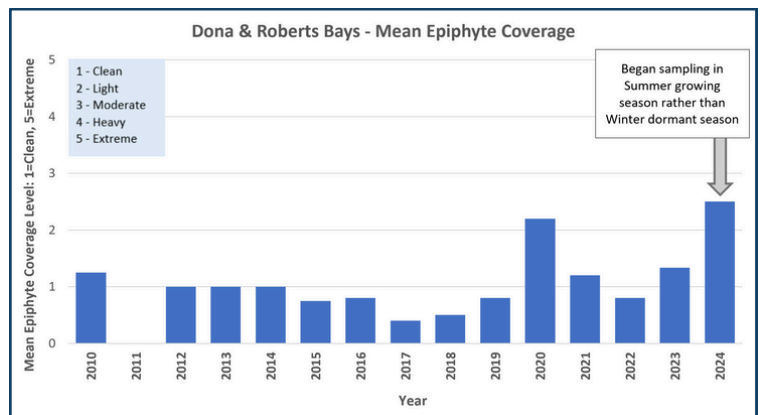
The bar graphs below depict the changes in presence of different species of seagrass found at monitored locations in Dona & Roberts Bays. Persistent seagrass species include Shoal grass (*Halodule wrightii*), Turtle grass (*Thalassia testudinum*), and Manatee grass (*Syringodium filiforme*) for the years 2010–2024. The graphs demonstrate that Turtle grass and Manatee grass saw drastic declines in abundance at multiple monitoring locations starting back in 2016. Data collected in 2024 demonstrate large gains for seagrass throughout the region, though not full recovery.

The reason for this decline is complex and likely involves several factors. This includes impacts from recent storm events such as additional nutrient polluted runoff from land, Hurricane Irma, increased temperatures and rainfall, as well as prolonged red tide and algae blooms in the region. The CHNEP continues to work with our partners to better understand causes and investigate solutions.
